Our Ref: JBA 21/346 ECO03

RE: Updated internal and external inspection of buildings to be impacted at The Gables, Kelvedon Road, Tiptree, Essex.

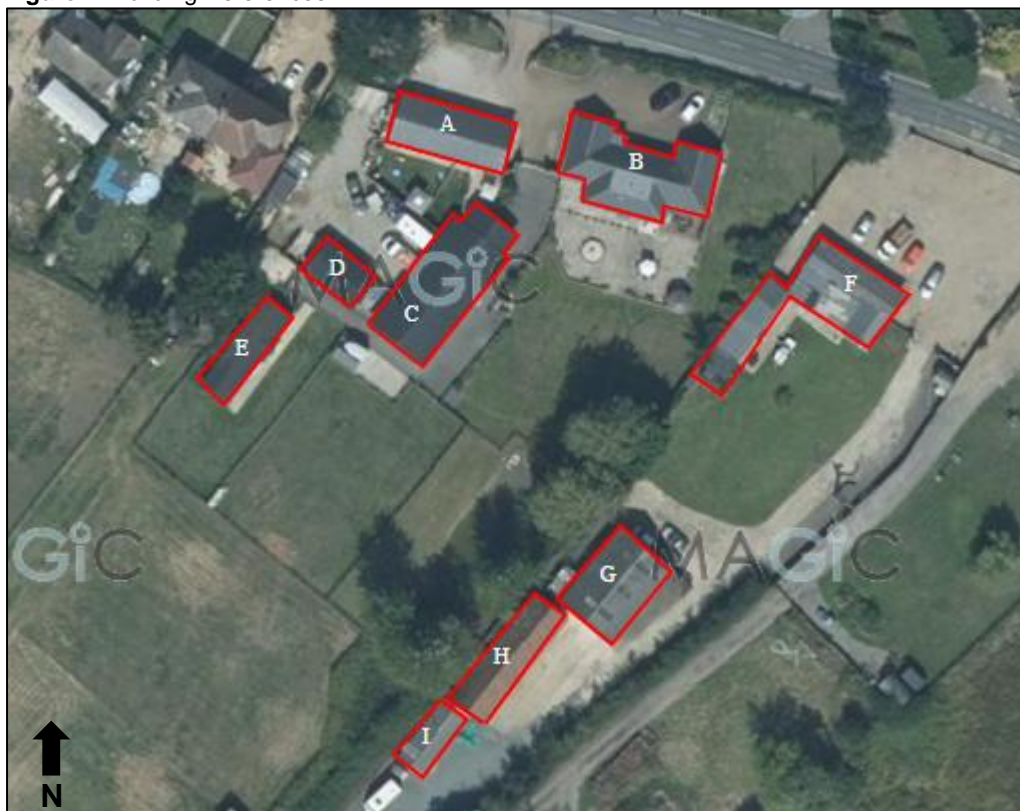
Figure 2: Building References

The site consists of nine buildings of varying size and condition (see Figure 2 below for building references); with three being active accommodation.

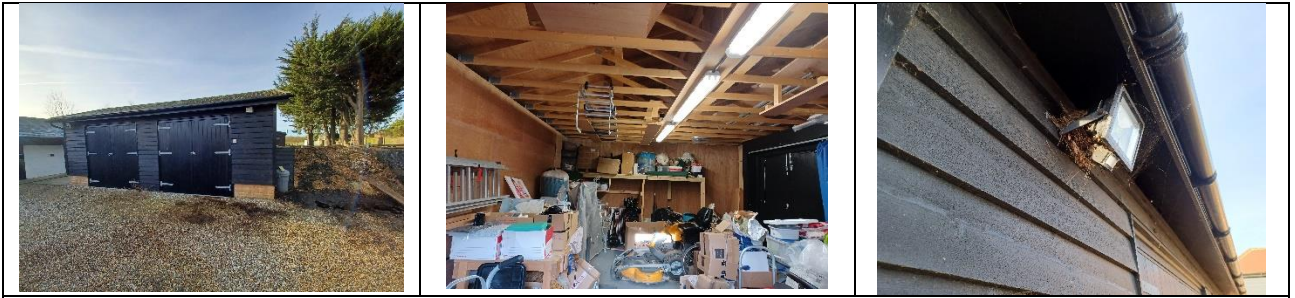
Building E is an office building, although not in regular current use. The previous survey commented on the tight seals to all walls and roofing, with no potential roosting features found. No change had occurred since the previous survey, with no features found, although with cobwebs around the exterior. Building E is considered to have 'negligible' BRP.

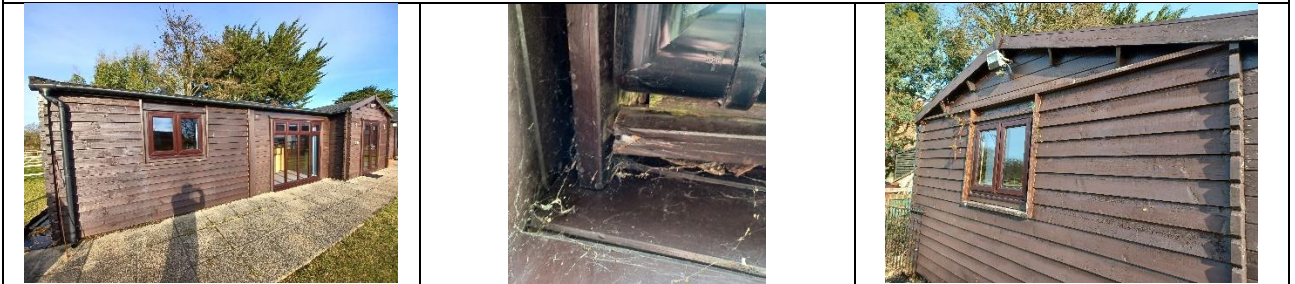
Building F is comprised of 2 single-storey buildings, actively used as residential properties. The building to the north has a loft, however access is not possible. The previous survey noted both buildings were tightly sealed and lacked any features that could be used by roosting bats. Some change has occurred to building F since the previous survey, although overall these buildings were intact and sealed, as well as being actively used. The only change observed was on the northern building with two cavities on the eastern fascia observed, and one gap under the fascia on the northern side. Part of the northern building

has white walls, with no staining apparent. The main accommodation to the north was considered to have 'low' BRP, with the link accommodation to the west considered to have 'negligible' BRP.

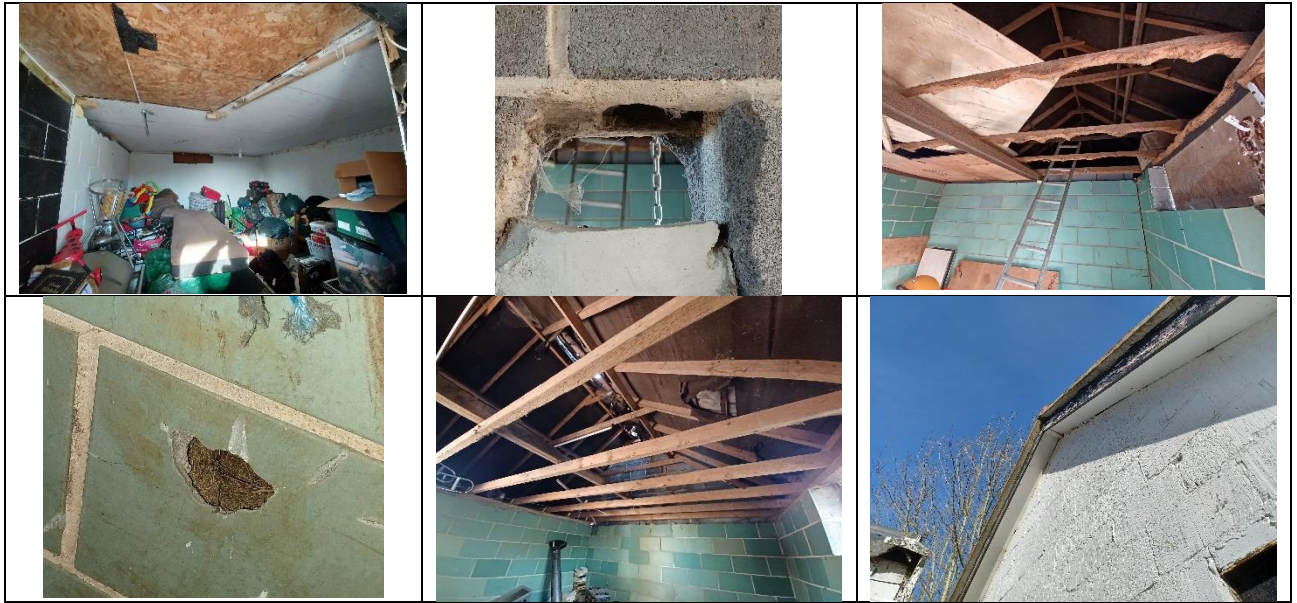
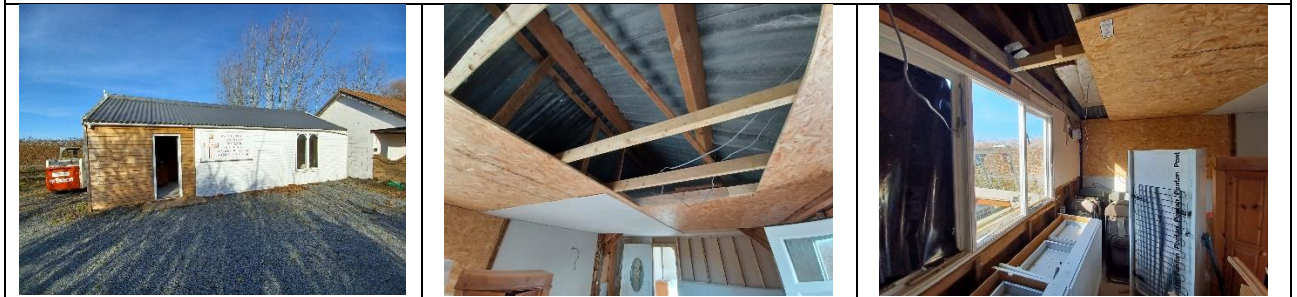
Building I is a single storey, detached building with a corrugated asbestos roof and white boarded walls. The previous survey found no evidence of bats upon loft inspection. There has been some change since the previous survey, with some degradation of the building observed. On external inspection, shifted ceiling boards meant the loft was able to be accessed from the ground floor, with some dark and undisturbed corners noted, as well as hole in the asbestos roofing. Suitable, large gaps behind the boarding on the walls were also observed. However, no droppings were noted at the time of the survey. Building I was considered to have 'low' BRP.
