SCHEDULE OF CONDITION

***ST. PETER'S CHURCH
BIRCH
COLCHESTER, ESSEX***

Inspected on: 25th June 2003

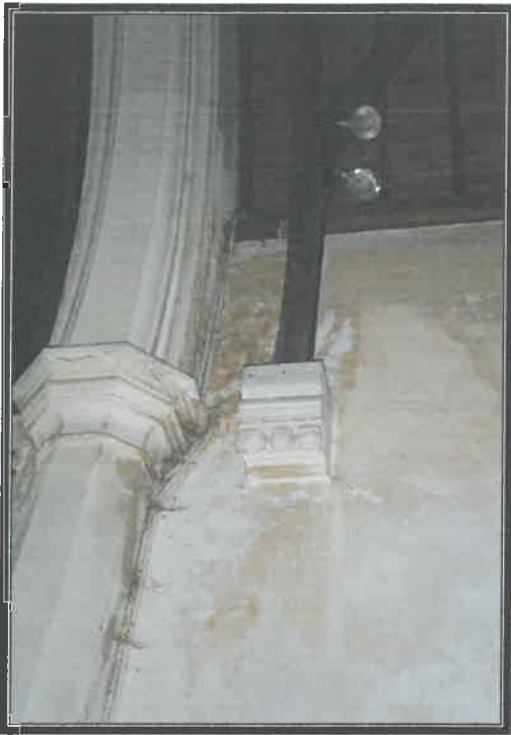
DAMP TO WALL IN CHANCEL

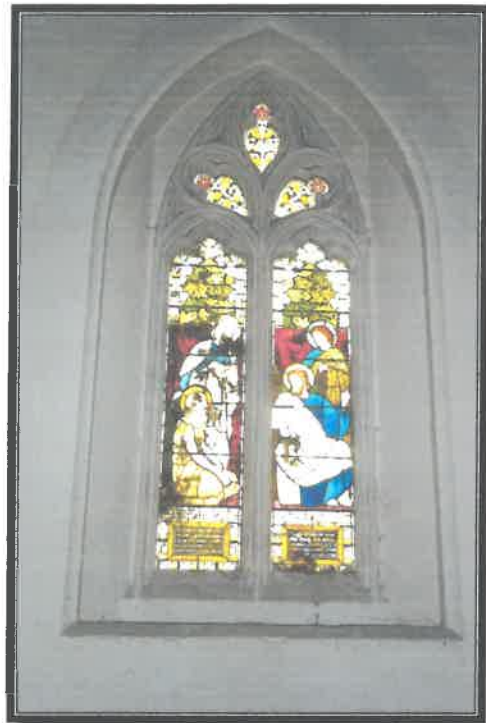
INTACT BUT UNPROTECTED STAINED GLASS WINDOW

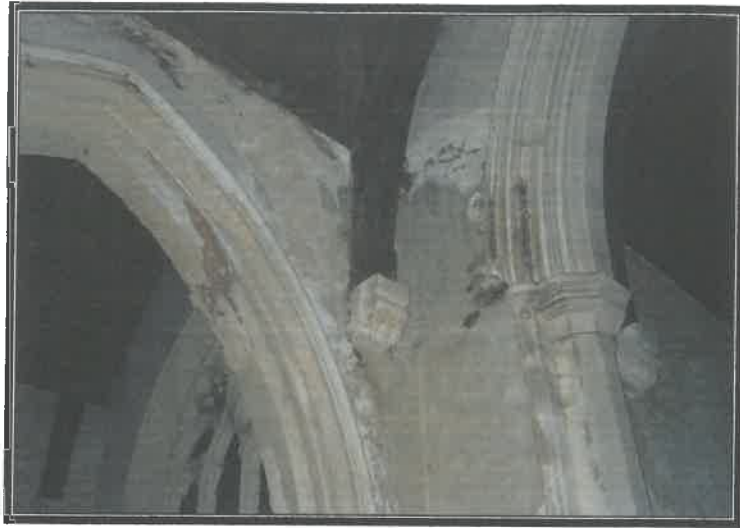
The walls appear to be in generally good condition although very dirty internally. There are signs of minor hairline cracking in numerous areas to the plaster together with signs of damp penetration at the wall/roof abutments, which is causing the limewash to flake, particularly to the left hand side over the arches and capitals of the North aisle and through the external wall. At these locations there are noticeable signs of damp that is affecting the internal walls and causing deterioration. Some further damage is also evident to the stone reveals and detailing around the entrance door, whilst at the far end of the building in the Chancel there are two areas to the left hand side by the door leading to the Boiler room that are badly damaged.

SIGNS OF DAMP AT WALL/ROOF

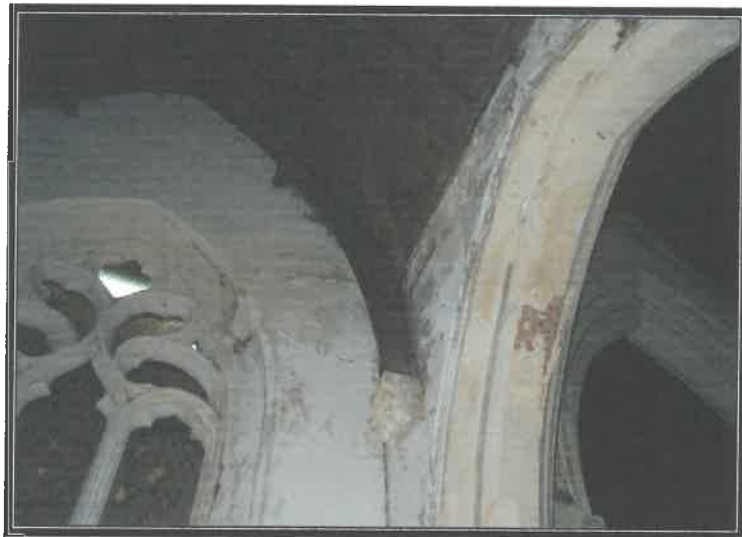
SIGNS OF DAMP AT WALL/ROOF

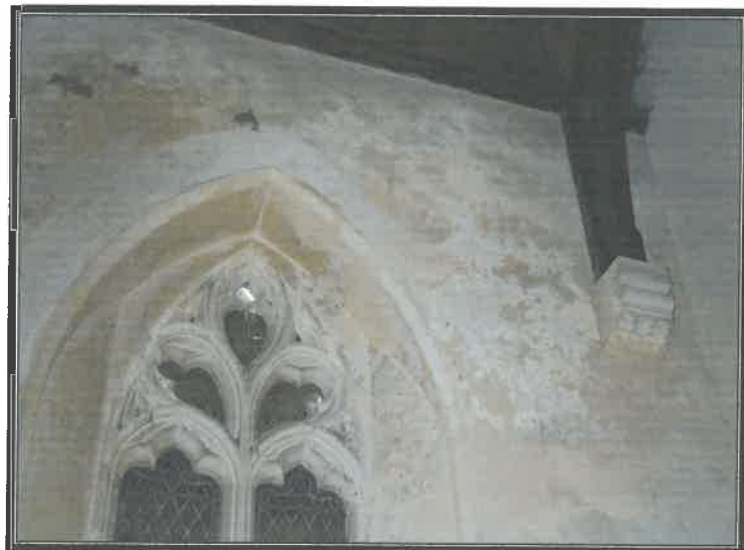
SIGNS OF DAMP AT WALL/ROOF

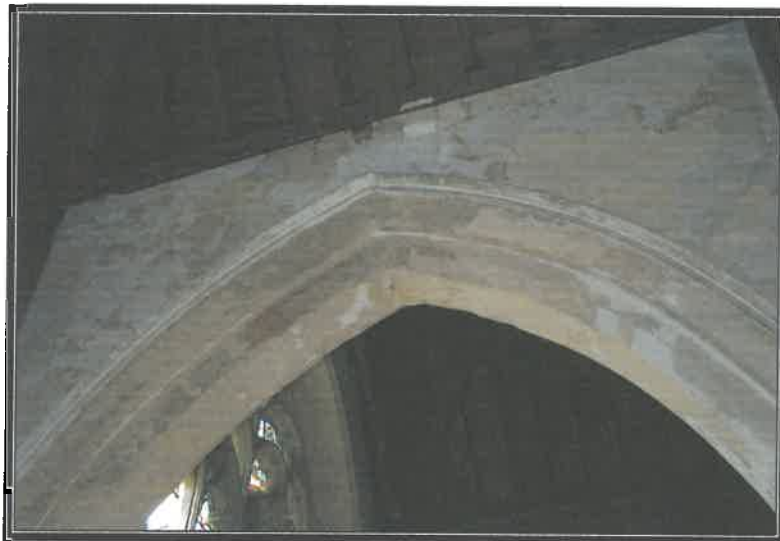
SIGNS OF DAMP AT WALL/ROOF

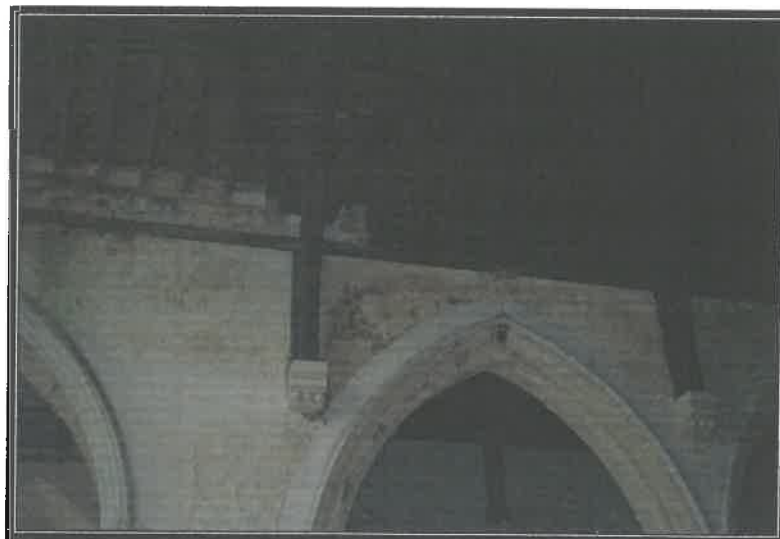
SIGNS OF DAMP AT WALL/ROOF

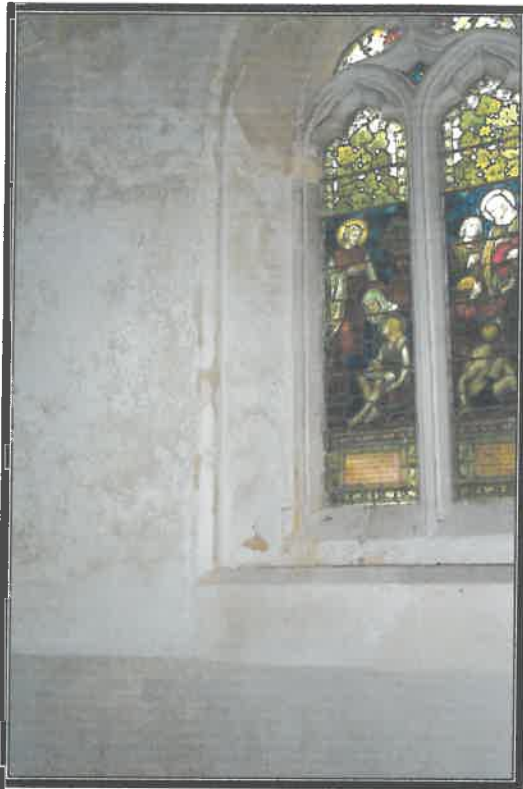
PARTIALLY PROTECTED STAINED GLASS WINDOW

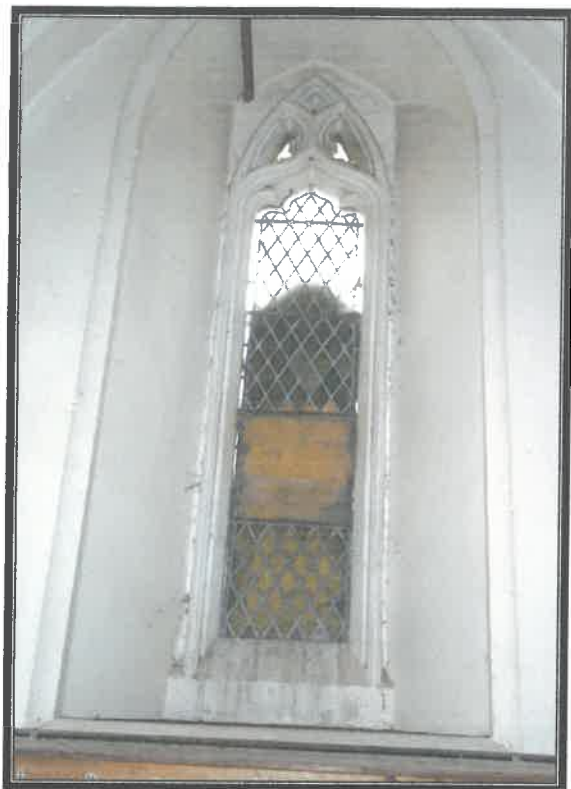
Most of the windows appear to be in good condition but some have suffered damage, although this has been generally to the clear leaded glass lancet windows that are not boarded and most noticeably to the stained glass window above the entrance door also unprotected.

DAMAGED LEADED LIGHT WINDOW

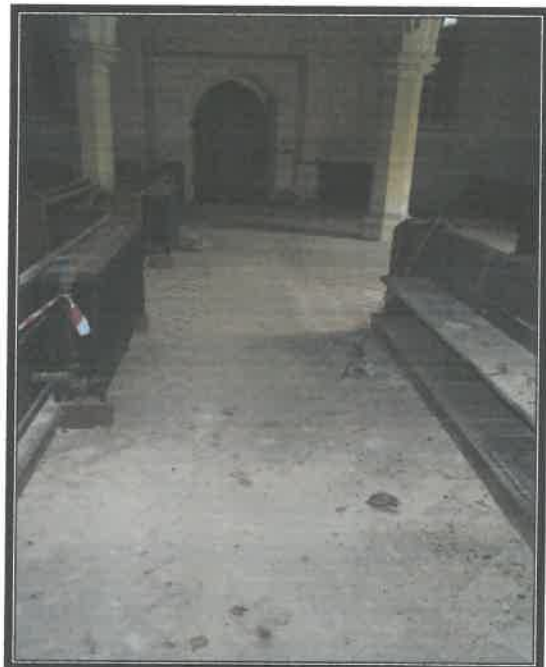
All tiles and stone blocks would appear to be generally in good condition, however, it was evident that large areas had been cut out and made good using concrete, particularly to the left hand side behind the pews of the North aisle and also along the Nave.

CONCRETE REPAIRED FLOOR TILES

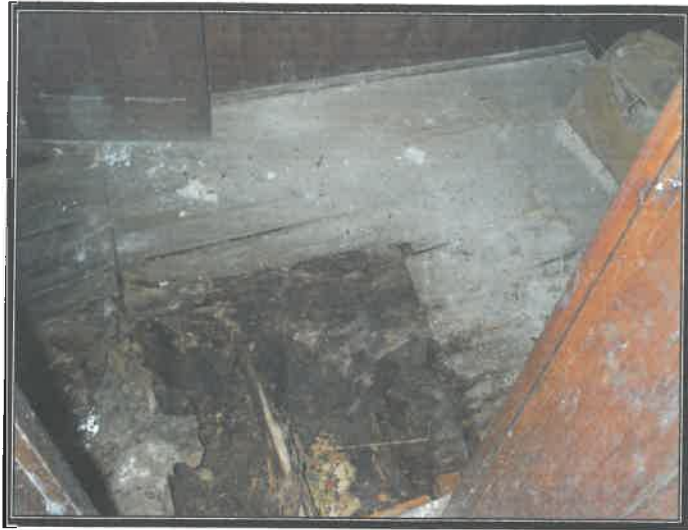
The vaulted roof timbers generally appear in good condition, however, there are serious signs of rot and deterioration to the Vestry enclosure. There are signs of wet rot with what also appears to be dry rot and the existing floor has collapsed due to rotten floorboards and floor joists. Furthermore there are signs of fungal infestation beneath the fuse box on the front wall, which would appear to originate from a leak stemming at high level from the roof. The pews to the main church appear in reasonable condition although they are both dirty and dusty which limited the inspection possible. However, it was noted the first bench to the left hand side of the North aisle on entering the building is showing signs of rot and damp deterioration. It was noted that no pews or bench seats were installed in the Chancel, this chorister seating having previously been removed.

ROTTEN FLOOR TIMBERS TO VESTRY

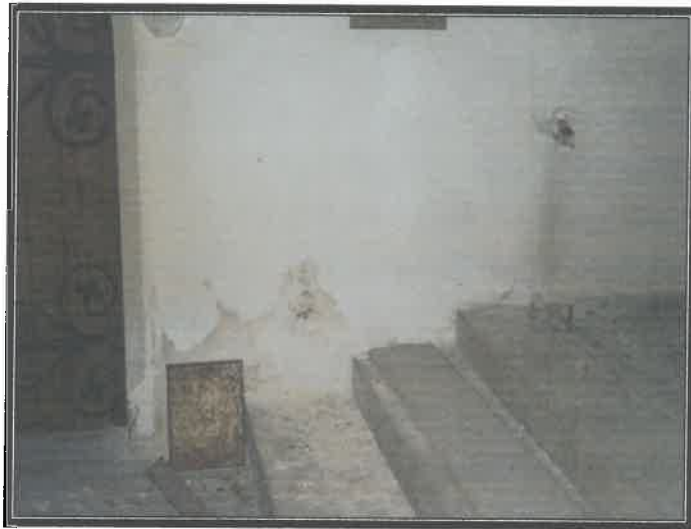
DAMAGED WALL IN CHANCEL

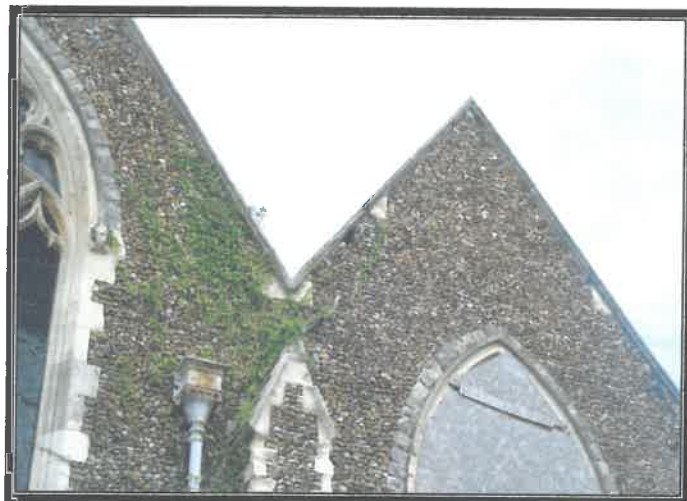
The stone detailing to window and door openings appeared in fair condition, although there were signs in a number of areas of decay and deterioration. It was noted that numerous areas were affected by ivy that has climbed over the building and whose vines are established on the stonework to the elevations. In some places this has been cut back, although it is generally in abundance over the elevations of the property, particularly to the left hand side. Furthermore it was noted that moss has established itself in a number of areas on the stonework particularly to the low level detailing on the rear elevation to the left hand side. Further close inspection of the elevations was not available due to the protective corrugated galvanised hoarding located around the perimeter of the church. At high level to the right hand side elevation, two areas of the stonework render had fallen away from the wall exposing the inner leaf of the stonewall.

IVY GROWTH TO EXTERIOR AND MISSING STONWORK AT ENTRANCE

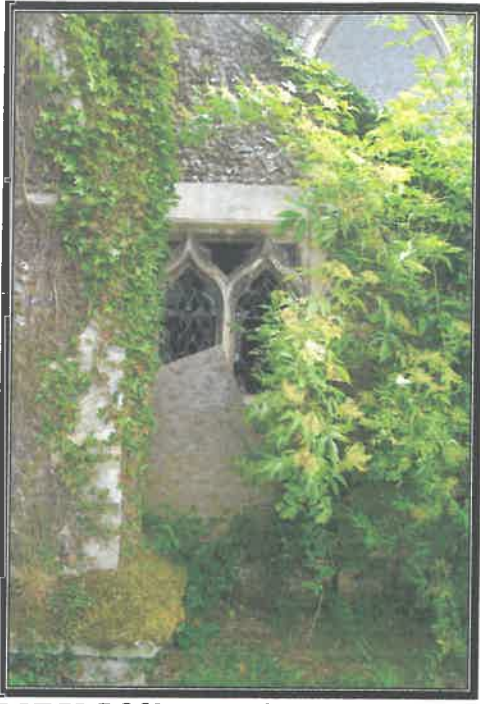
BOILER ROOM WINDOW UNPROTECTED

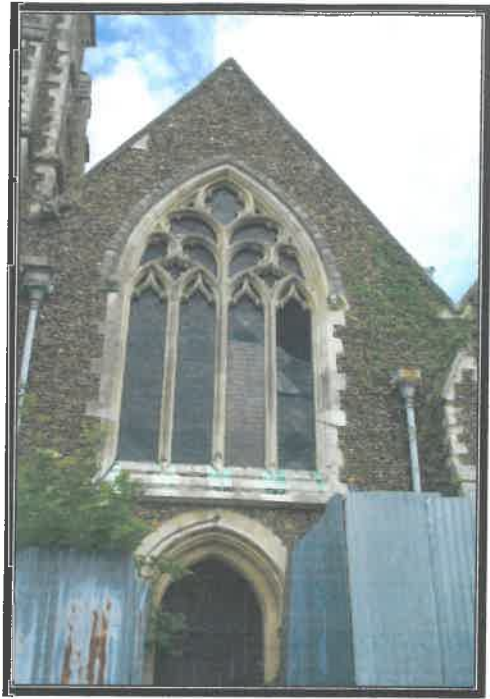
DAMAGED STAINED GLASS WINDOW AT
ENTRANCE

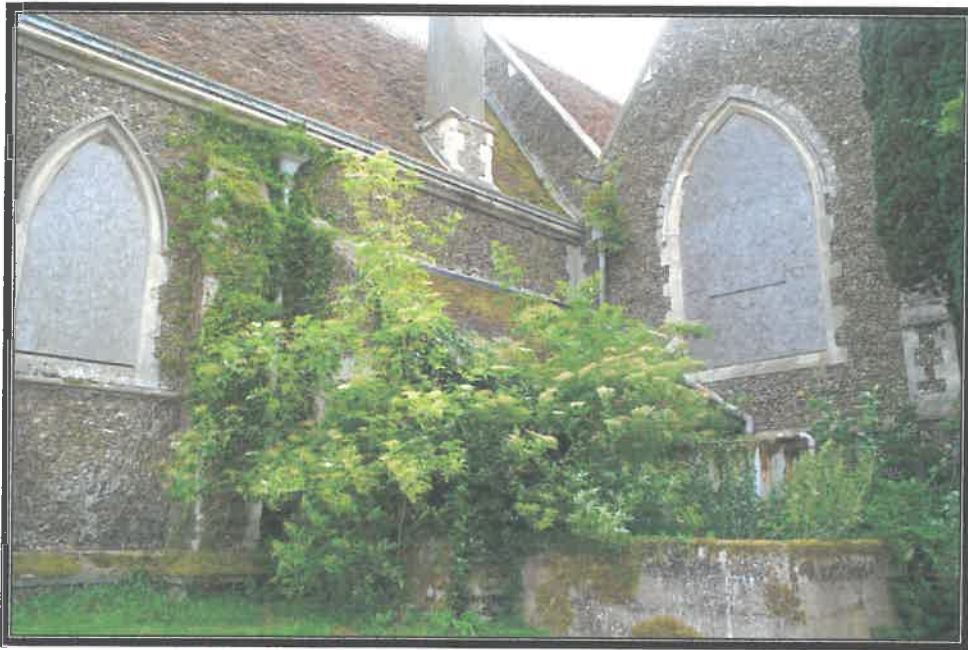
EXTERNAL VIEW OF BOILER ROOM AND TANK WHERE OVERGROWN

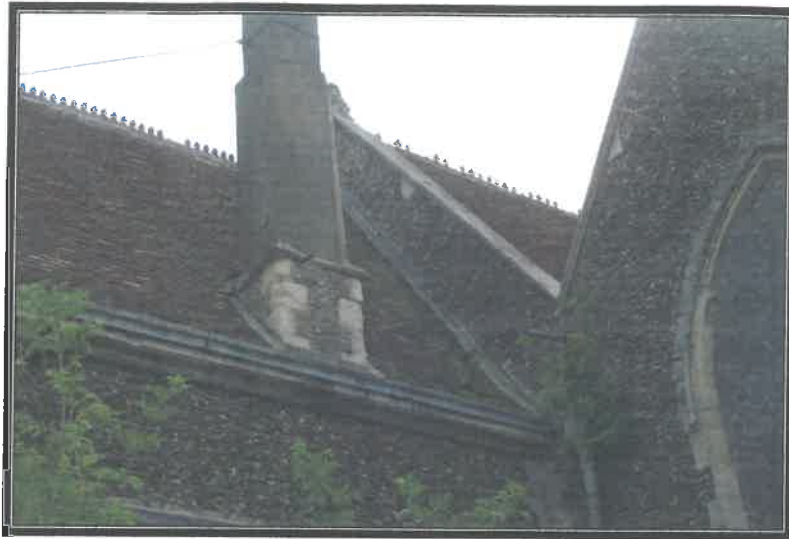
Generally the pegtiles to the roof appeared in fair condition although it was noted that to the right hand side elevation above the Porch there was an area close to the ridge of the roof at the centre of the pitch where approximately 100 No. pegtiles appeared to be loose or deflected, approximately 10 No. of which were actually missing. It was also noted to the small side addition roof of the Porch on the right hand side that there were also some defective pegtiles visible to this roof area. The cast iron ogee gutters to the perimeter of the building appeared to be in generally good condition although some signs of rusting were apparent together with leaks from the gutter joints that were beginning to wash/wear the stonework detail beneath the gutters causing staining and deterioration. We believe from our inspection that some of these rainwater goods are blocked. No inspection was available to any valley gutters at the time of our inspection, however, evidence would suggest due to the internal leaks at the areas of the roof/wall abutments within the Church that these may also be blocked or defective valley gutters to the roofs of the building.

VIEW OF BLOCKED GUTTERS AND RAINWATER PIPE TO CHANCEL

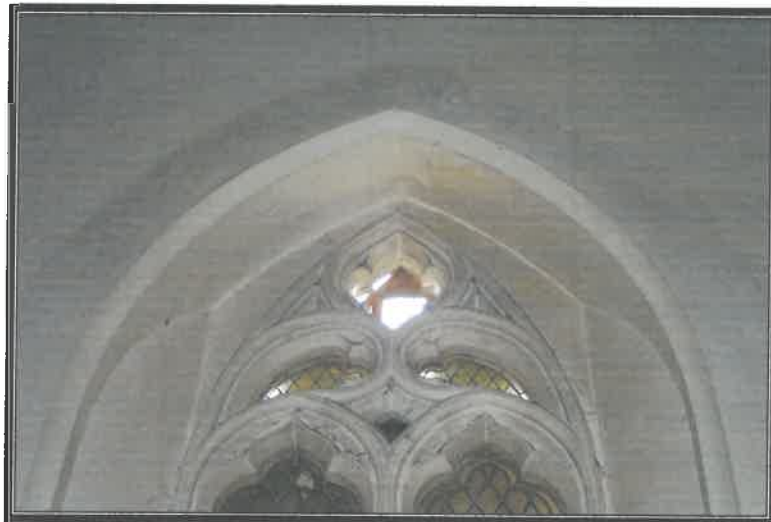
EXAMPLE OF DISCOLOURED WALL INTERNALLY

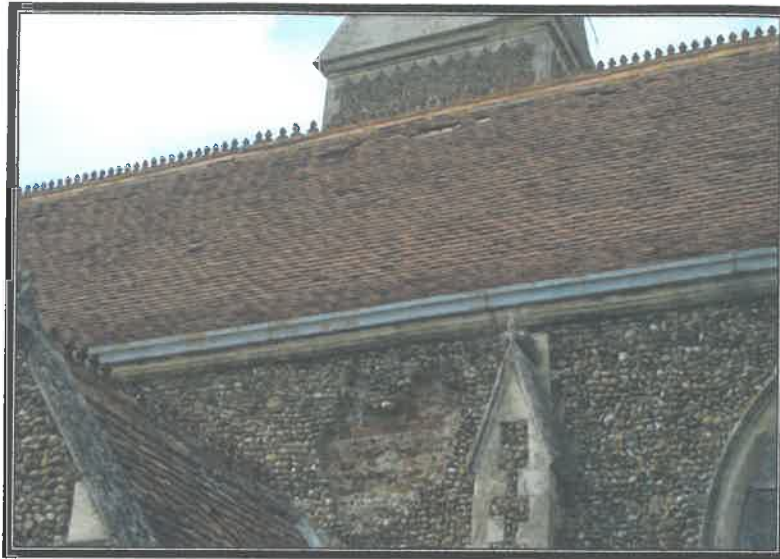
DEFECTIVE STONE FLINTS

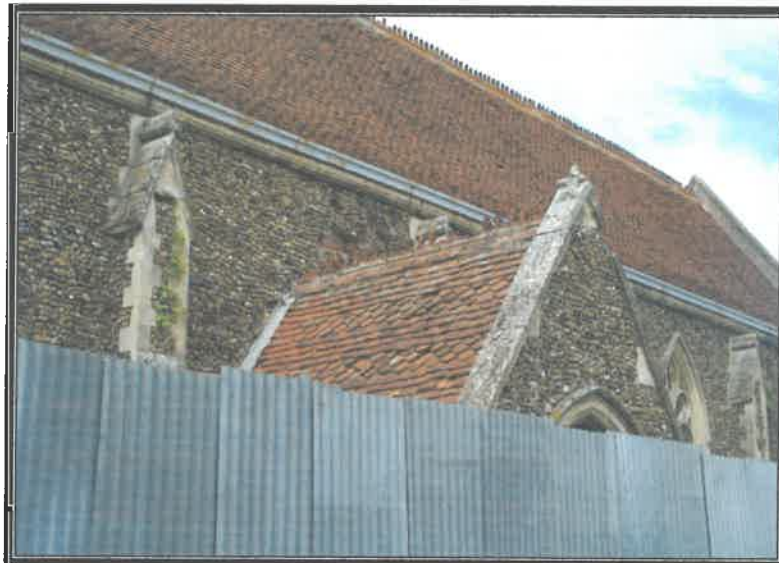
MISSING STONE FLINTS TO RENDER AND DAMAGED STONEMWORK TO RIGHT HAND SIDE

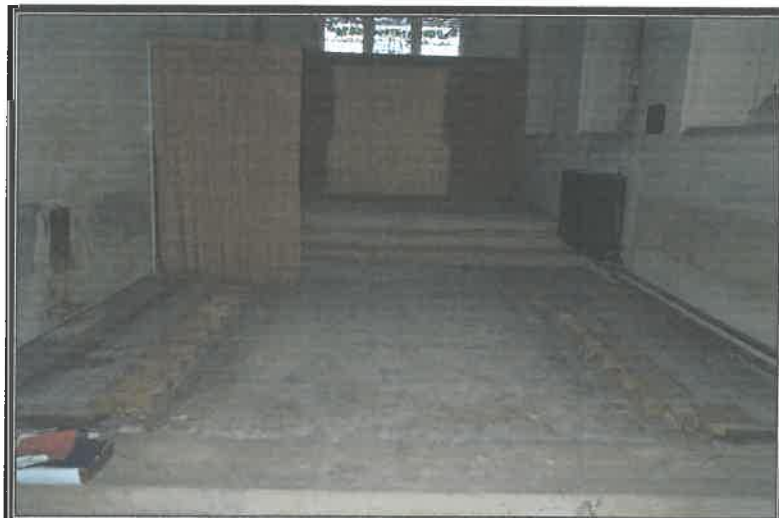
INTERNAL VIEW OF CHANCEL WITH CHOIRISTERS SEATING REMOVED

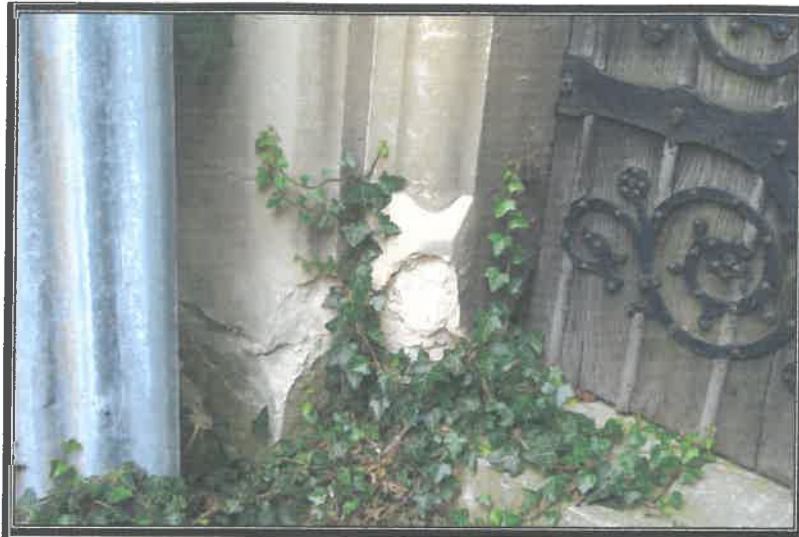
DAMAGED STONWORK TO FRONT ENTRANCE

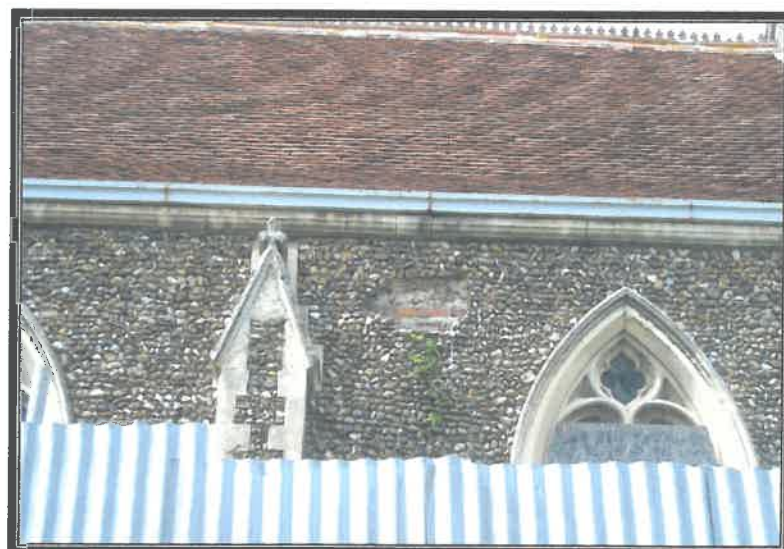
SECTION OF MISSING EXTERNAL STONE FLINTS TO RIGHT HAND SIDE OF CHURCH

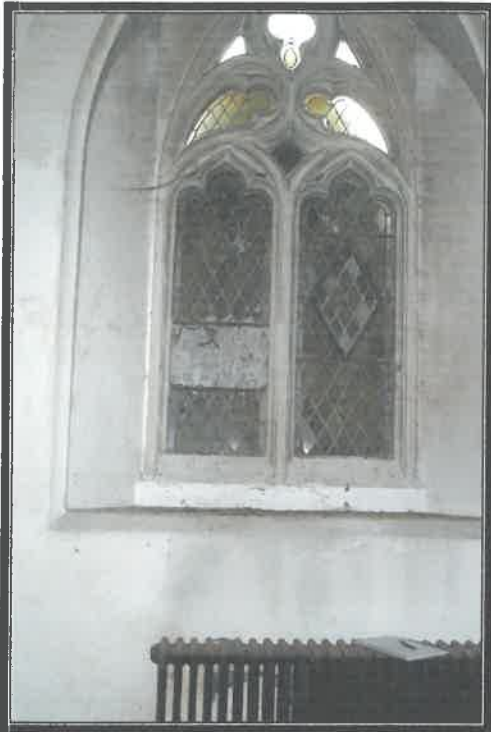
BROKEN GLASS TO BOARDED WINDOW

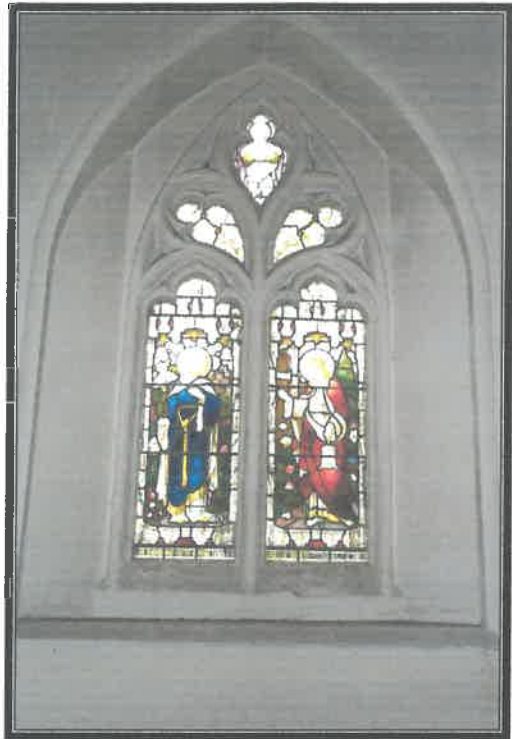
UNPROTECTED STAINED GLASS WINDOW

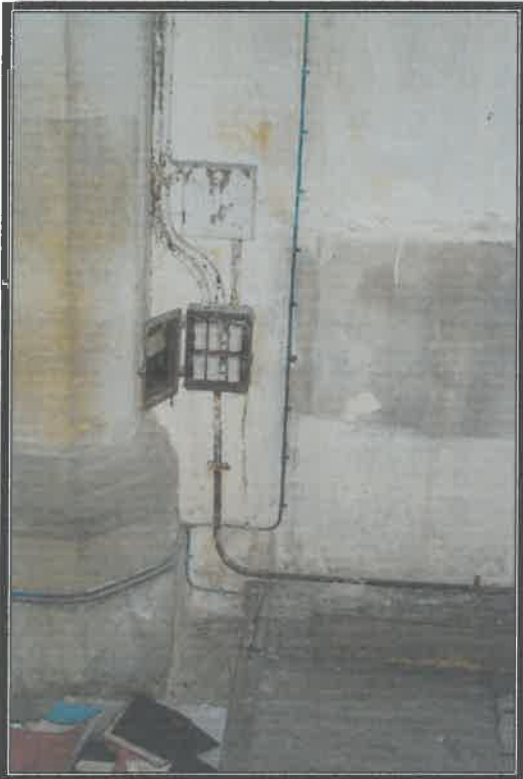
The electrical and heating services to the church do not appear to be functioning and are in poor condition. It was noted that 8 No cast iron radiators were installed to the Nave, North and South aisles whilst there were 2 No. further cast iron radiators located to the Vestry and the Chancel. No access was available to inspect the Boiler room during the inspection, however an inspection through an unboarded external window showed the plant to be in poor repair and condition. It was noted that the fuse box within the Vestry appeared to be in poor non-functioning condition and has suffered water/damp penetration from a leak above at high level to the roof.

CORRODING FUSEBOX IN CHANCEL

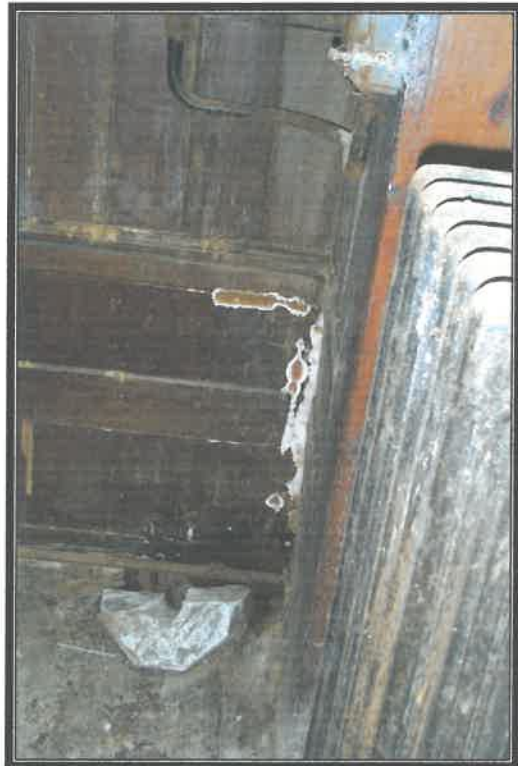
DAMP/FUNGAL GROWTH TO VESTRY

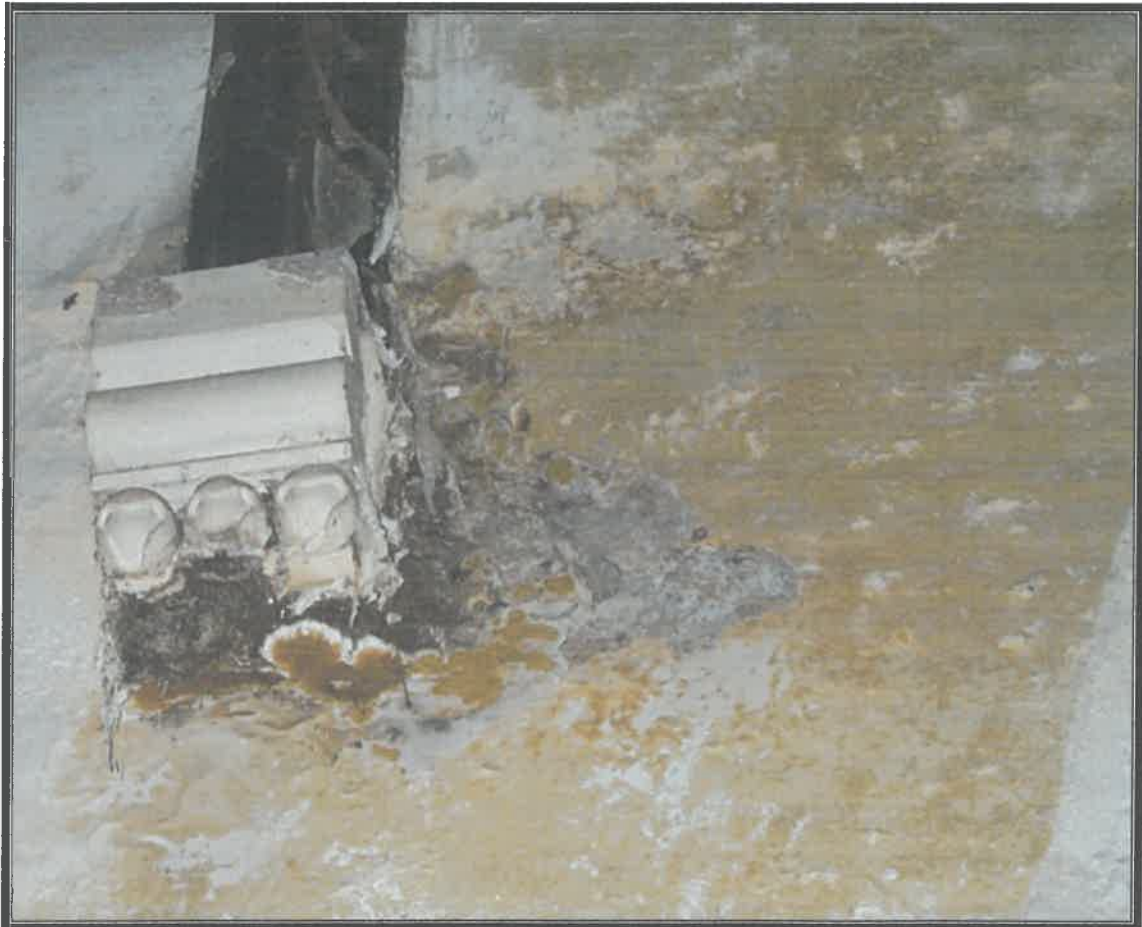
SIGNS OF DAMP AND FUNGAL GROWTH AT HIGH LEVEL CORBEL
