ST PETER & ST PAULS CHURCH, BIRCH, ESSEX
Condition Survey

January 2012

Condition Survey

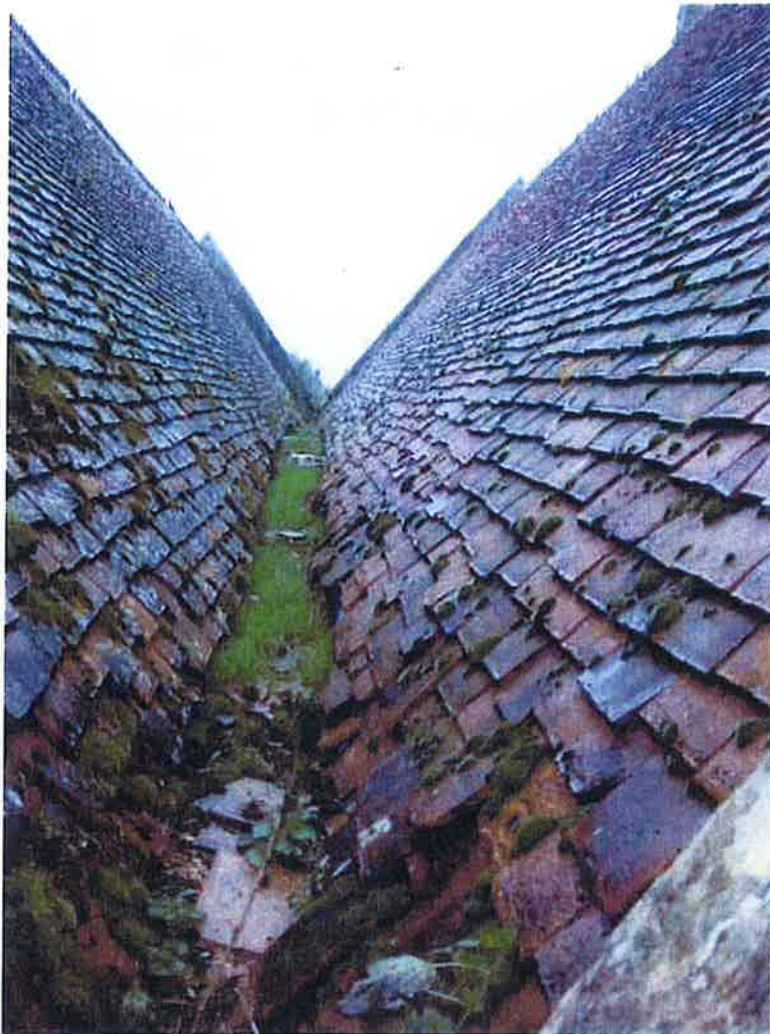
- 3.6 A restricted visual inspection from a ladder only was made from the east end of the valley gutter between the nave and south aisle (see image 01) which shows that there is extensive vegetation and debris which is badly blocking the gutter and will undoubtedly be leading to serious water penetration and possible decay.

Image 01: View of the valley gutter between the nave and south aisle

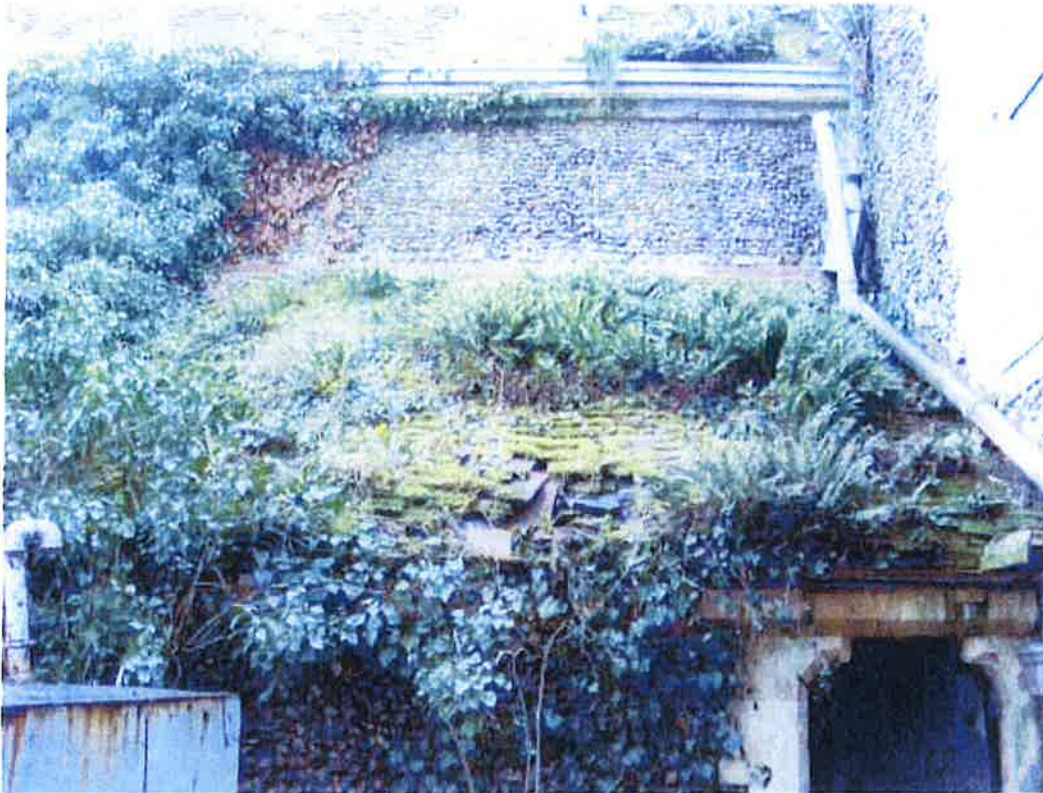
- 3.8 The south porch roof has extensive tile slippage and rainwater penetration is occurring.
- 3.9 The roof to the boiler house has extensive ivy growth and vegetation. There are areas where the roof structure has collapsed and serious rainwater penetration is occurring into the structure below (see image 02).
- 3.10 Generally the rainwater fittings are in poor condition which ranges from severe deterioration through rusting as can be seen across the north slope of the north aisle, as well as areas where guttering, downwater pipes and fittings have broken loose and become dislodged, causing further extensive rainwater penetration into the lower areas of the fabric.

Image 02: The boiler house roof

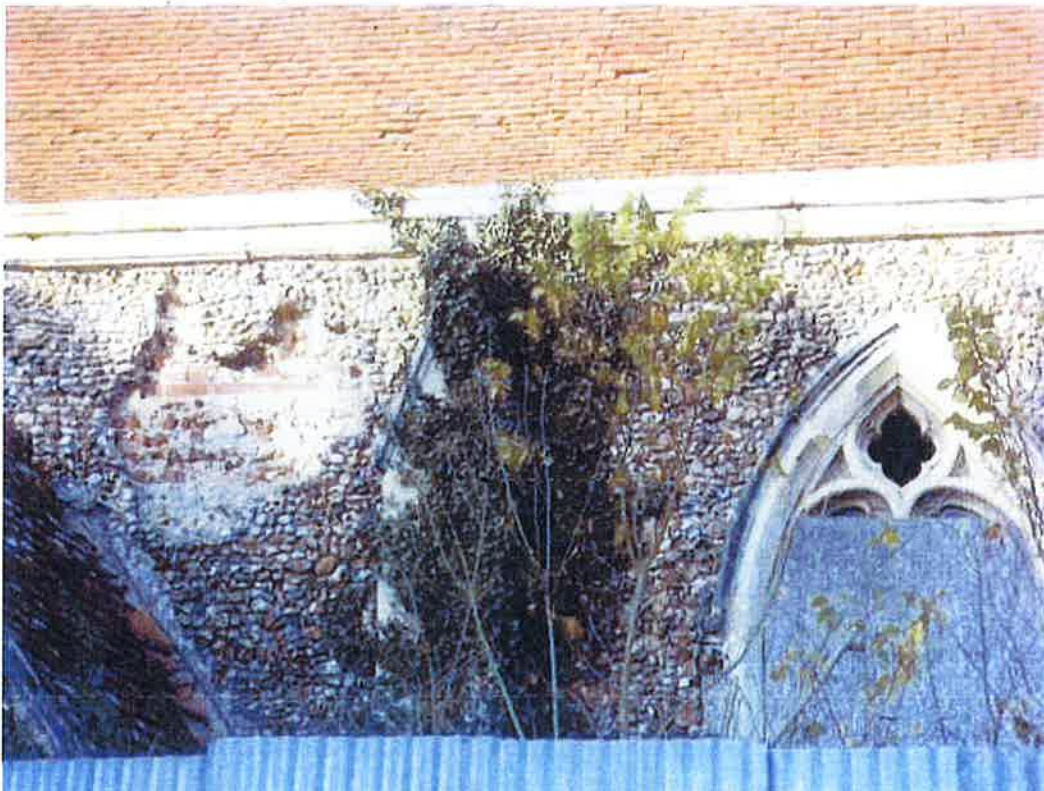
- 3.12 Masonry collapse has occurred to the wall face above the porch roof where a large area of flint work, approximately 1.5 sqm has broken loose and fallen onto the porch roof causing damage to the tiles. This area is now particularly vulnerable to further collapse as the masonry core has been revealed and remedial repair is urgently required (see image 03).

Image 03: Area of flint collapse above porch roof

Priority A: Undertake localised repair to the flint work:

£4,500

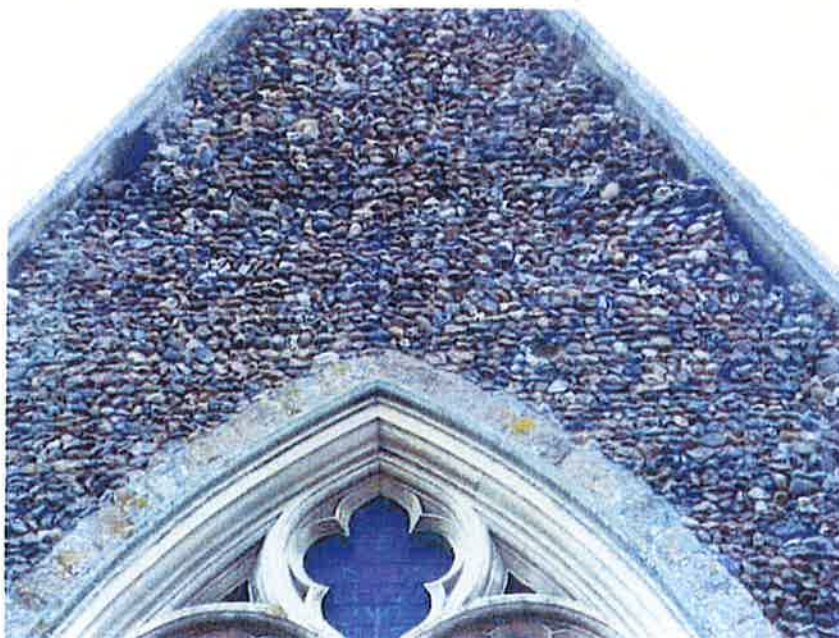
3.18 Flint work at high level is starting to fall away, primarily to the underside of the gable coping stones on both the north and south slopes, which if not attended to as early as possible, will lead to further deterioration and possible collapse of larger areas (see image 04). The lower areas of the wall are in a reasonably sound condition, but this will be dependent upon attention to the damage at high level.

Image 04: Flint work falling away below copings

Priority A: Repair flint work: £8,000

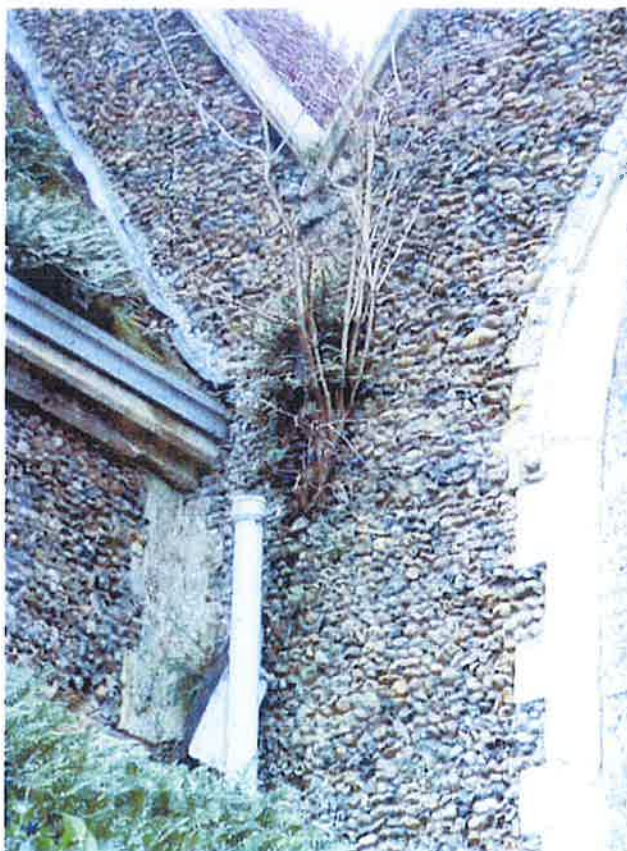
Image 05: Vegetation growth and damaged rainwater fittings

Remove vegetation and repair wall:

Approximately £8,000

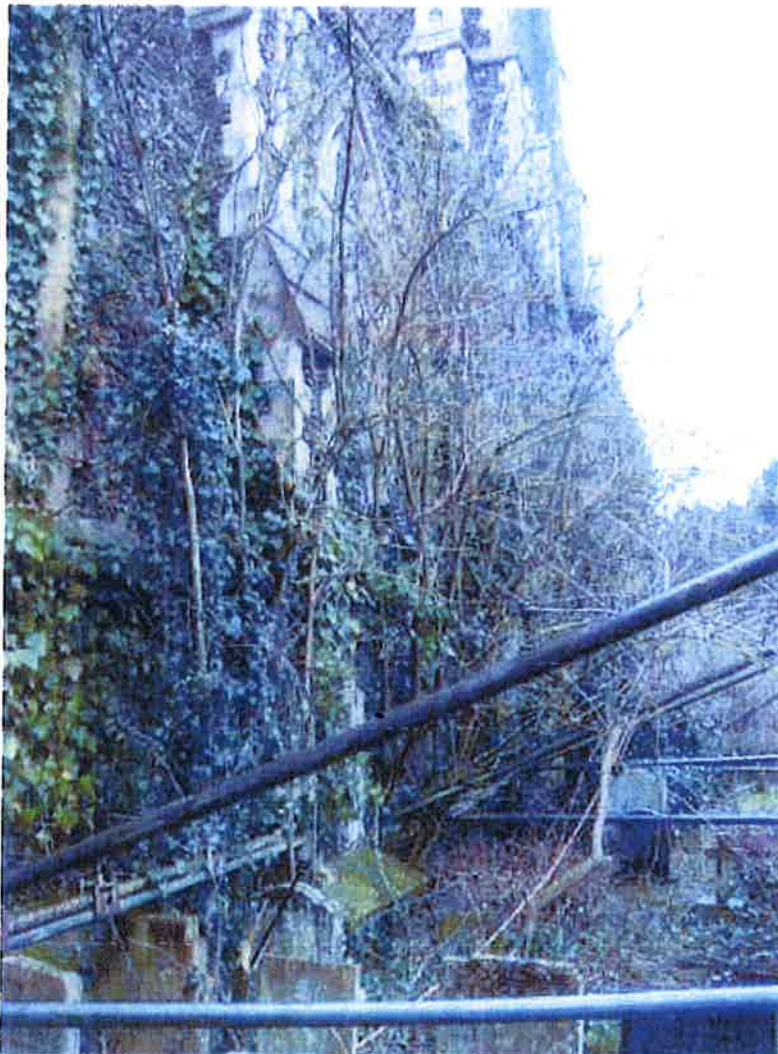
- 3.27 Three of the four windows to the north aisle north elevation have been boarded over with plywood, preventing close inspection of the glass and stonework behind. The remaining window is heavily engulfed with vegetation and will require repair and stabilisation of the stonework.
- 3.28 A hoarding has been constructed across the north side of the north aisle and beyond the west face of the tower, which has become heavily choked with vegetation and saplings, preventing proper access for inspection of this elevation (see image no 06).

Image 06: Vegetation growth along the north elevation

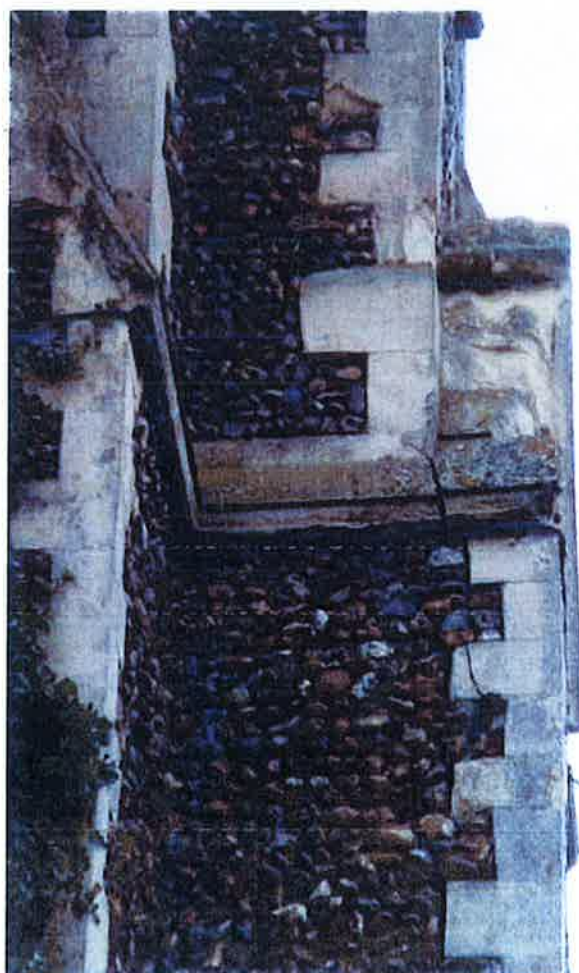
- 3.32 It was not possible to closely inspect the facades of the tower, although there is clearly evidence of movement in the masonry, particularly at the mid-point of the north west buttress where vertical cracking has occurred between the protective capping and passing down behind the quoins (see image 07).

This requires further investigation as soon as possible to ensure that collapse does not occur.

Image 07: Cracked masonry to the tower

Priority A: Engineer to inspect cracking and give recommendations.

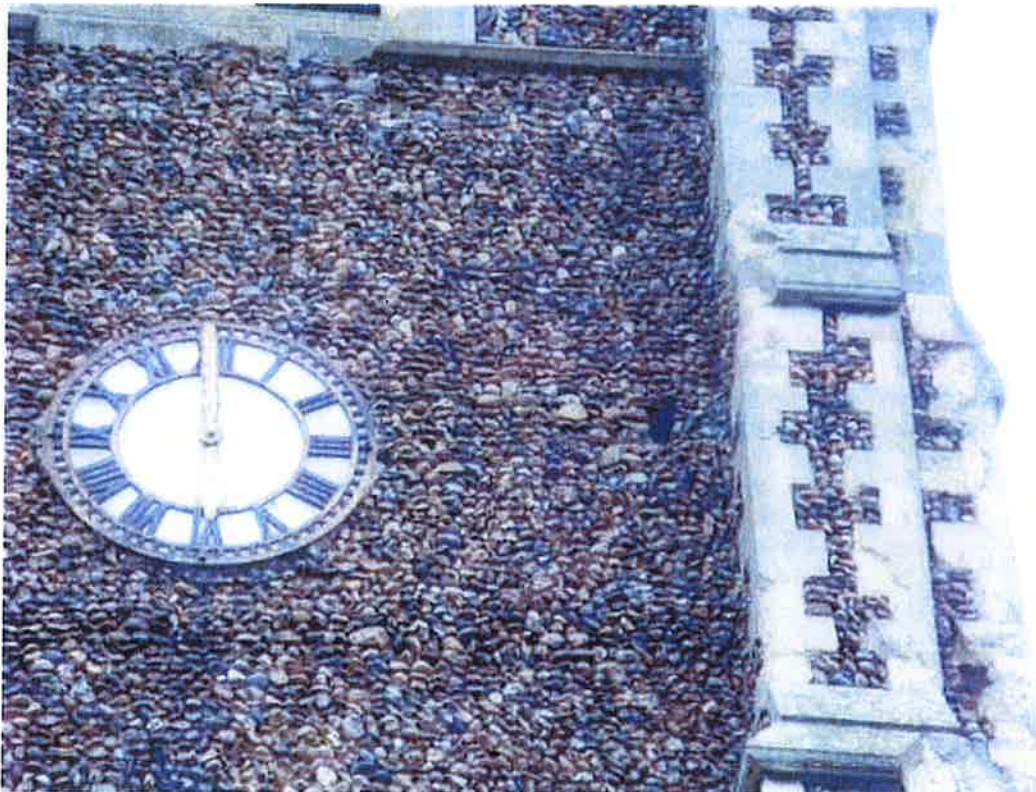
3.35 Generally, miscellaneous areas of flint have fallen away from the facades of the tower, primarily due to its exposed position and it is important that remedial repairs and reinstatement take place as early as possible to prevent a larger area coming loose from the façade. In particular, there are areas adjacent to the clock face and at high level on the west elevation, as indicated in image 08.

Image 08: Flint work has fallen from the tower

Priority A: Repair flint:

£10,000

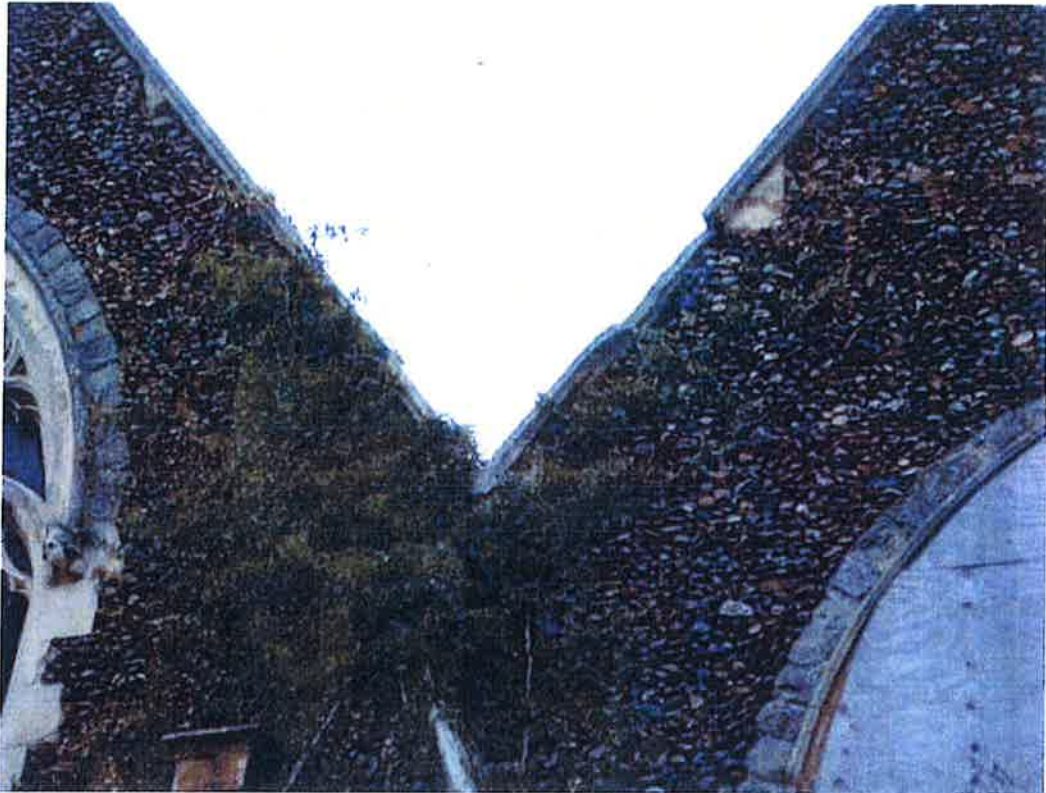
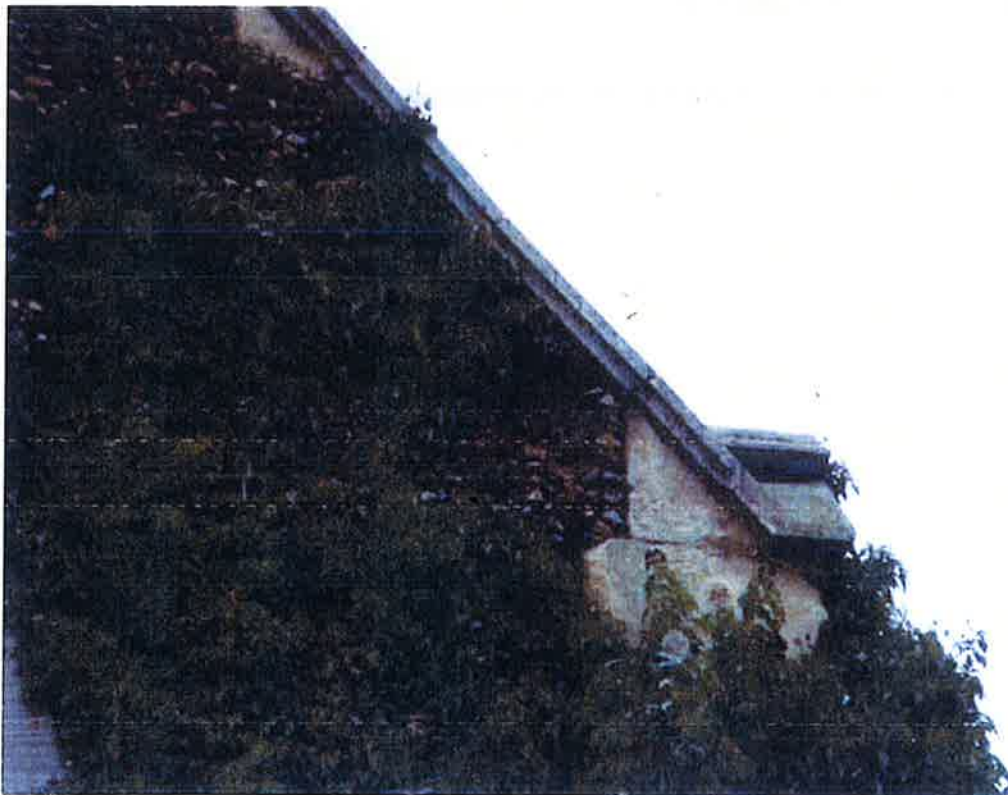
- 3.41 Masonry and flint have broken loose below the gable parapet copings and will require remedial repair (see images 09 and 10).
- Priority A: Repair flint work and stone: £12,000**

Images 09 and 10: Damage to flint and stone work

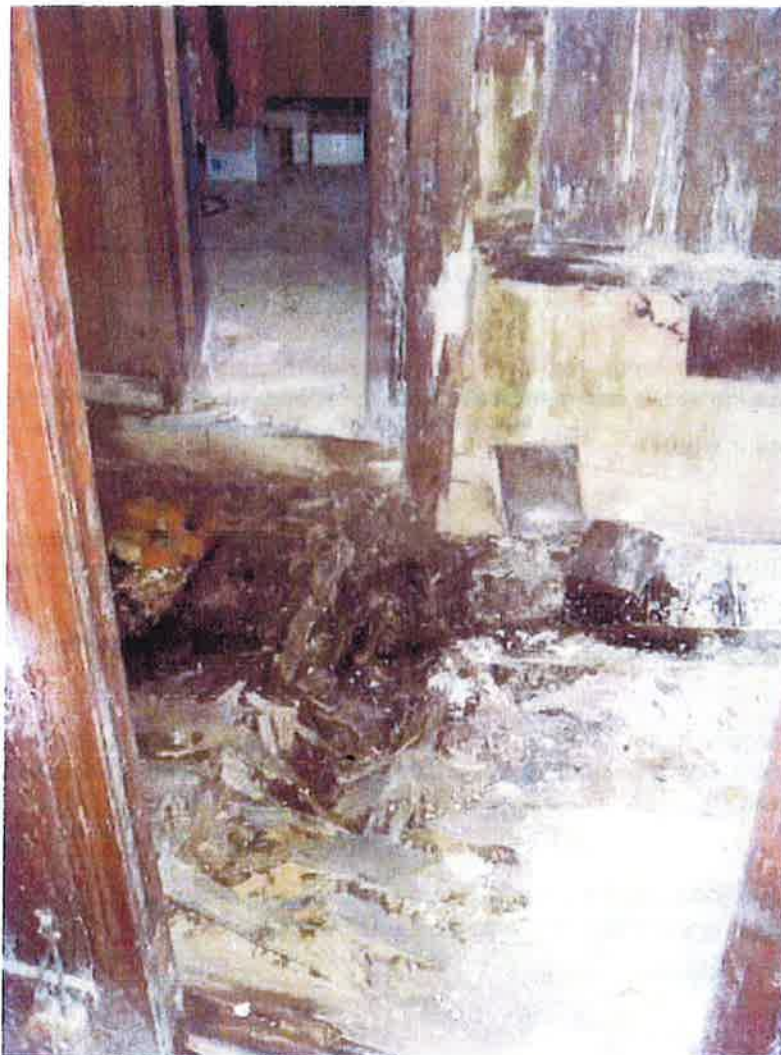
- 4.11 There is a small cubicle vestry at the north west corner of the nave which has a timber floor, however due to the rainwater penetration from above, this has now completely deteriorated and collapsed (see image 11).

Image 11: Collapsed floor to cubicle vestry

Priority A: Repair floor: £8,000

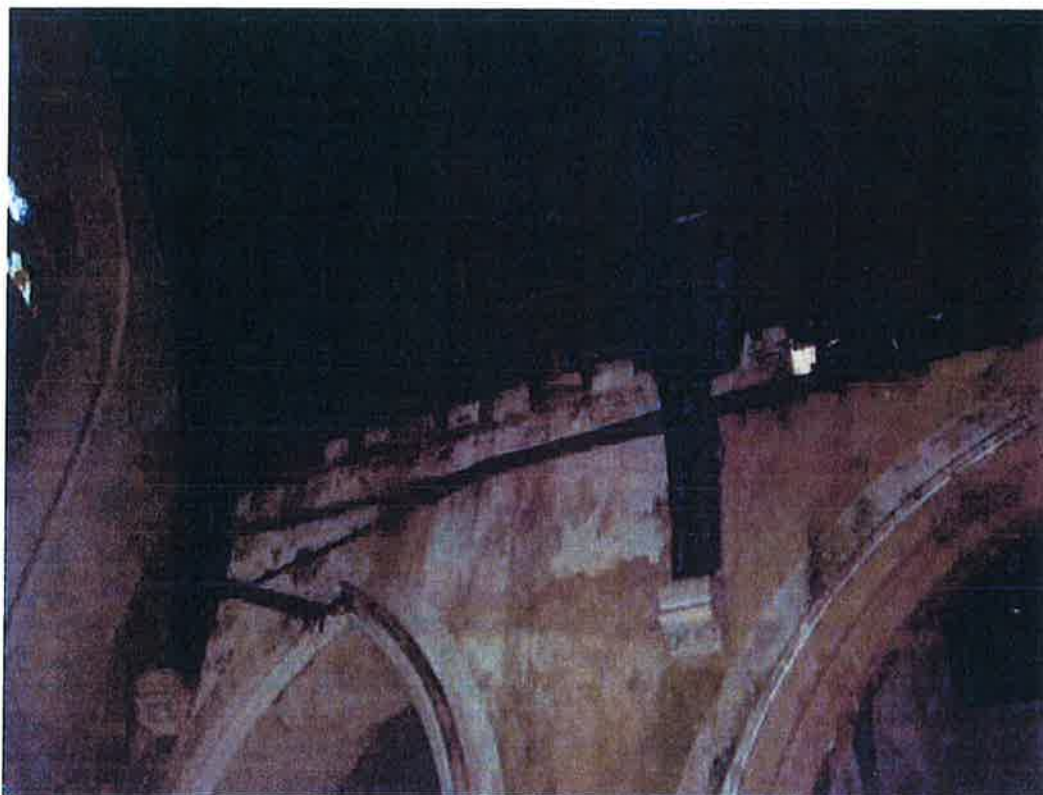
Image 12: Water penetration at high level to the nave, note daylight coming through

- 4.12 Rainwater penetration is occurring along the full length of the nave and causing serious damage to the plaster and stonework below, and particularly to the west end where again daylight can be seen through the north slope adjacent to the junction with the tower (see image 12).
