THE MORTON PARTNERSHIP LTD.

RE: ST. PETER'S CHURCH, BIRCH, COLCHESTER, ESSEX

As you are aware I attended site on Thursday 4th July 2013, in order to carry out an inspection of the Church to provide comments on the structural condition, and also to comment on the proposals to part demolish the building, with the retained elements being potentially converted to residential use.

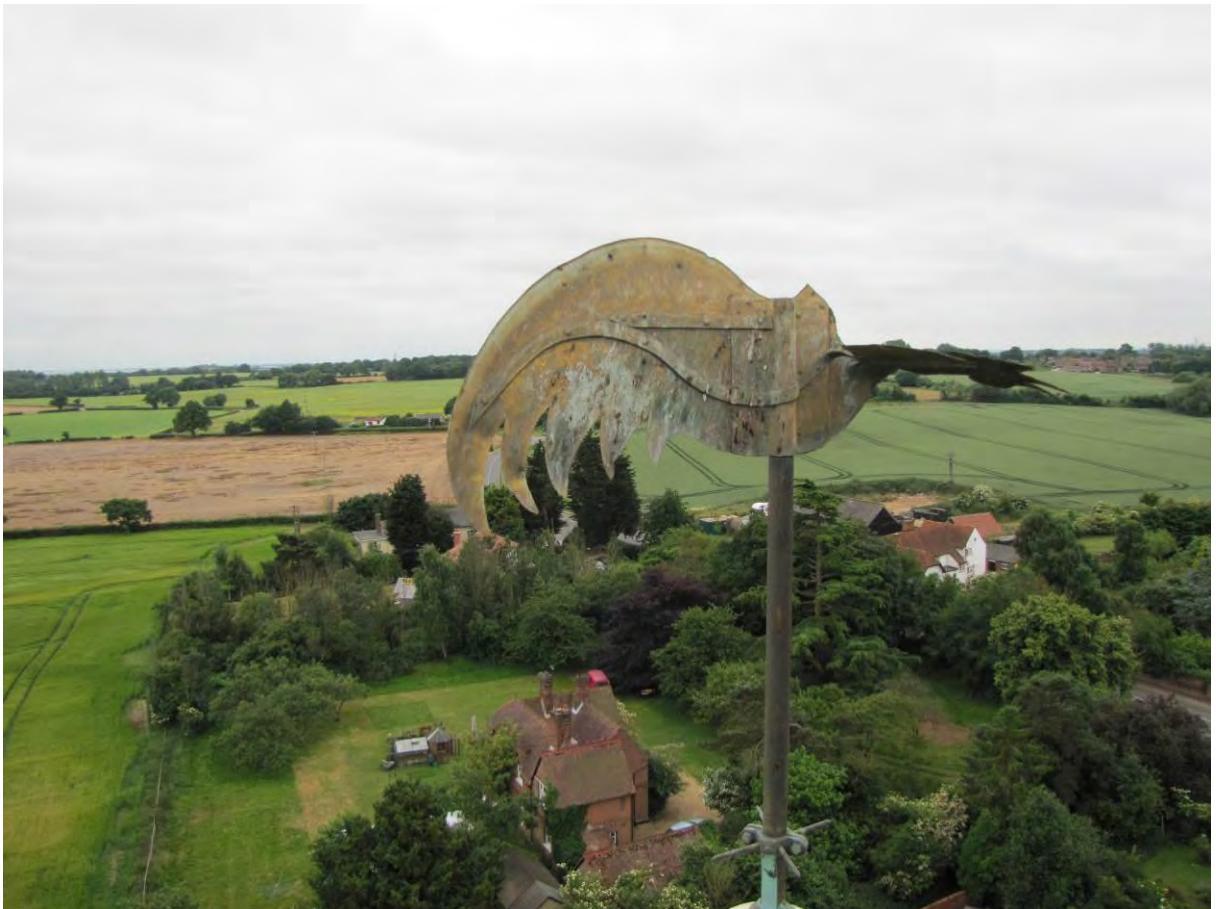
At the tip of the spire there was a weather vane with a cockerel motif. It is clear that the cockerel was previously gilded, and there was evidence of some shotgun pellet damage. The cockerel motif was bent out of shape; the local story being that this was caused by a helicopter. The Cadman site operative did gently bend this back into the correct position (see photographs 5 and 6).

Photograph 5: Cockerel to weathervane with bent head

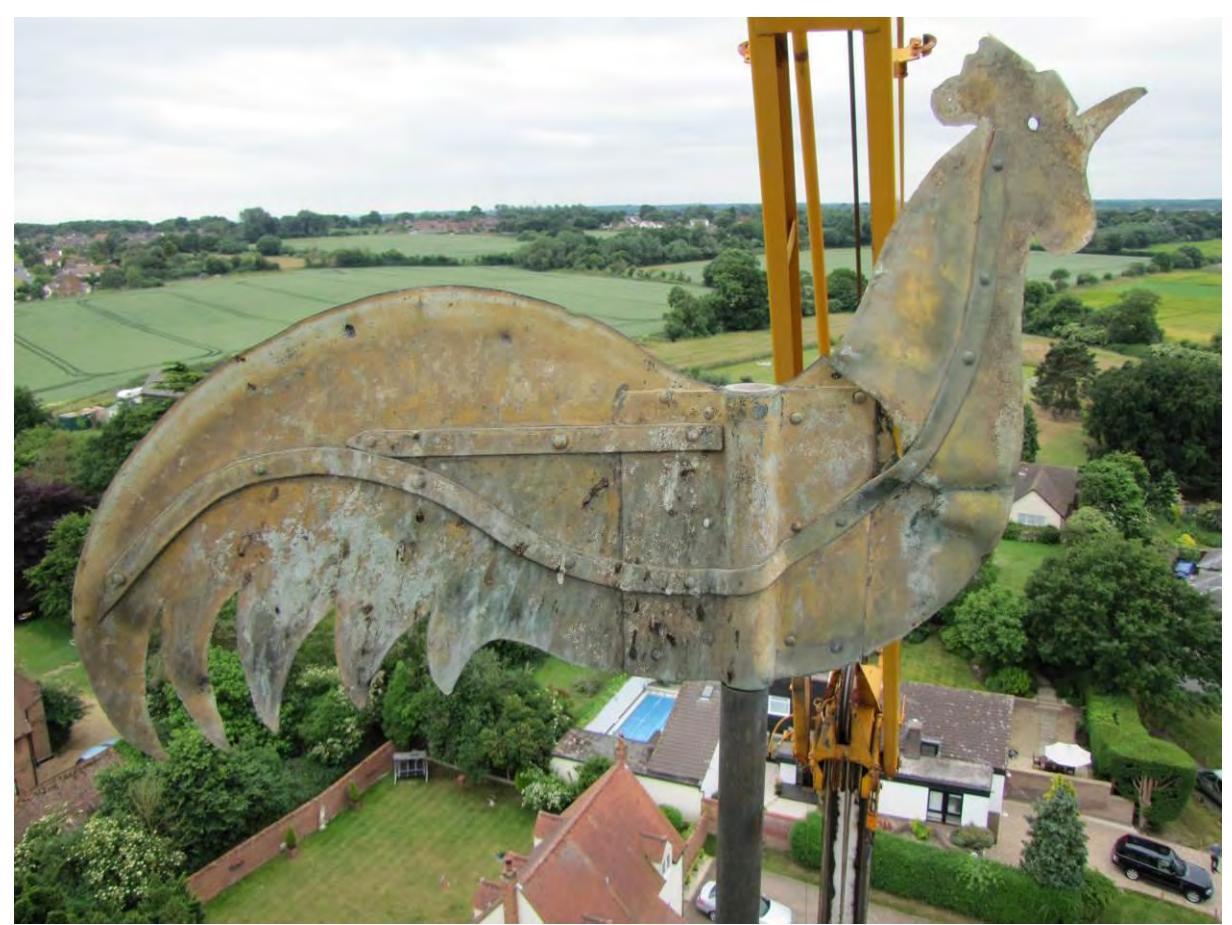
Photograph 6: Cockerel with head bent straight and evidence of gilding and pellet damage

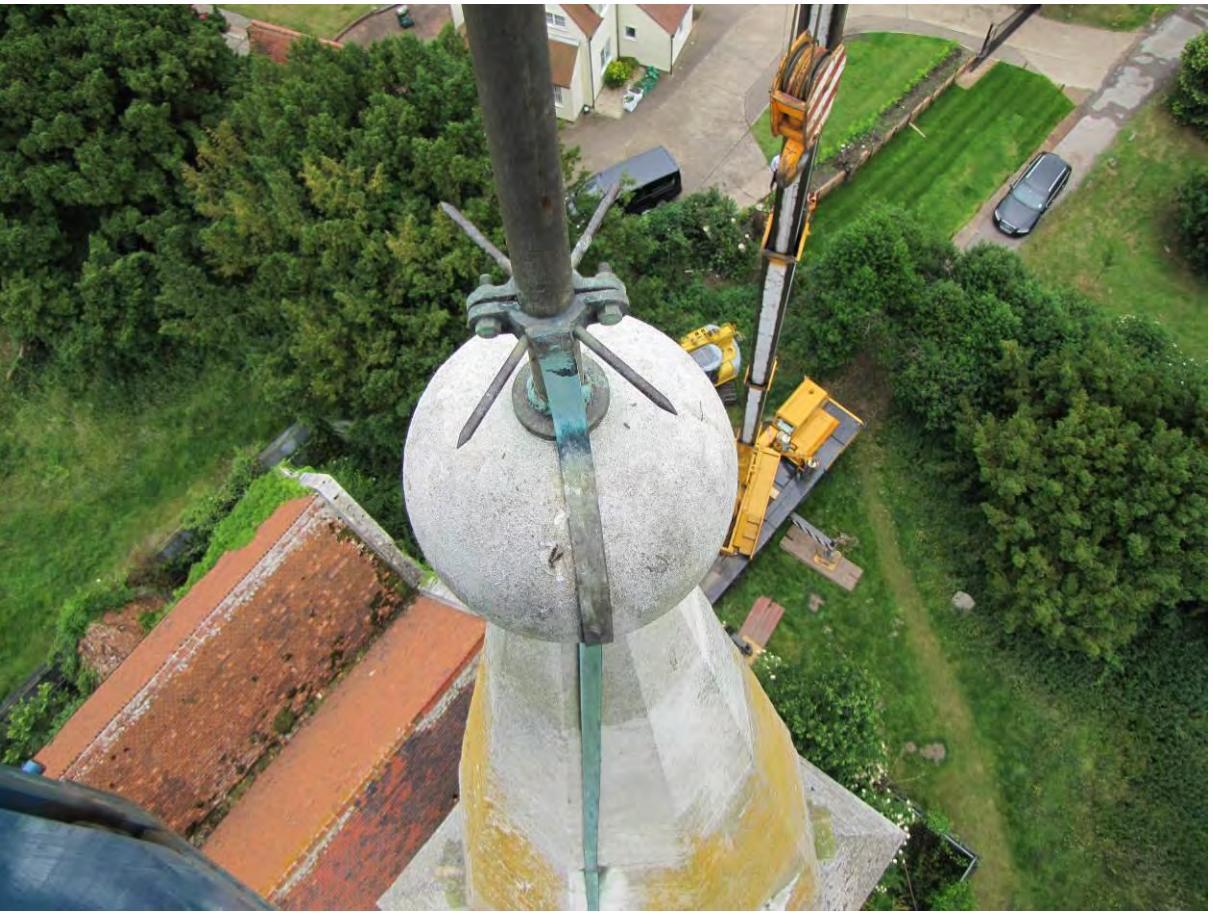
The dowel rod to which the weather rod is fixed appears to be copper, or at least non-ferrous (see photograph 7). It extends down, as expected, through the top of the spire and we presume to an internal cross tree or plate, which was possibly identified, but from some distance from the internal inspection (see photograph 8). I think it is highly likely that the top of the spire was rebuilt over a number of courses, as the colour of the stone is clearly different from the majority, and also as the weather vane rod is non-ferrous (see photograph 9). The lightning conductor will need to be checked, and I suggest at that time allowance for renewal is made, as the existing may not comply with current guidelines. The fixings to hold the copper tape in place are iron, and will need to be replaced (see photograph 10).

Photograph 7: Central dowel rod for weathervane and associated lightening conductor

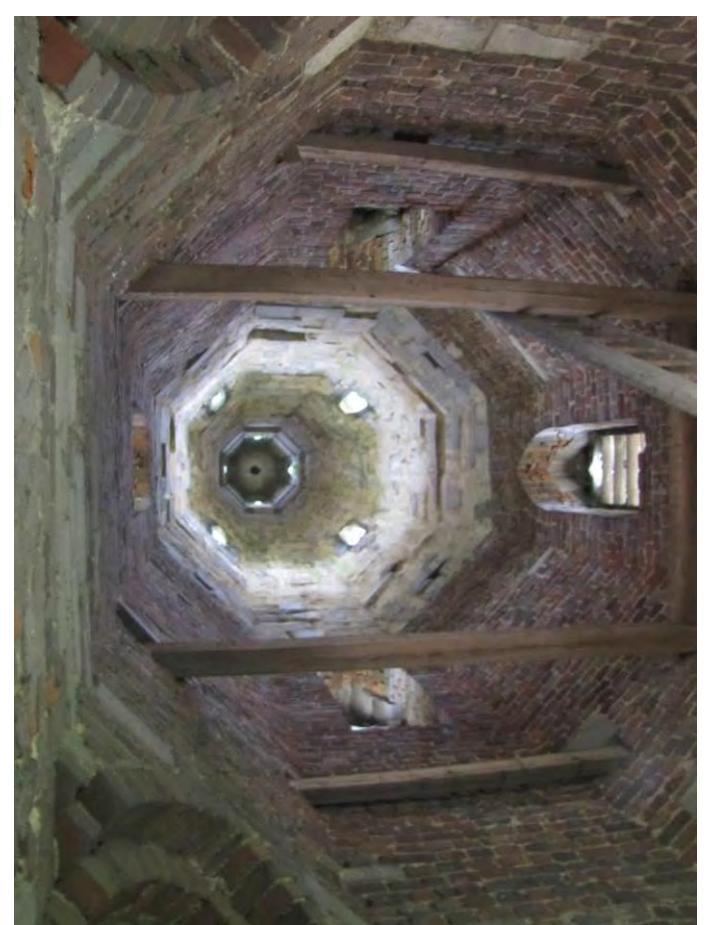
Photograph 8:Internal view up into spire with apparent fixing plate or cross-tree to solid tip

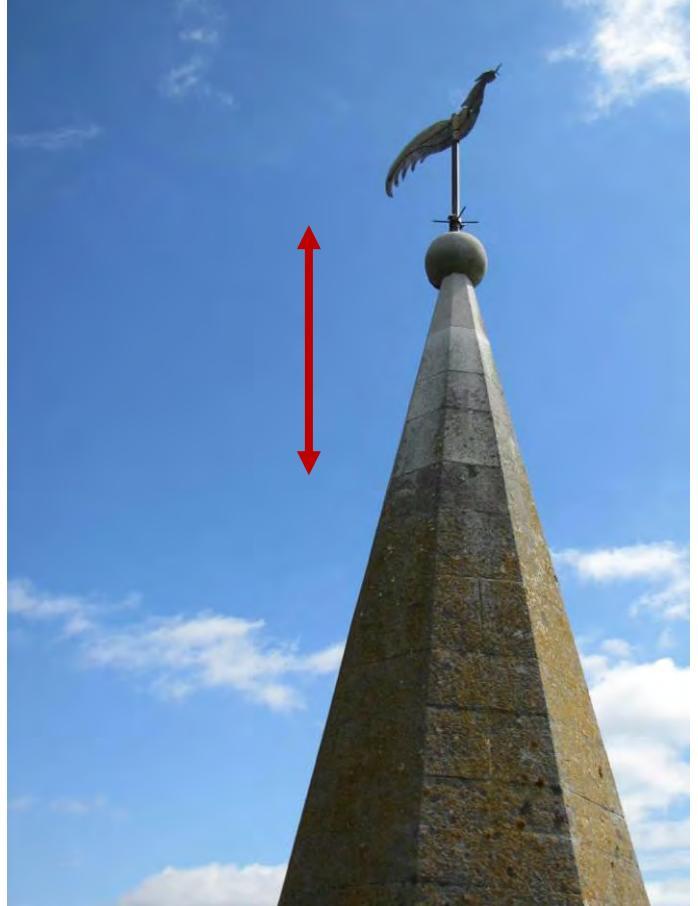
Photograph 9: Tip of spire a possible re-build?

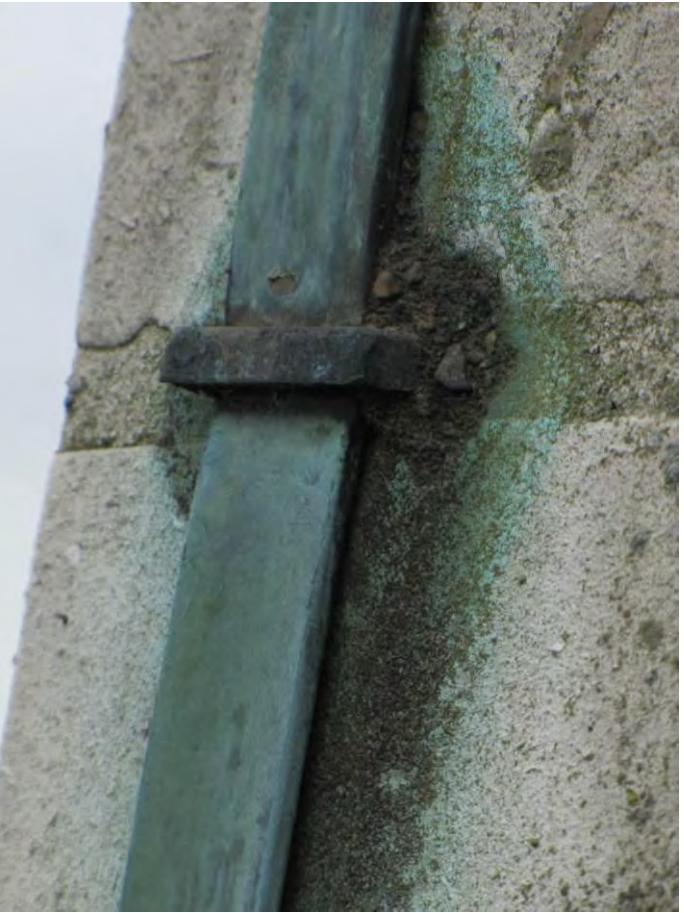
Photograph 10: Corroding iron fixings for copper tape

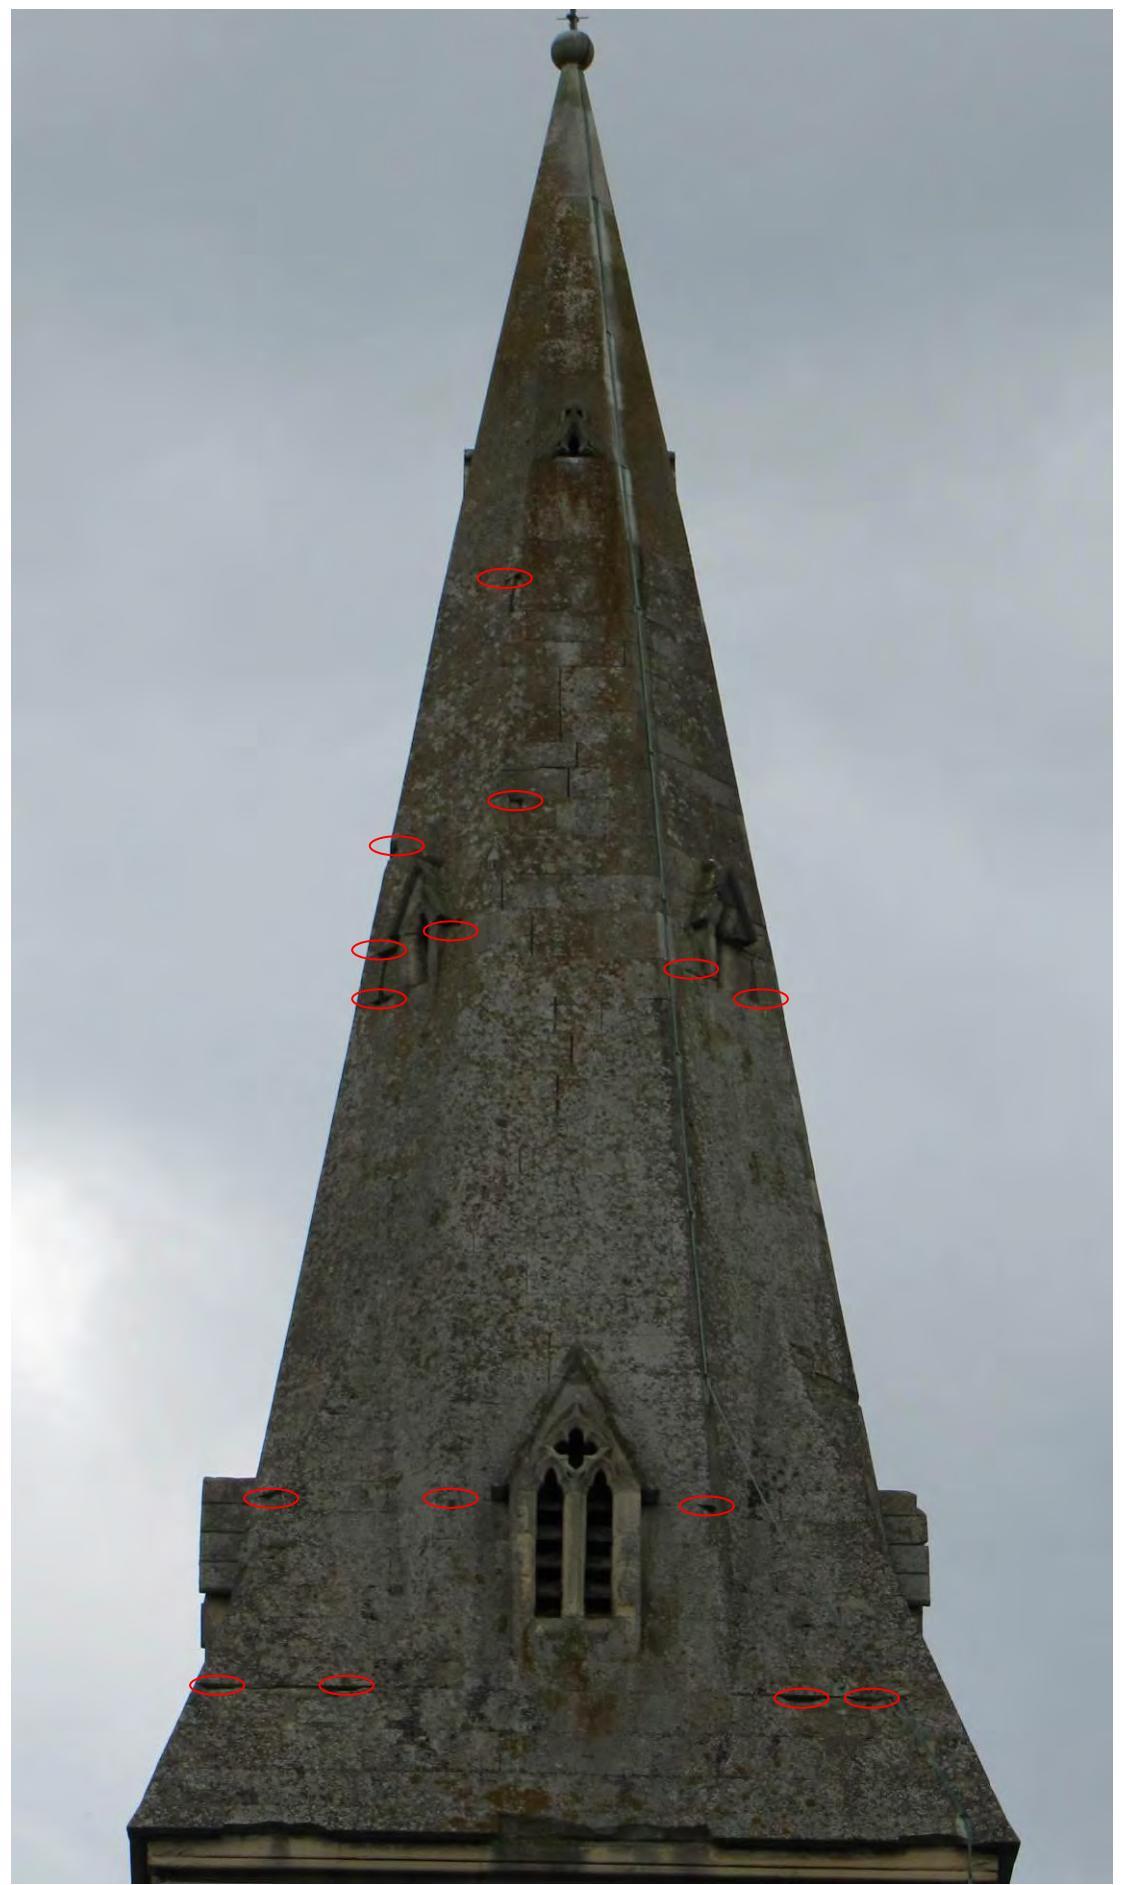
Overall the structural condition of the spire is not unreasonable, with there being no signs of any major instability. However, there are clear iron dog-leg cramps built into the structure, at various positions to help bind the spire, which is not unexpected (see photograph 11). It is not clear from the survey how regular these are, but there are large areas where no damage has occurred which may suggest that the cramps were only used at strategic positions in the height of the spire. Certainly the cramps seem to be concentrated around the windows in particular, a logical position to have these.

Photograph 11: East facing elevation marked up with identified cramp positions

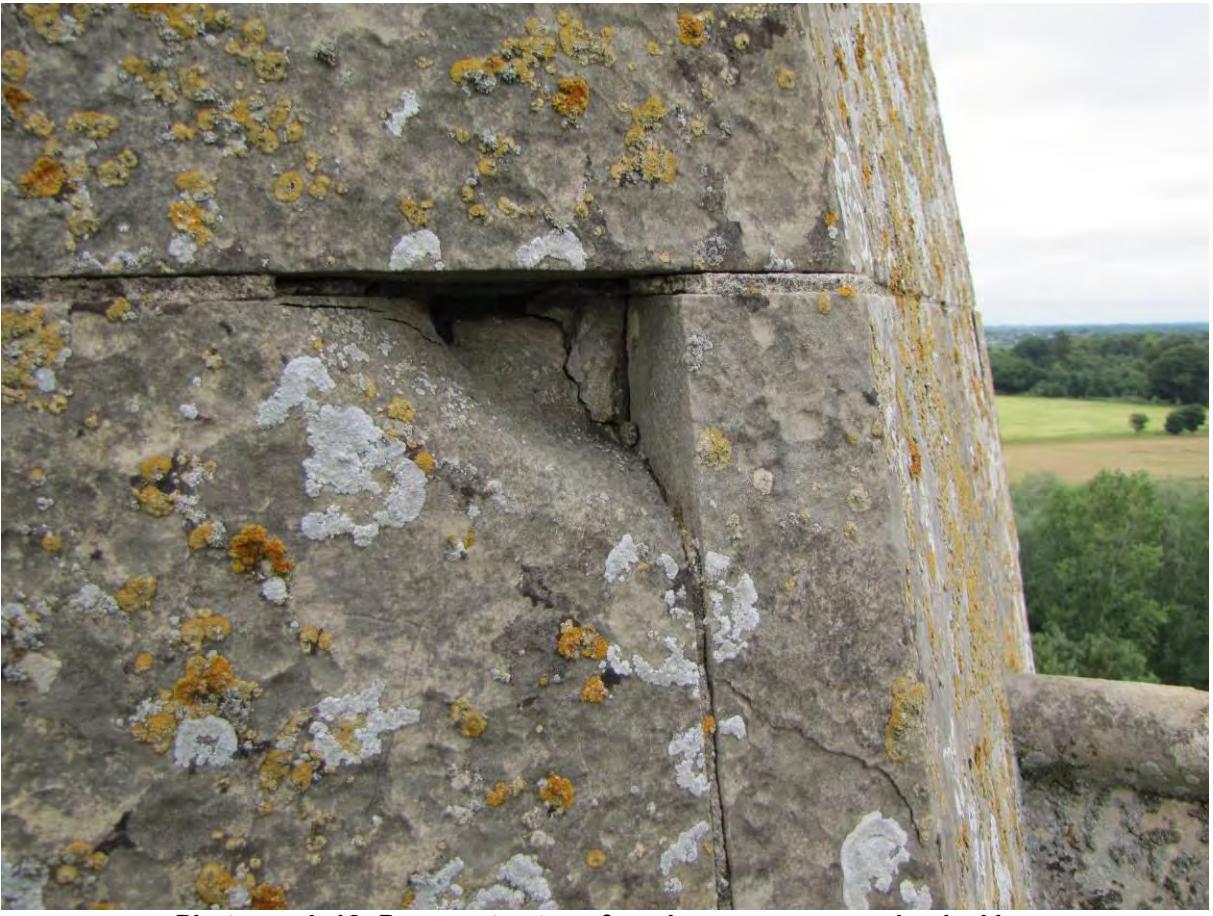
The cramps have corroded, with the associated corrosion jacking in the worst cases having forced sections of stone to pop off, (see photographs 12 and 13), fractures to develop (see photographs 14 and 15), and indeed some lifting of the structure, identified through open horizontal joints (see photograph 16).

Photograph 12: Damage to stone from iron cramp corrosion jacking

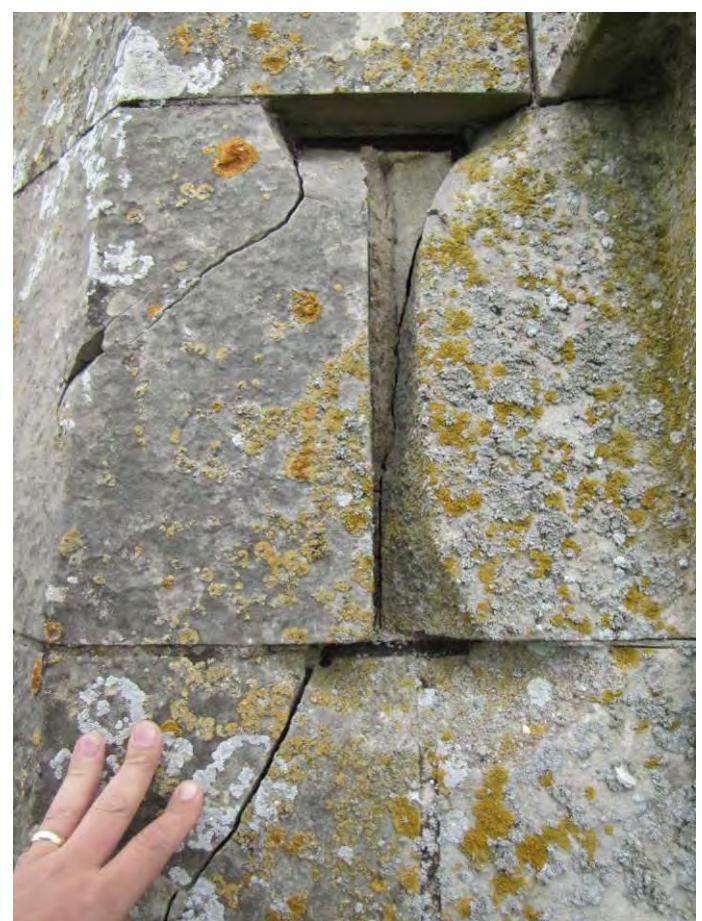
Photograph 13: Cramp damage in two courses with associated damage

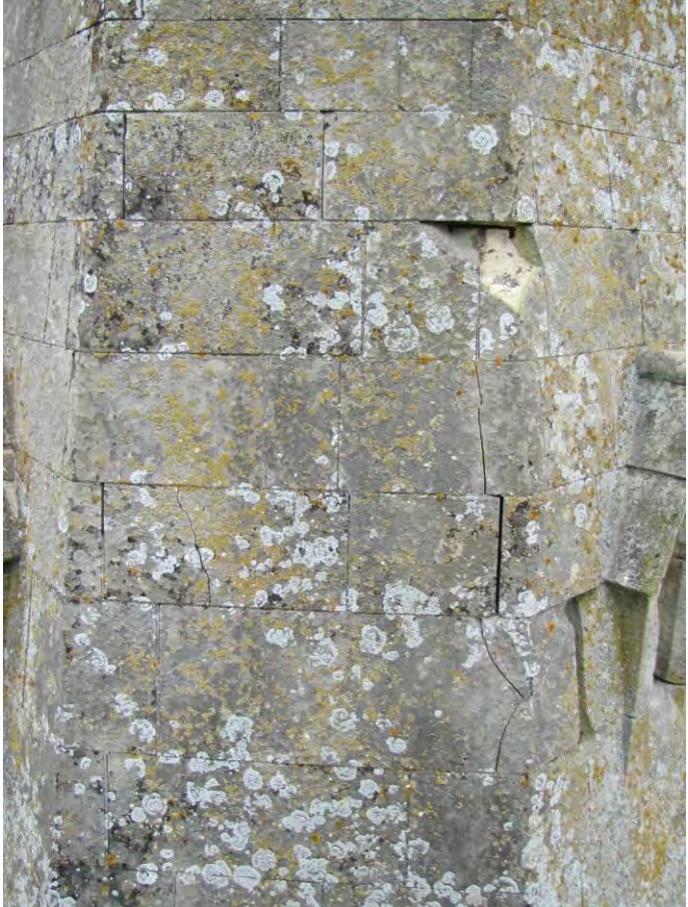
Photograph 14: Fractures developed in the stonework through corroding cramps

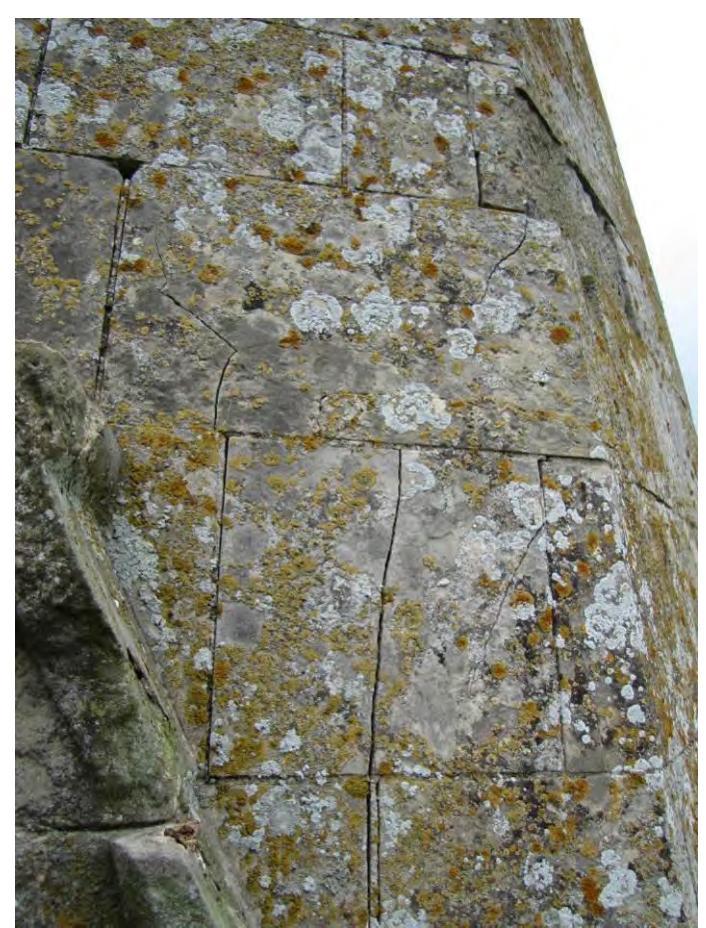
Photograph 15: Fractures developed in the stonework through corroding cramps

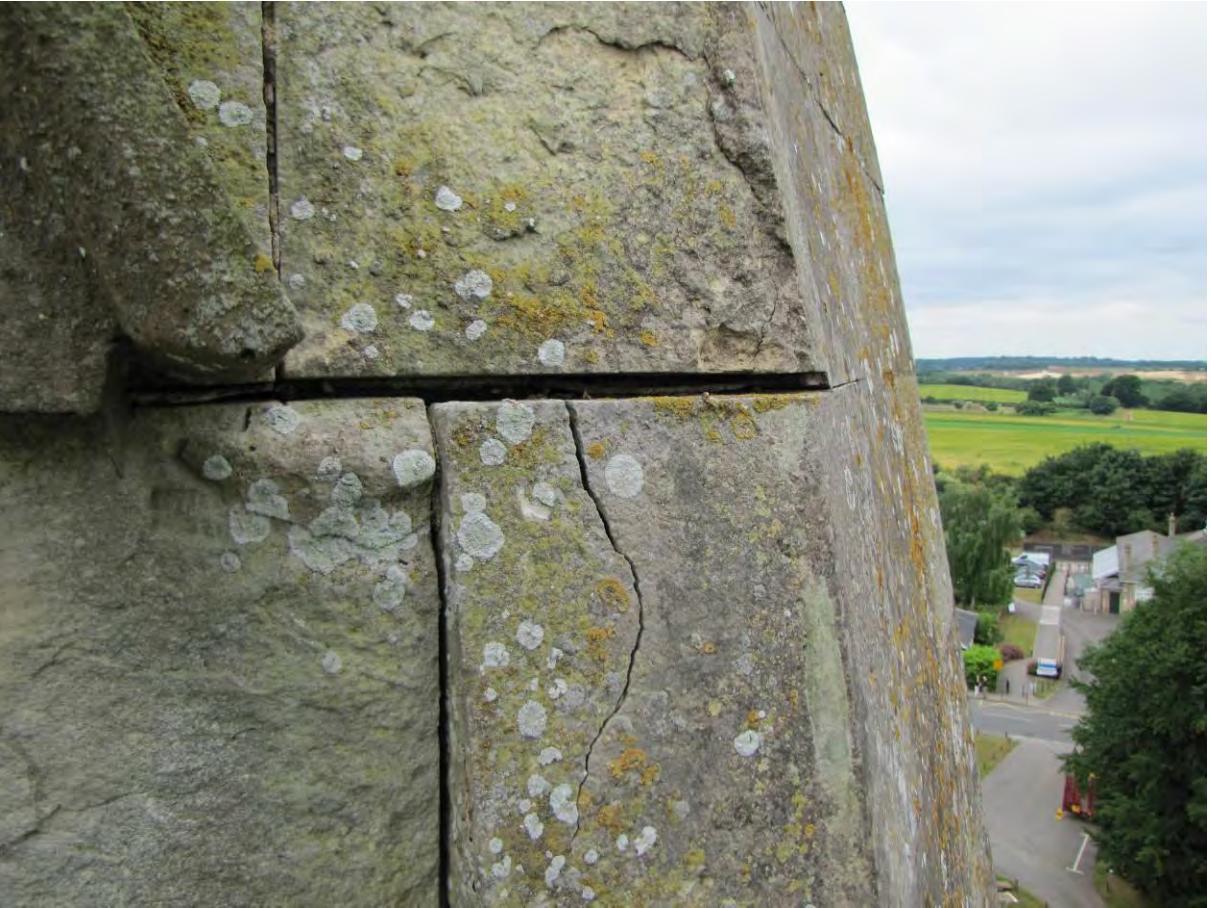
Photograph 16: Lifting of stones through corrosion jacking

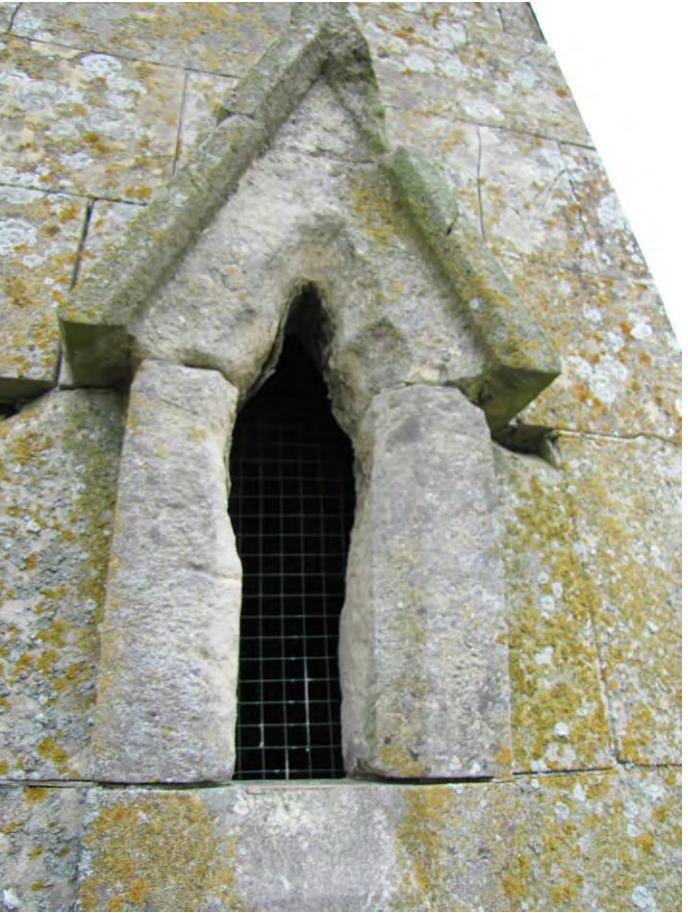
Photograph 18: Erosion and some cramp damage to central lucarne window to spire

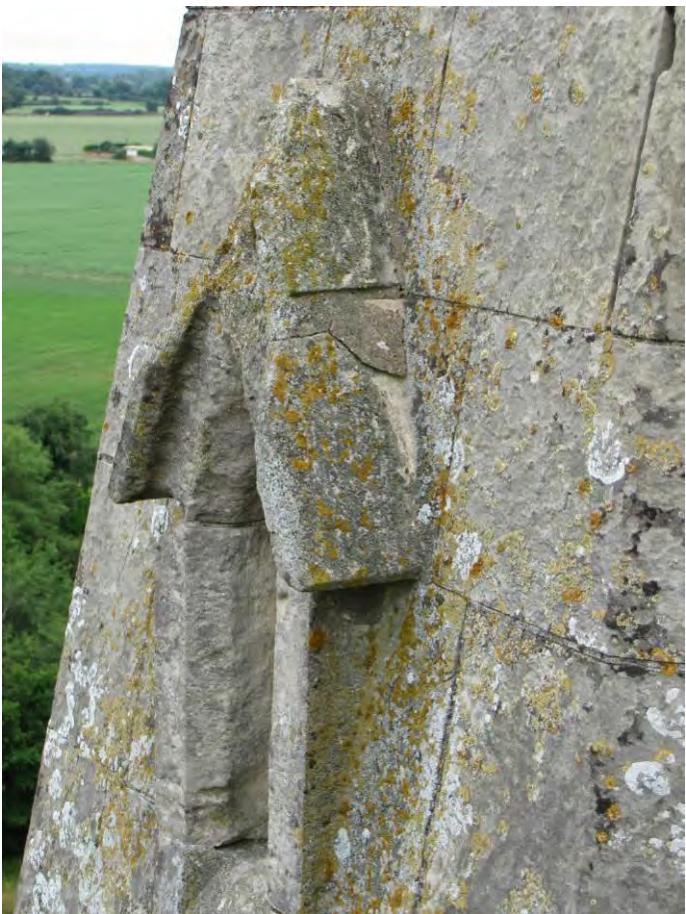
Photograph 19: Damage to head of central lucarne window

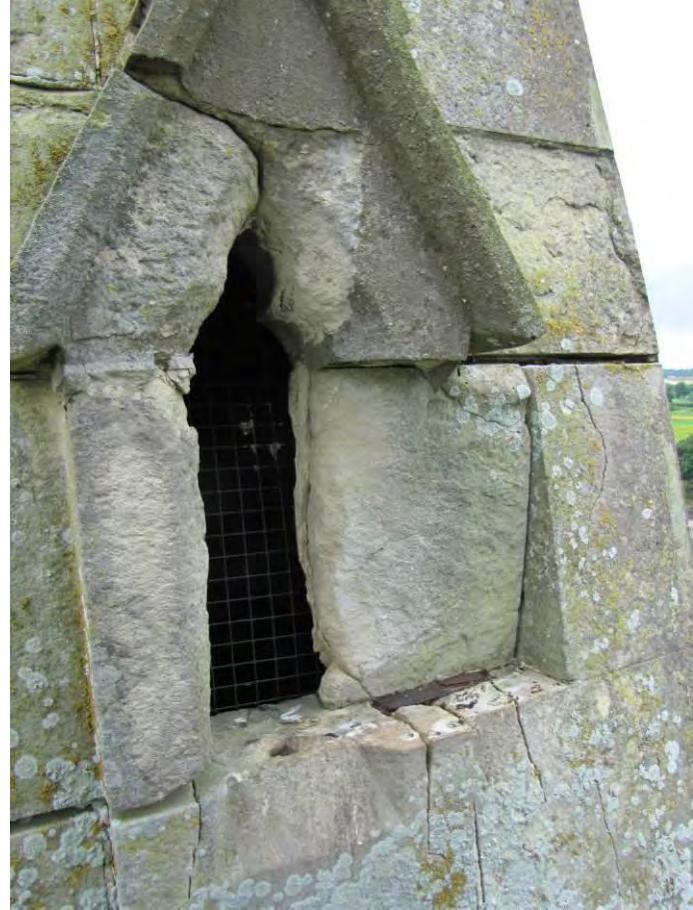
Photograph 20: North eastern central lucarne window in poor condition

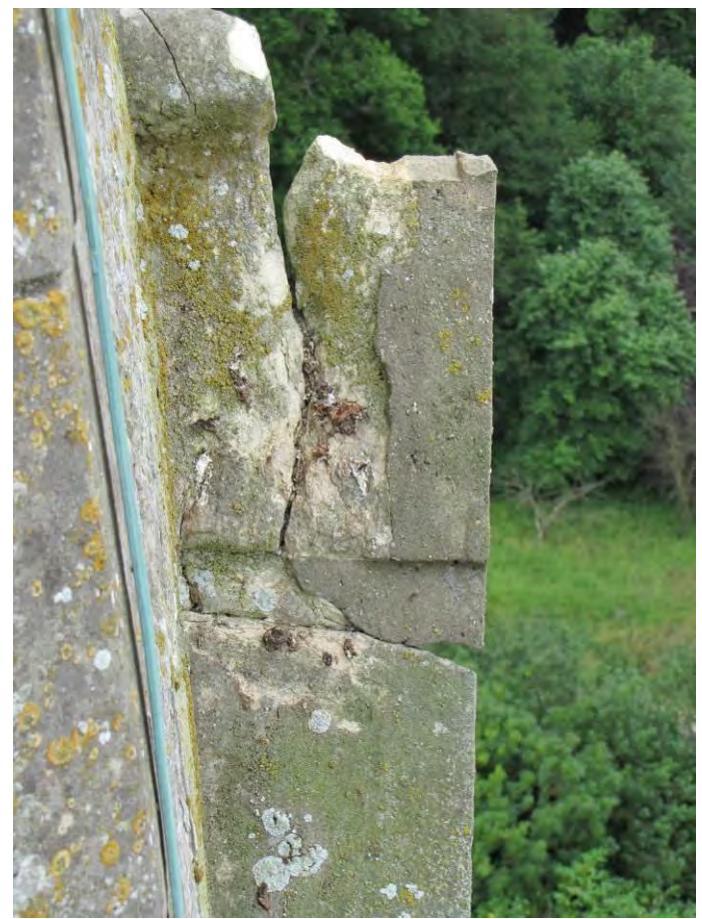
Photograph 21: Loose section of stone to head of NE central lucarne window

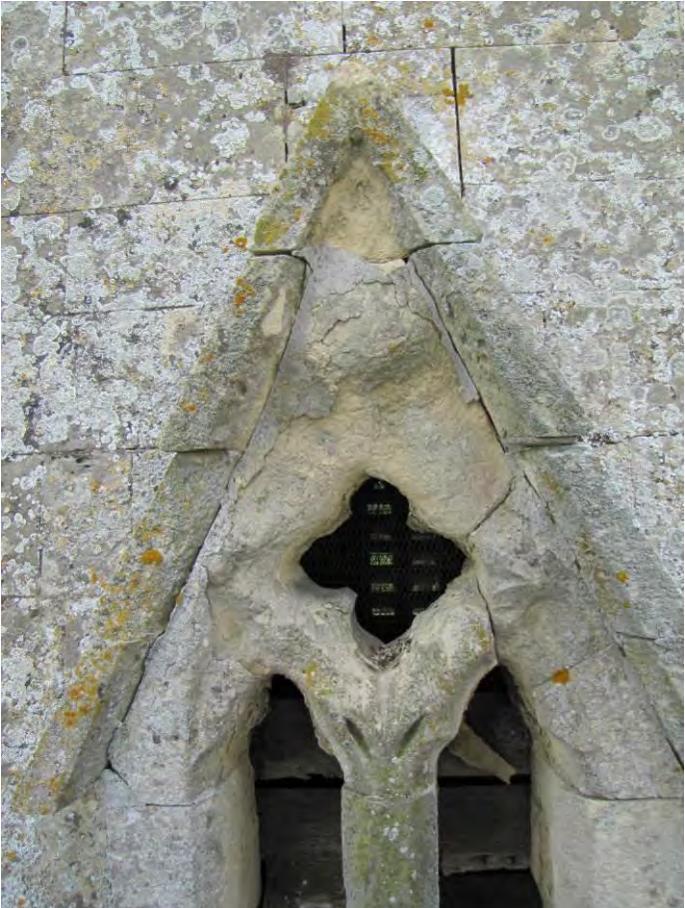
Photograph 22: Lower lucarne window with evidence of past cement pointing

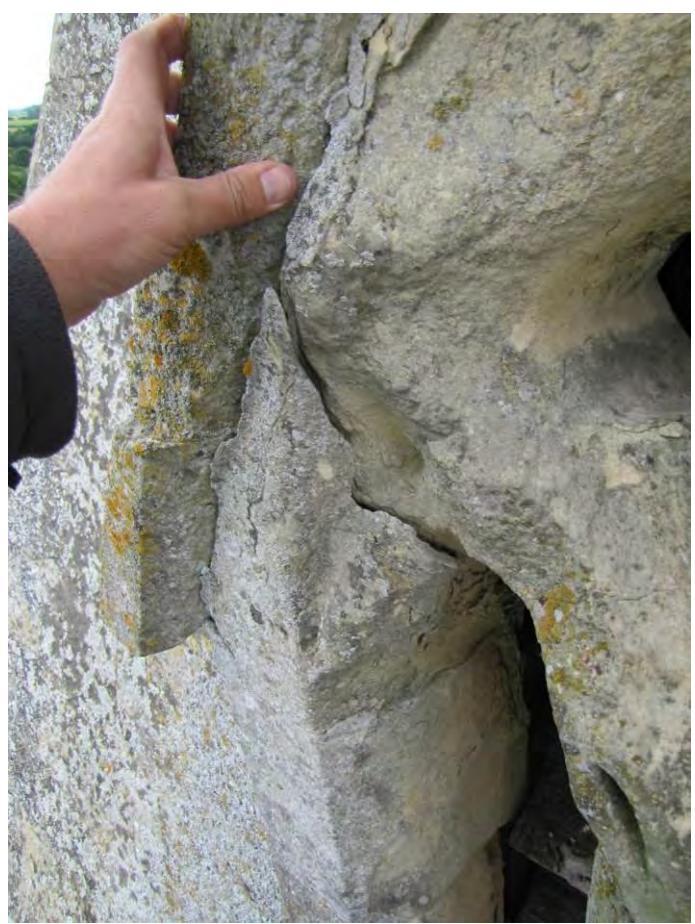
Photograph 23: Fracture to side of lower lucrane window

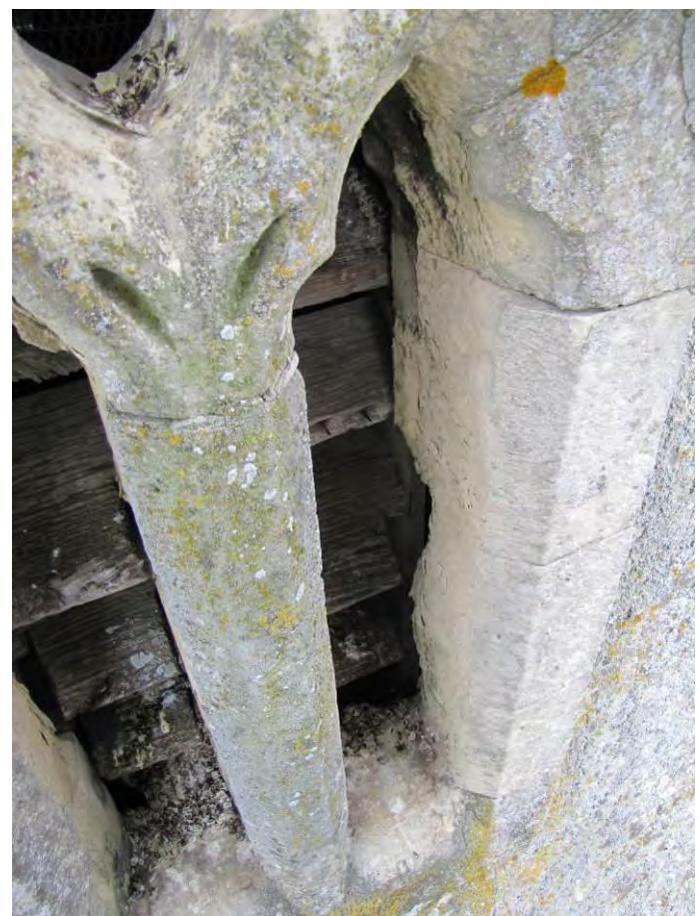
Photograph 24: Erosion and decay to internal face of lower lucrane window reveal

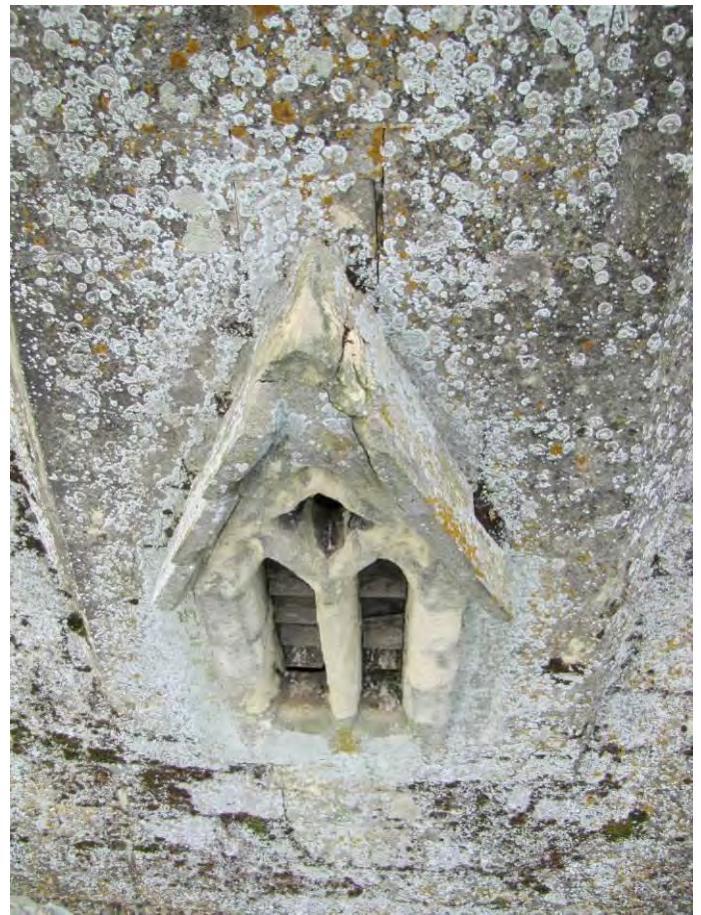
Photograph 25: Fracture to head of lower lucarne window opening

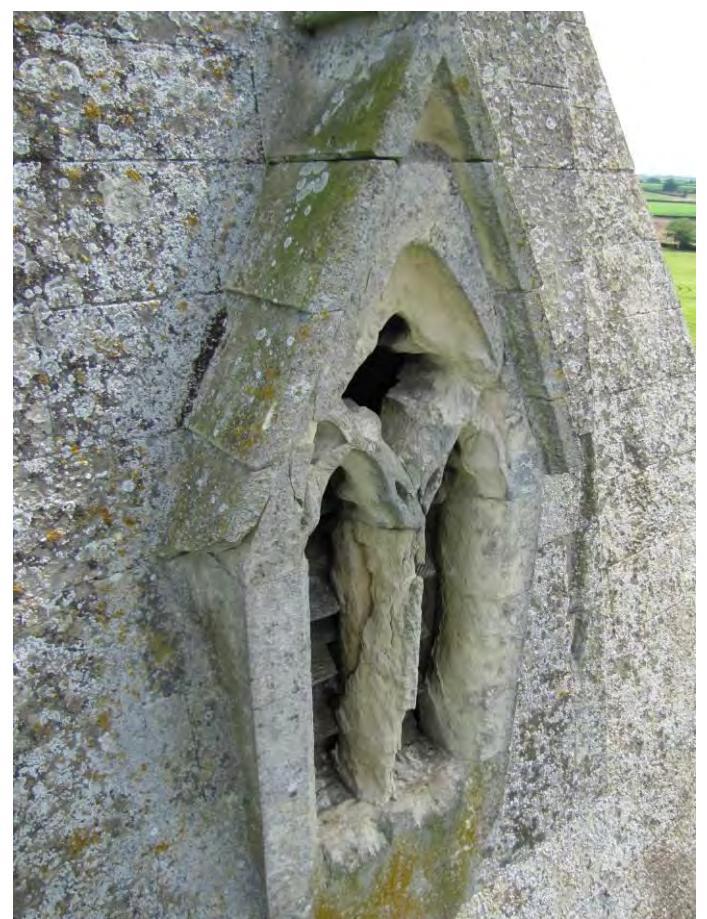
Photograph 26: Decayed mullion to lower lucarne window

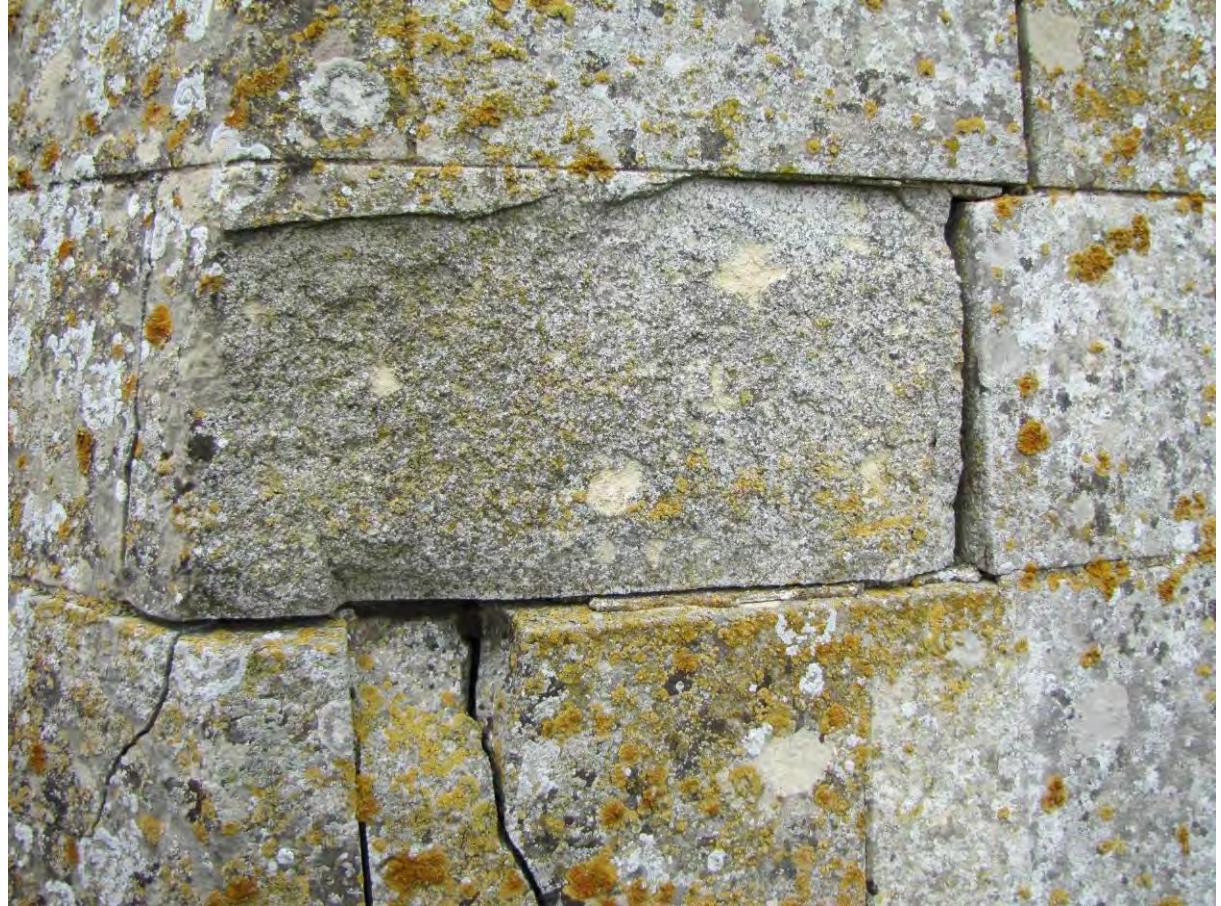
Whilst in overall terms the stonework has fared reasonably well other than the cramp damage, the windows have been more affected by erosion as expected. These are in variable condition, but clearly will require some repairs and also replacement. Some windows have evidence of past cement based repairs, whilst others have fractures to elements, or decay to areas, as well as evidence of past cement pointing or repairs (see photographs 17 to 26). Odd stones show evidence of more advanced decay to the face (see photograph 27), although this seems to relate to the quality of the stone, probably from a weaker bed in the quarry.

Photograph 27: Face of stone decayed

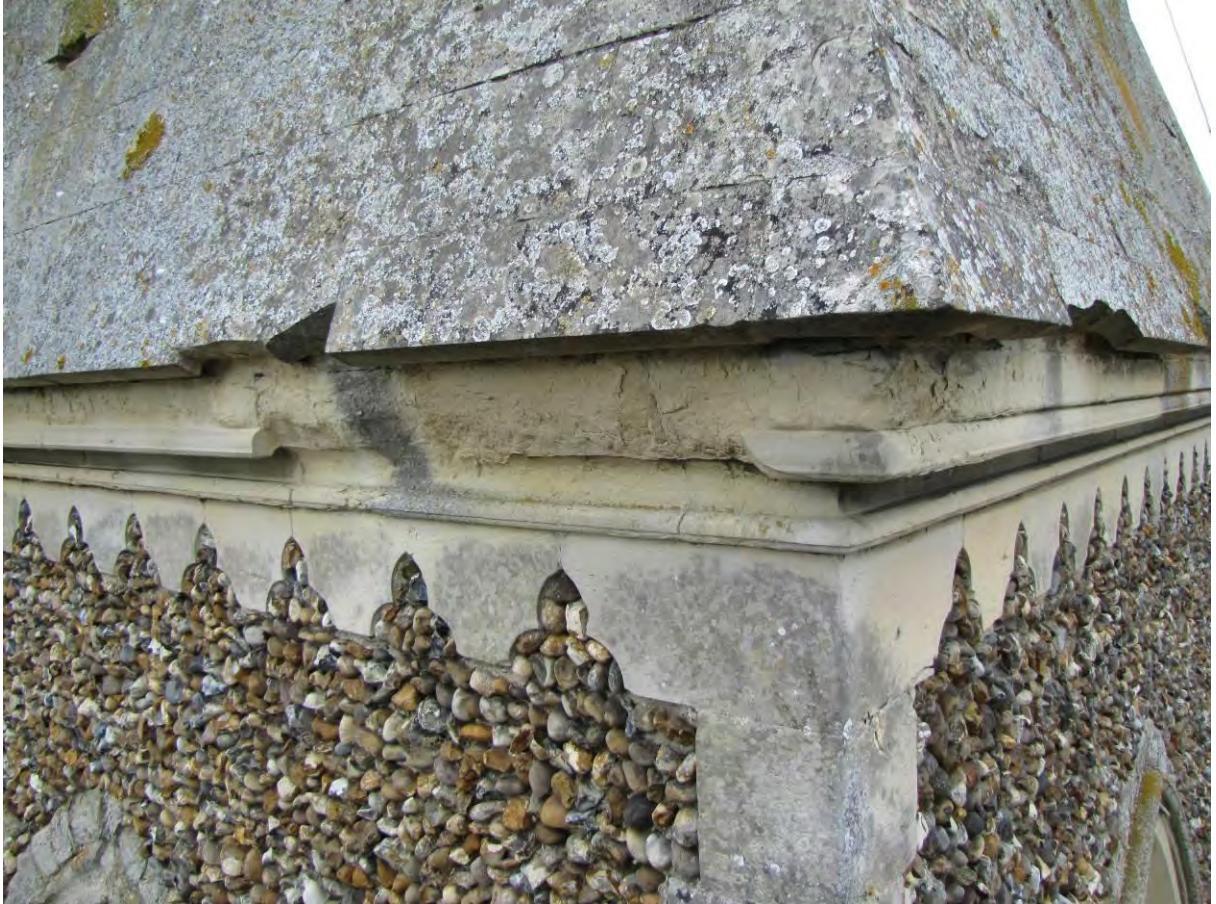
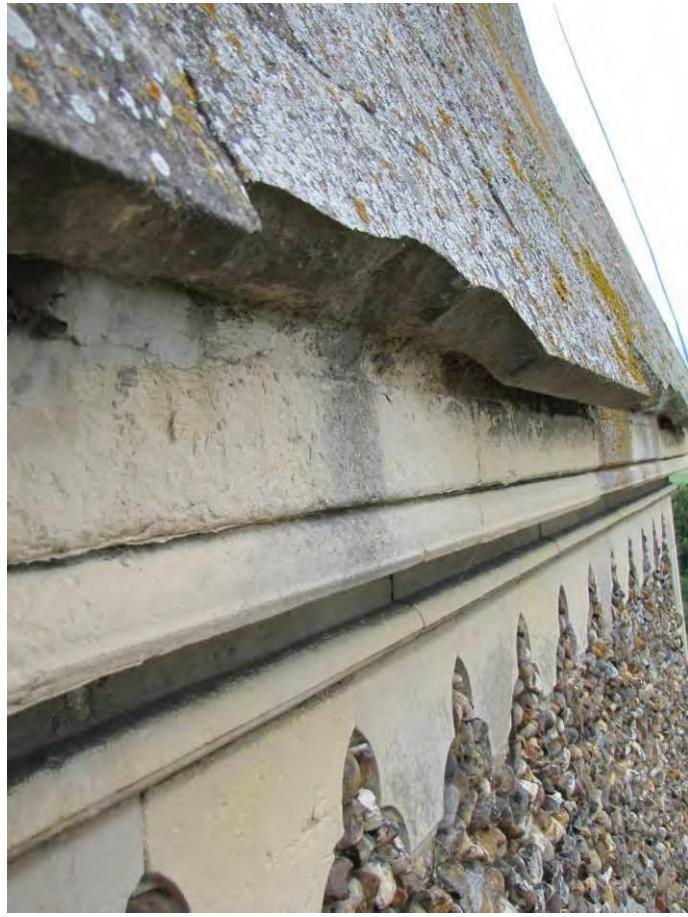
At the base of the spire, the stonework overhangs the masonry of the walling below, with occasional lost edges, but which is structurally not significant. Below this is a roll moulding, which has suffered quite significant erosion in local areas. This is not required structurally, and I suggest simply needs de-frassing to remove loose material (see photographs 28 and 29).

Photograph 28: Eroded roll moulding below base of spire

Photograph 29: Eroded roll moulding below base of spire

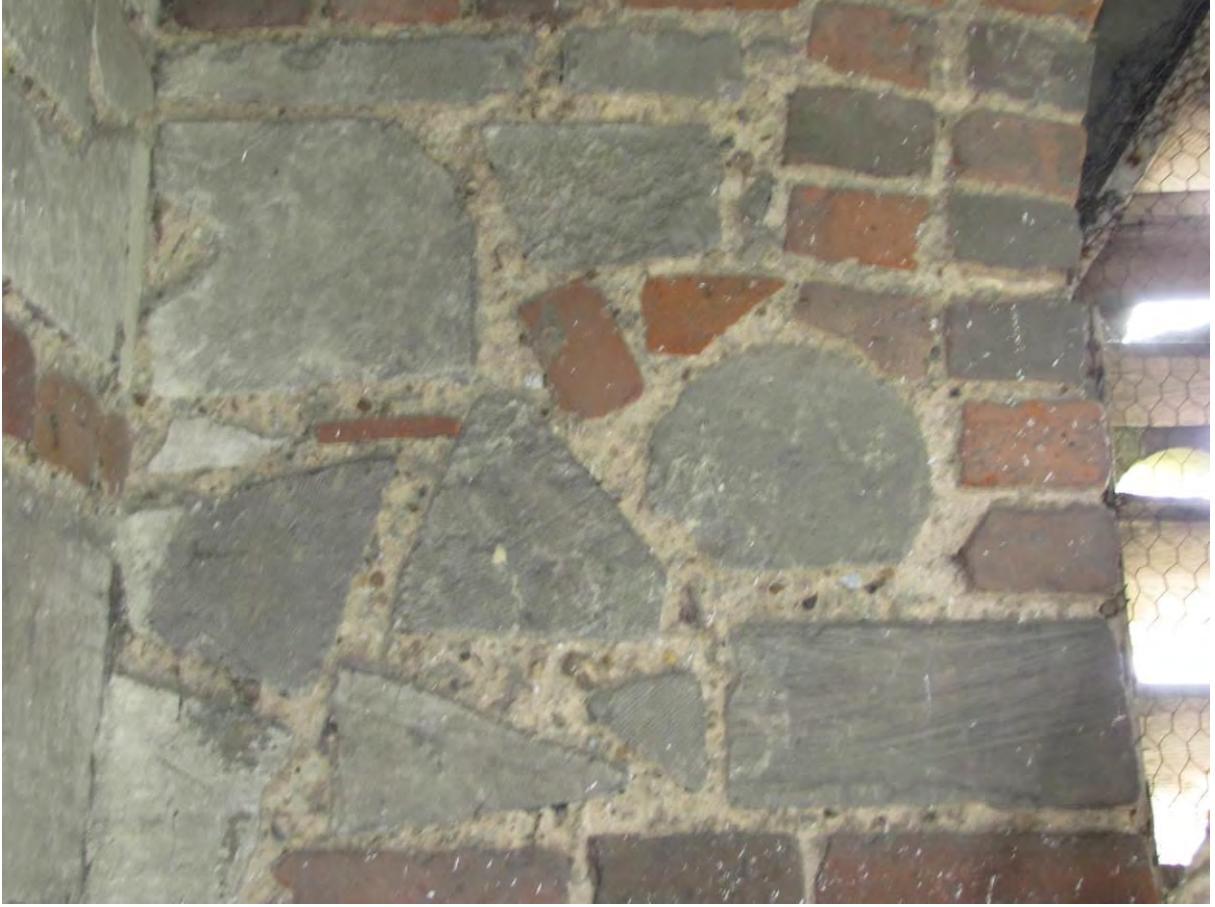
The tower faces below are formed of stone quoins, stone window dressings, and then flints set in mortar built onto a masonry core. Whilst I was anticipating that this core was predominantly of brick, on inspection inside the tower it seems quite clear that they reused the masonry from the previously existing Church on the site (see photographs 30 and 31), along with elements and banding with brick.

Photograph 30: evidence for re-used masonry in tower
