THE MORTON PARTNERSHIP LTD.

RE: ST. PETER'S CHURCH, BIRCH, COLCHESTER, ESSEX

As you are aware I attended site on Thursday 4th July 2013, in order to carry out an inspection of the Church to provide comments on the structural condition, and also to comment on the proposals to part demolish the building, with the retained elements being potentially converted to residential use.

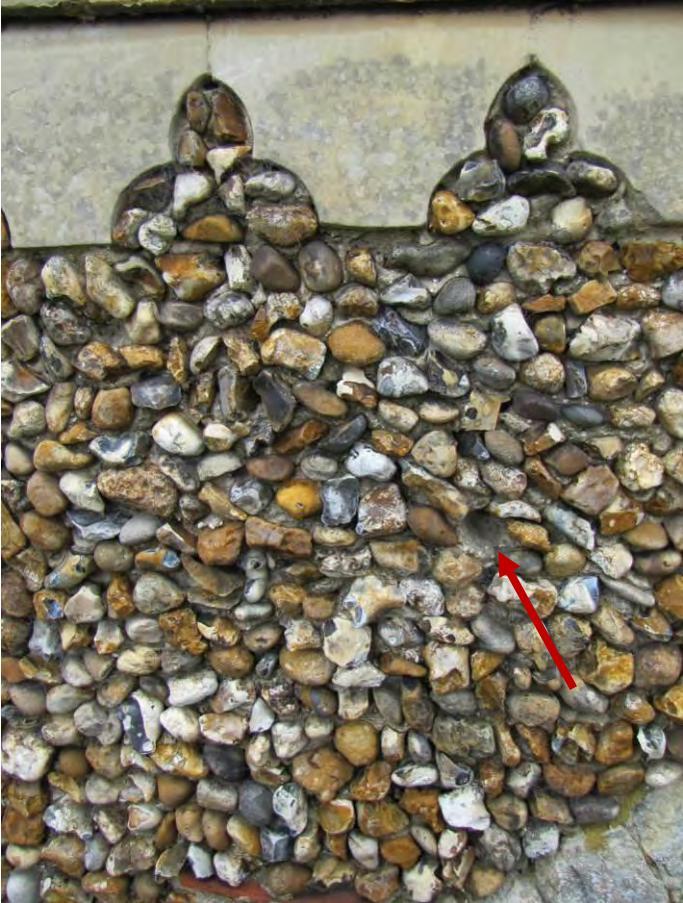
In all areas inspected I checked the integrity of the flint facing, as it is not uncommon for flints to fall away, or bulges to form where the facing comes away from the core of the wall. Whilst there were very occasional missing flints (see photograph 32), overall I found that they were well adhered, being set in a relatively deep mortar. The pointing is somewhat eroded, and it would benefit from some repointing to prevent further flints dropping out (see photograph 33).

Photograph 32: Occasional missing flints to tower

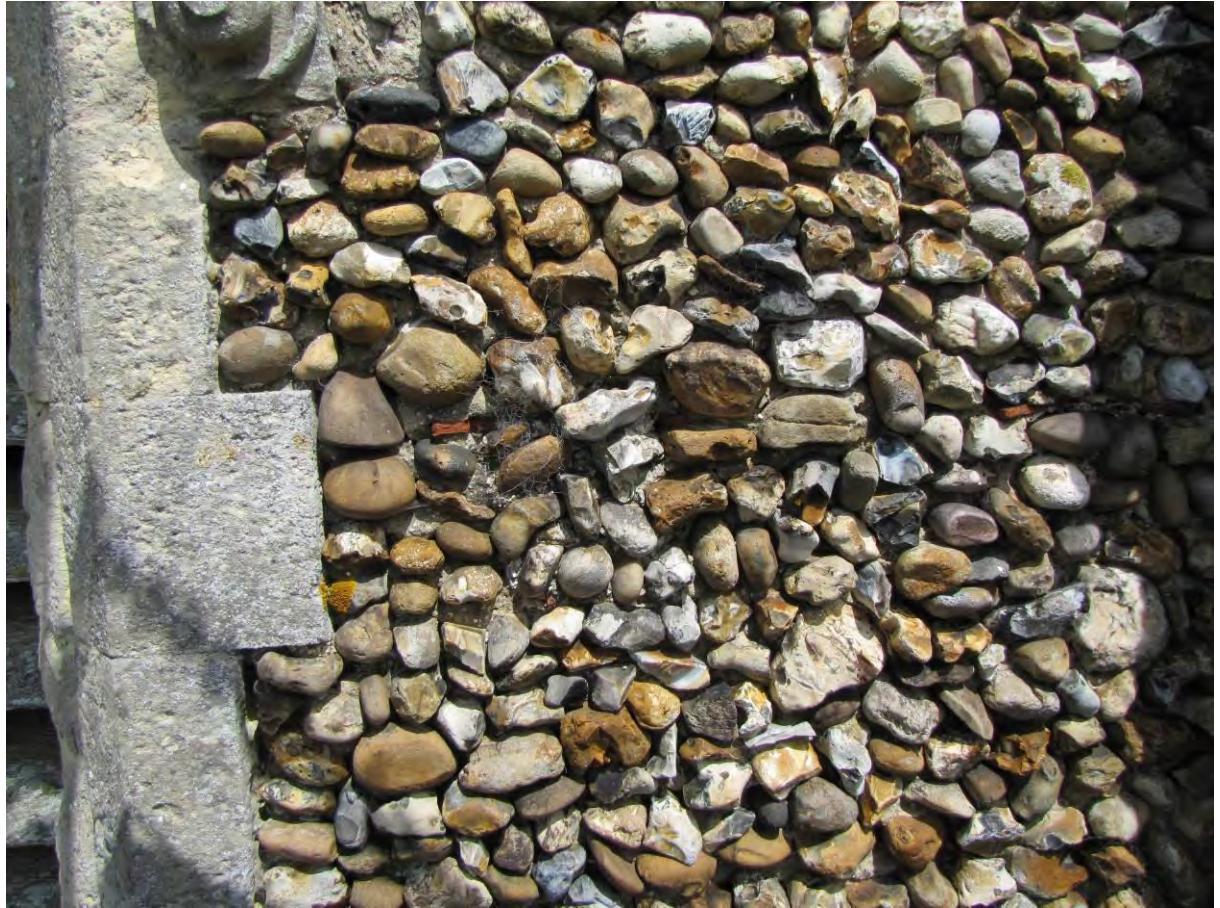
Photograph 33: Mortar eroded to flint facing

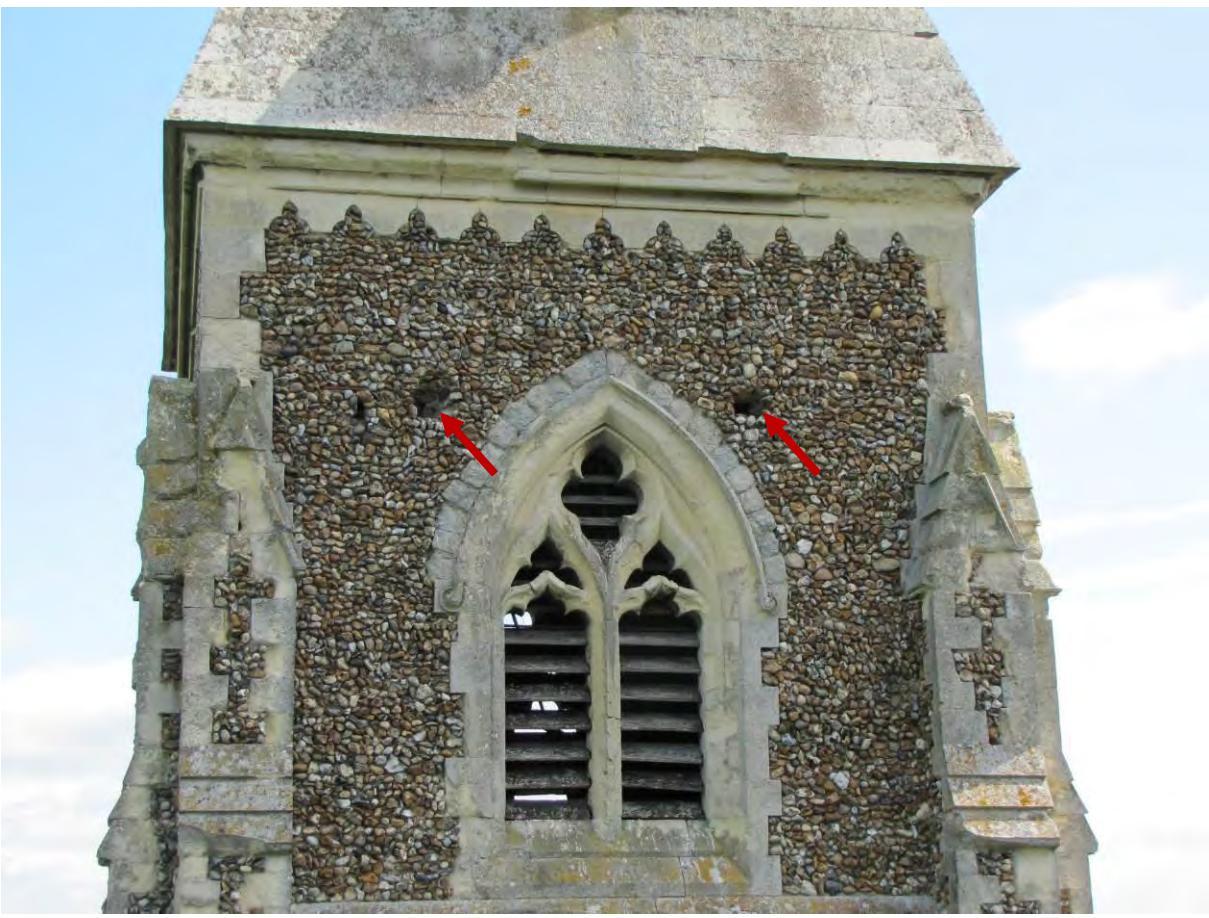
At a number of positions in the height of the tower, old apparent putlog or scaffold holes were noted, often with a tile spanning over the hole to allow the flint work above to be set during the original construction. Many of these putlog holes were not filled in their depth, but simply a face built up, and some of these have now opened up and formed nesting points (see photographs 34 to 36).

Photograph 34: Putlog holes to west elevation

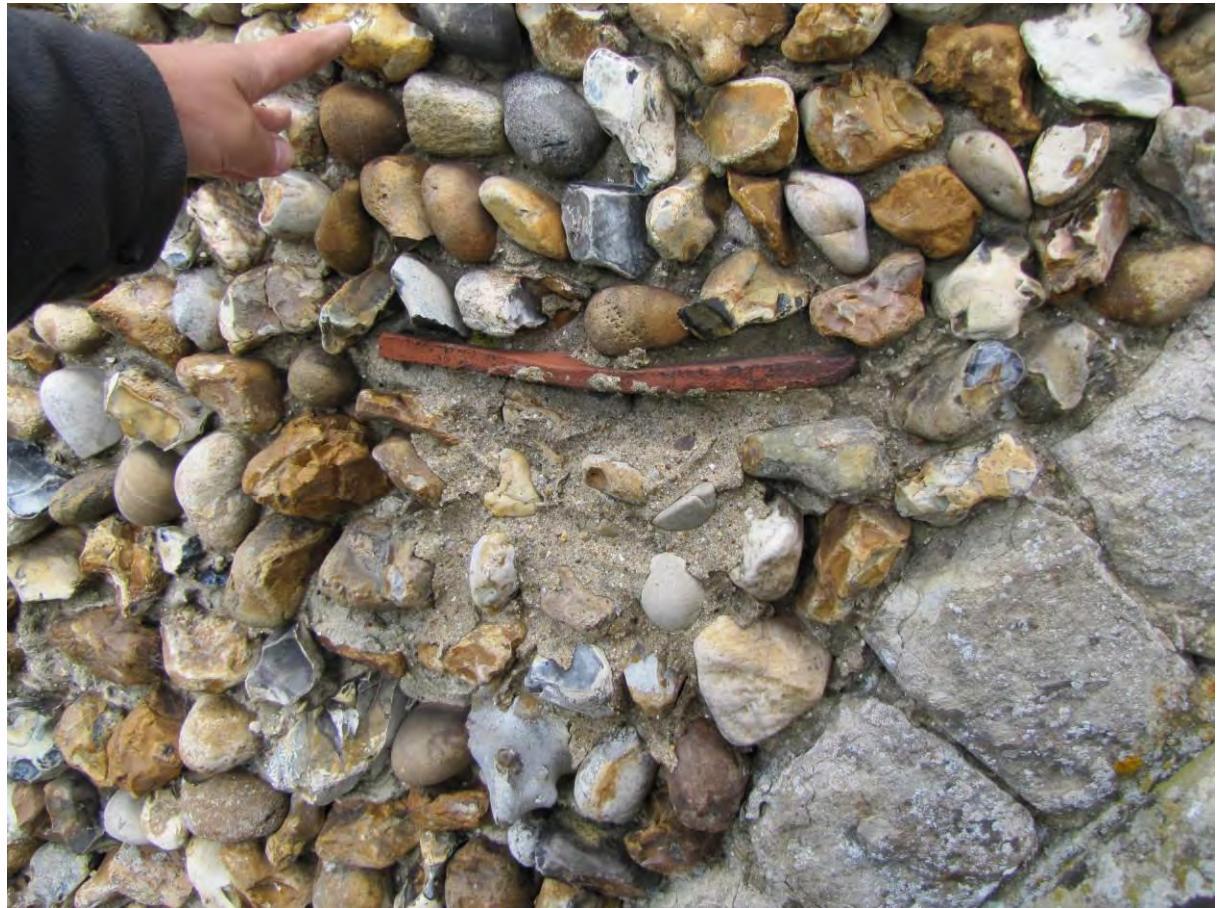
Photograph 35: Part filled in apparent putlog hole

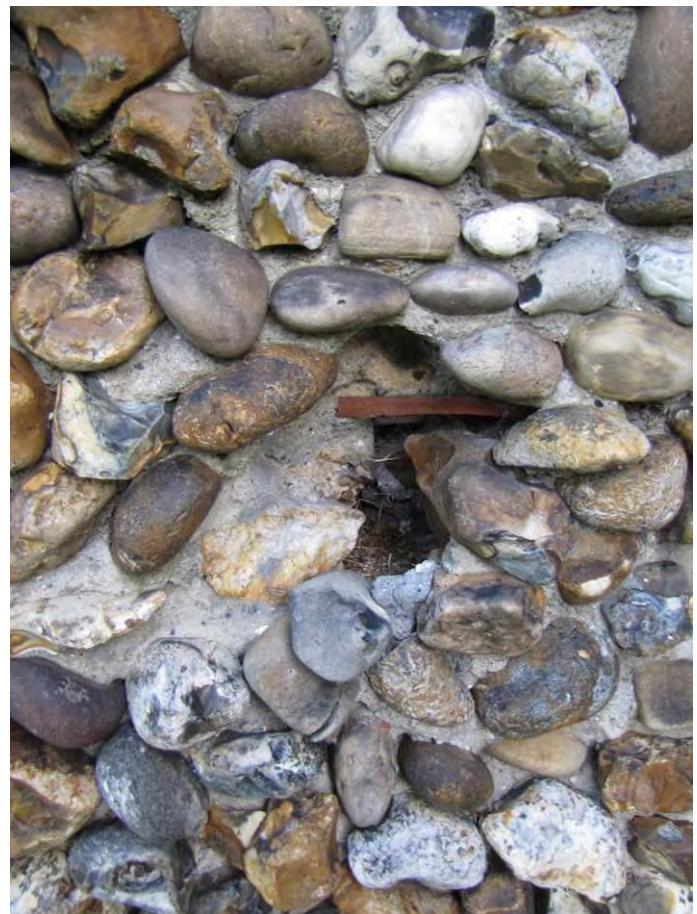
Photograph 36: Part filled in apparent putlog hole

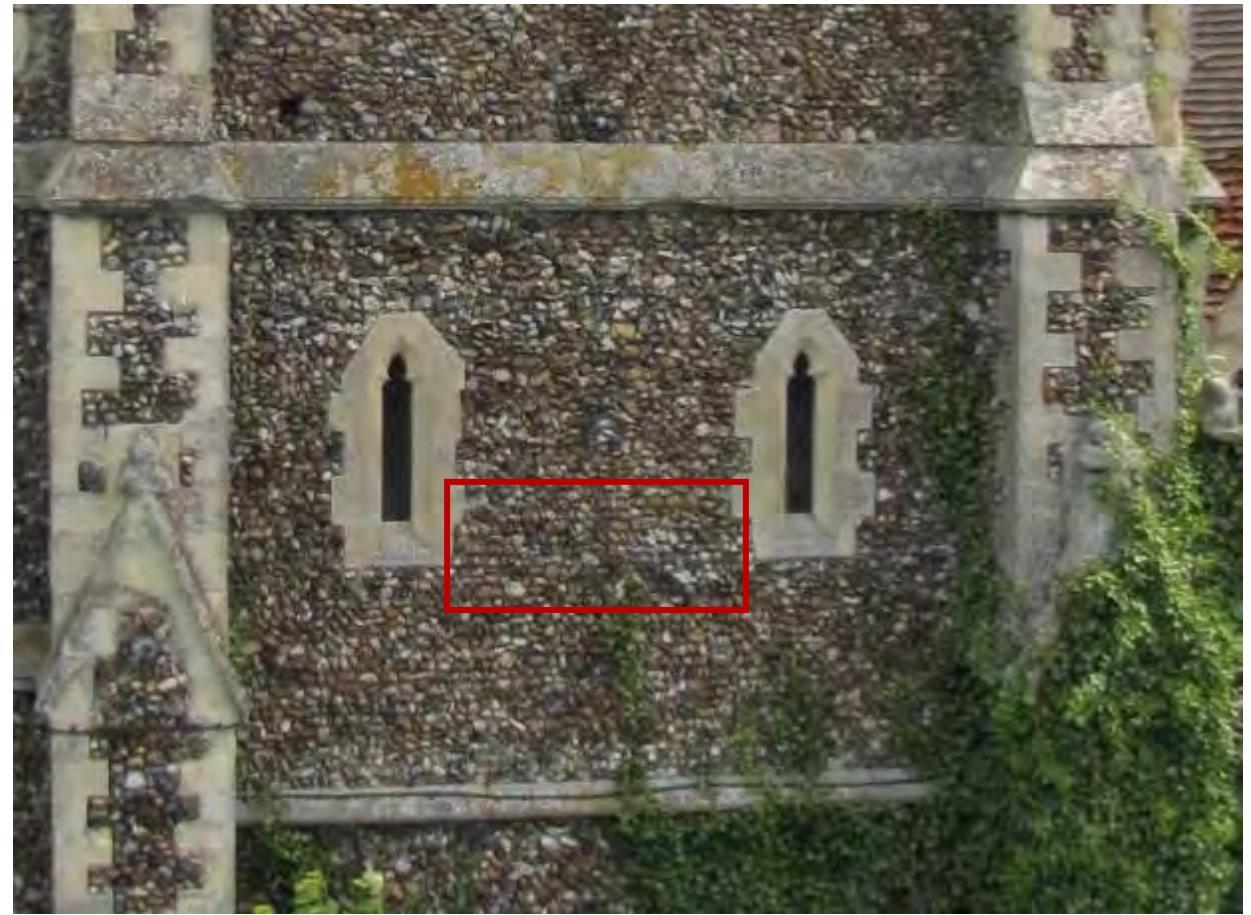
To the west elevation at the base of lower window cills, a more significant bulge of the face work was found and when tapped, was clearly found to be hollow behind (see photograph 37). This area will need to be carefully removed and re-built.

Photograph 37: Approximate area of bulged flintwork to west elevation

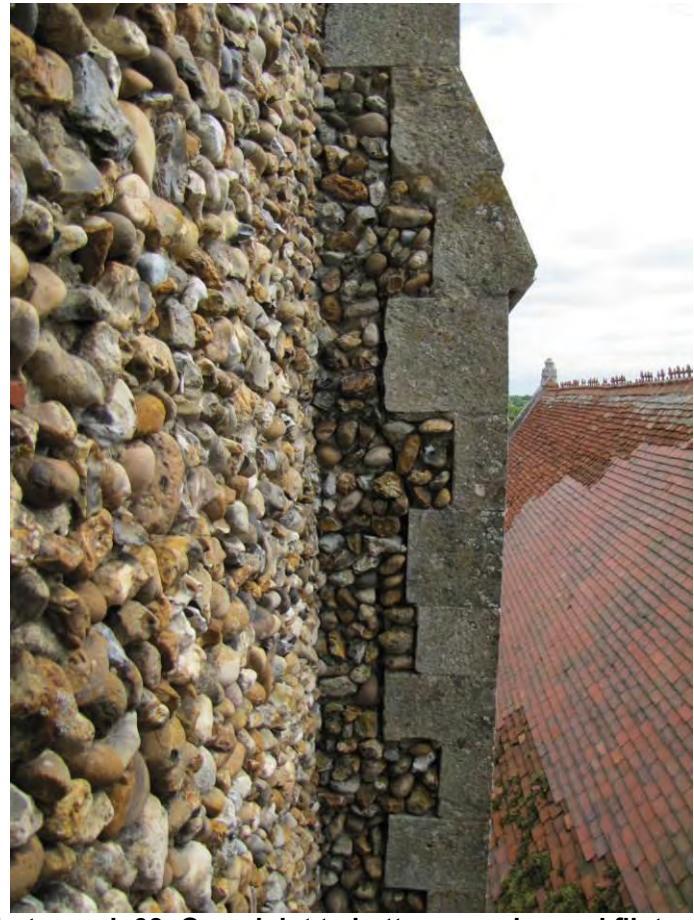
To the buttresses generally, there has been erosion of mortar at the joint between the stones and the flint work (see photograph 38). However where tested, the quoins are still stable generally. The exception was the north buttress to the west elevation of the tower, where the quoins to the north side were loose (see photograph 39). Whilst it may be possible to pin these back into the core, I suggest an allowance for rebuilding these quoins and the associated flint work alongside is included. It is possible that these may fall, particularly over the winter period.

Photograph 38: Open joint to buttress quoins and flintwork

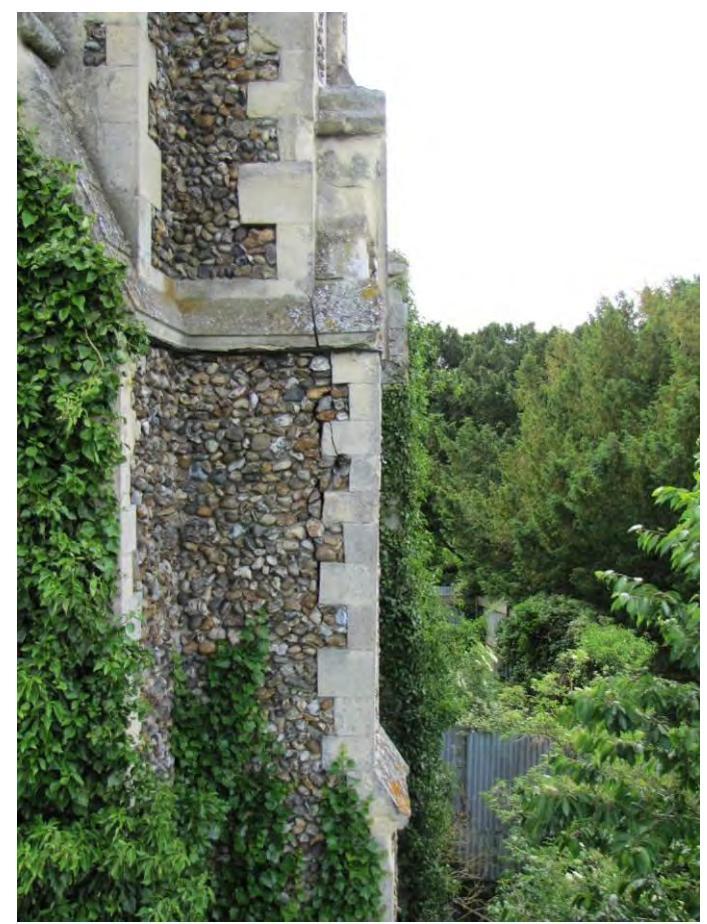
Photograph 39: North buttress to west elevation with 'live' quoins

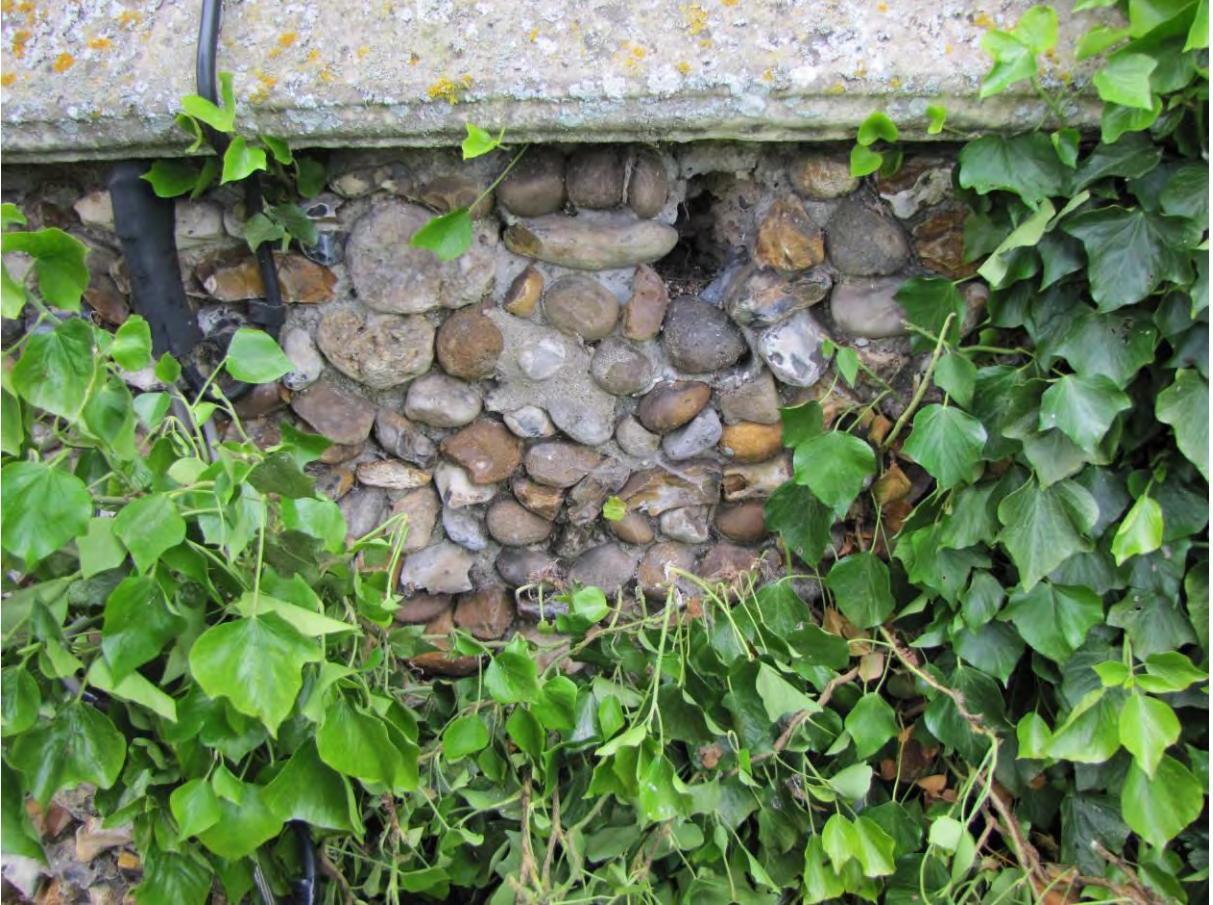
At some lower levels it may be found that the ivy has disrupted the flint work face more through root growth (see photograph 40), but generally I could not inspect these areas in detail, and the extent of work is unclear.

Photograph 40: Ivy growth to flint facework to north elevation

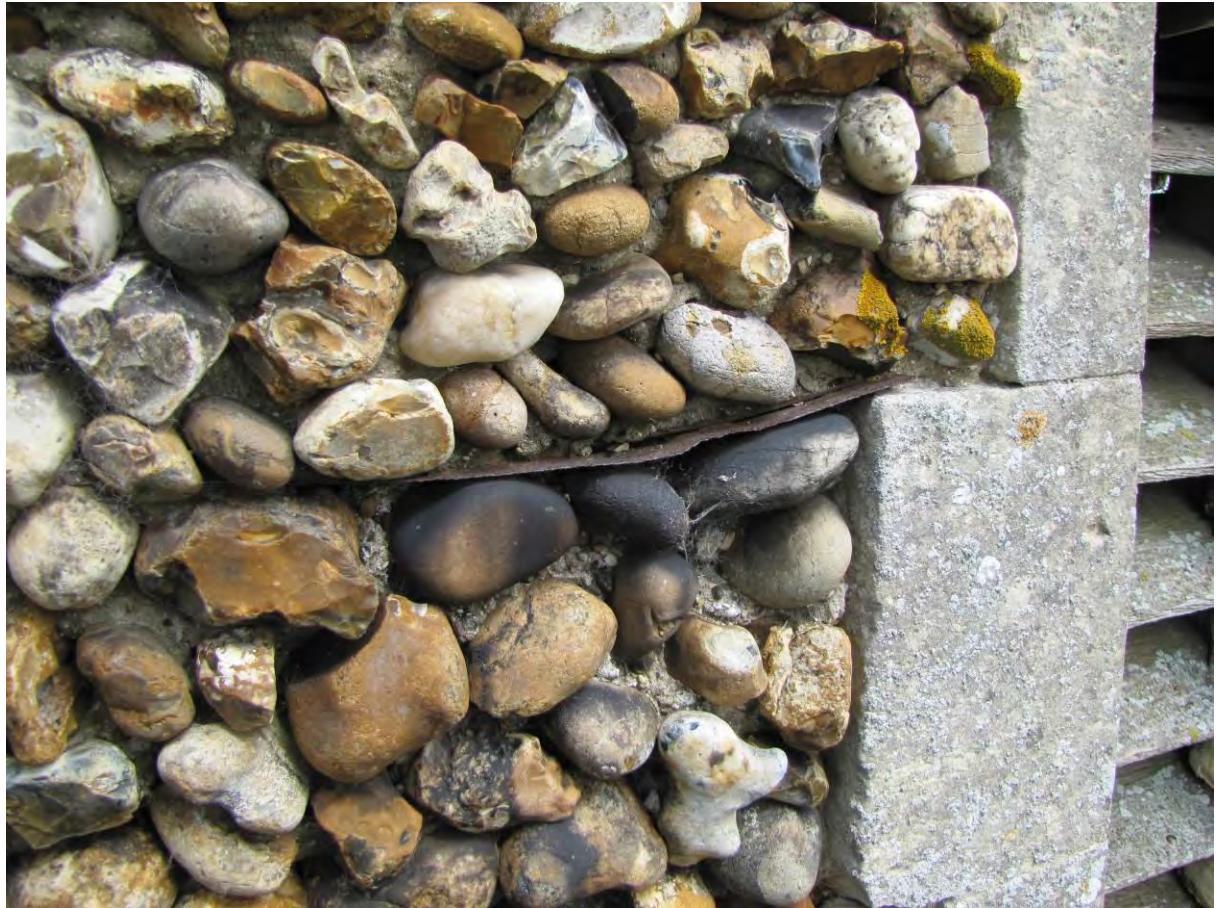
At one position adjacent to a window, a short section of 'hoop iron' was located (see photograph 41). This was a material used quite regularly by Victorian builders to reinforce masonry, but generally brickwork where the coursing is regular. No other evidence was found, and its position within the flintwork is odd. Some repair work to the belfry windows is required where the stone had eroded (see photographs 42 and 43), although this is not wholesale. The single lancet windows at lower level are generally in reasonable condition (see photograph 44). One name was found carved into the stonework to a corbel to a buttress to the south side (see photograph 45).

Photograph 41: Short section of 'hoop iron' in flintwork

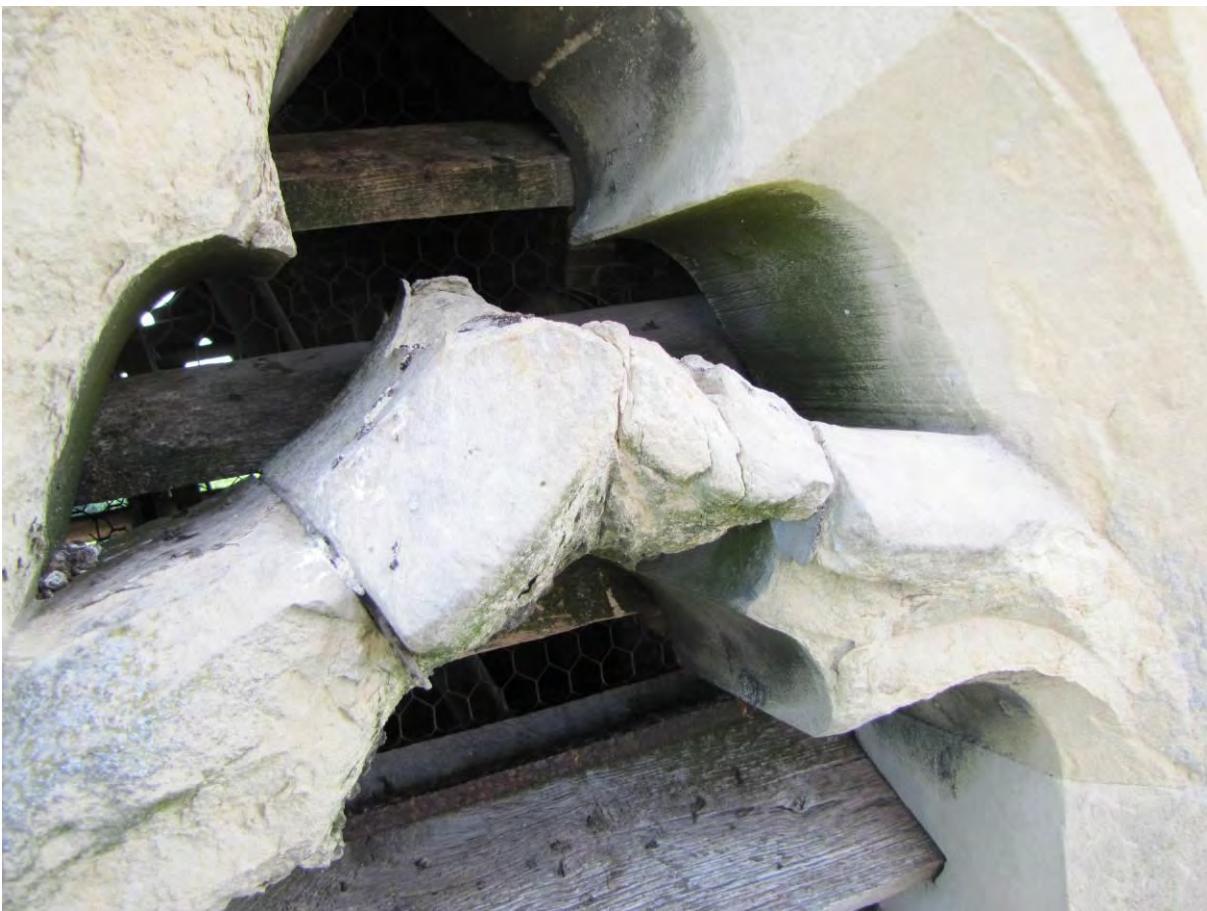
Photograph 42: Belfry window stonework in poor condition

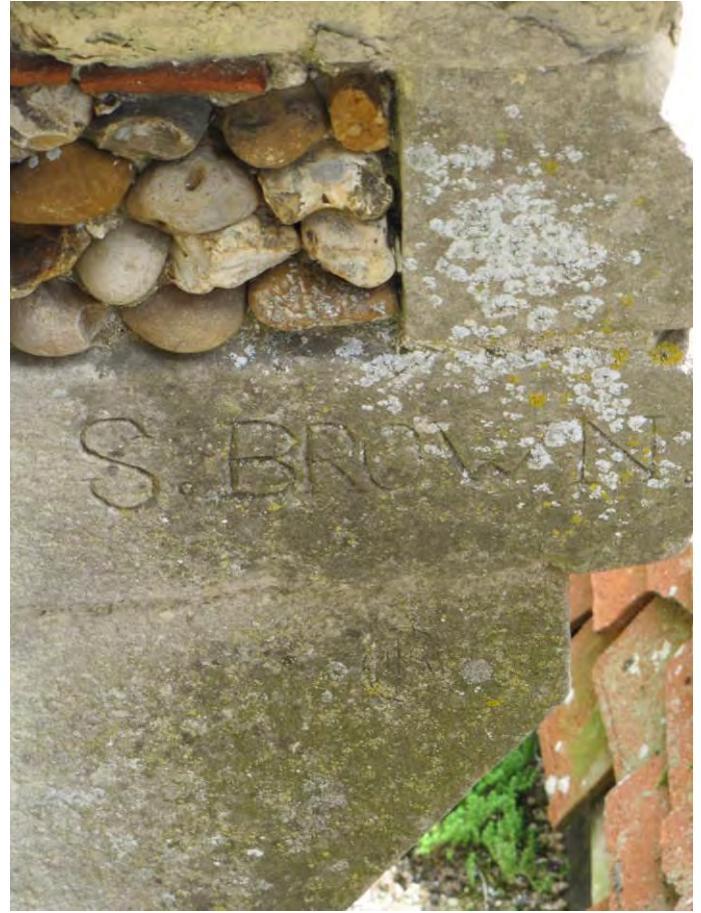
Photograph 45: Graffiti to stone corbel

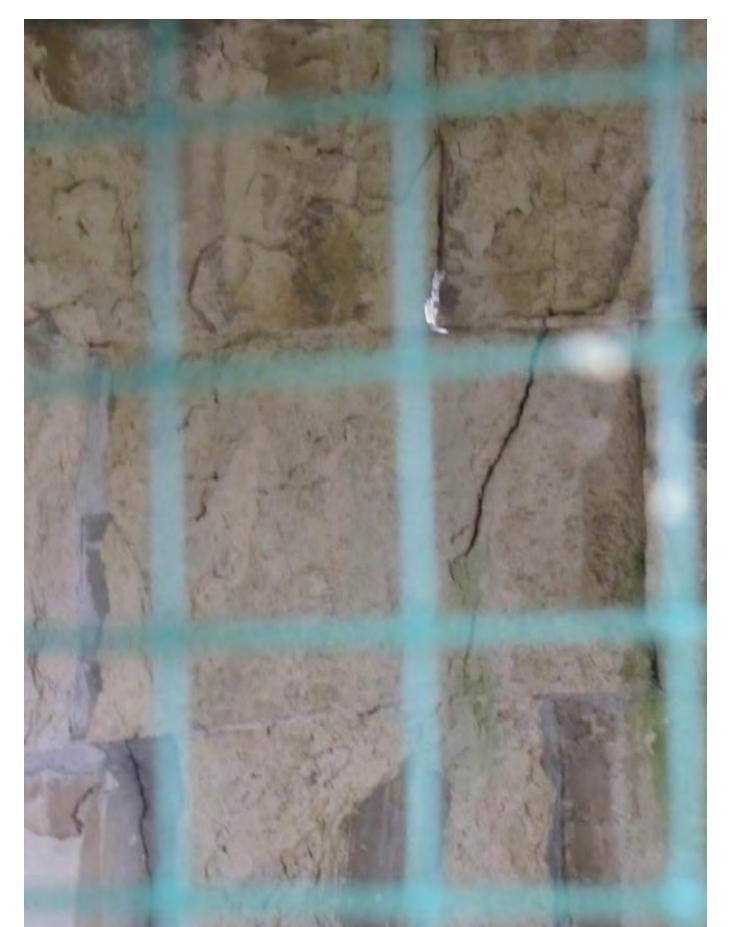
In a few locations it was possible to take some photographs into the spire through openings. The condition appears as expected in the local areas viewed (see photograph 46), with odd areas where daylight could be seen through the joints (see photograph 47). This probably relates to lifting from corroding cramps, but suggests some repointing will be necessary in areas of the spire – this is backed up by the evidence of water staining seen internally.

Photograph 47: Daylight seen through joints

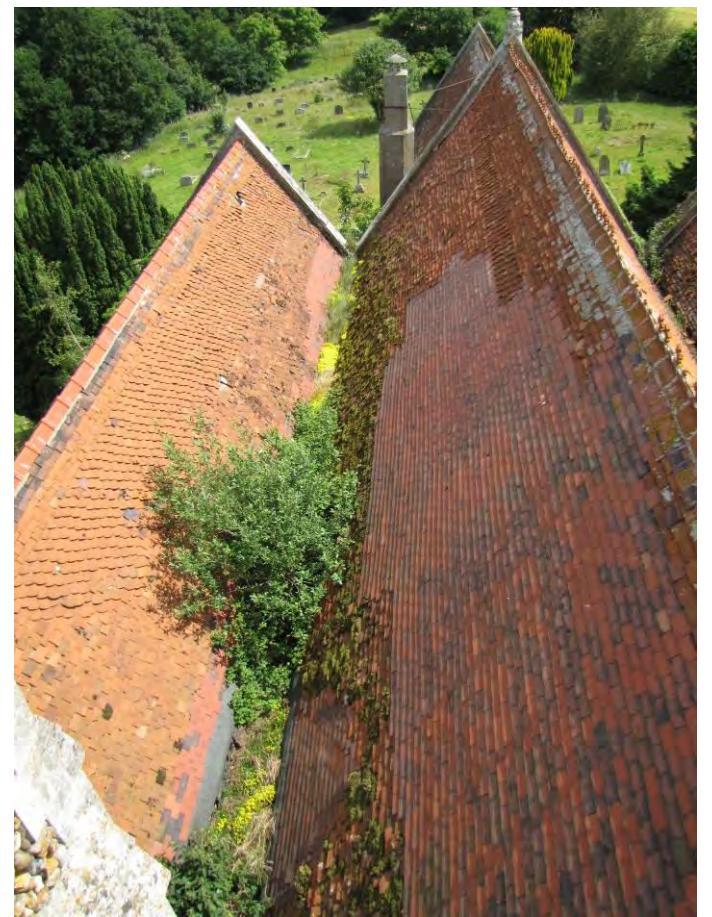
From the crane cradle it was possible to over view the roofs (see photograph 48). The valleys are clearly blocked and this is allowing water ingress and significant decay to the roof structures (see photograph 49).

Photograph 49: Blocked valley gutter

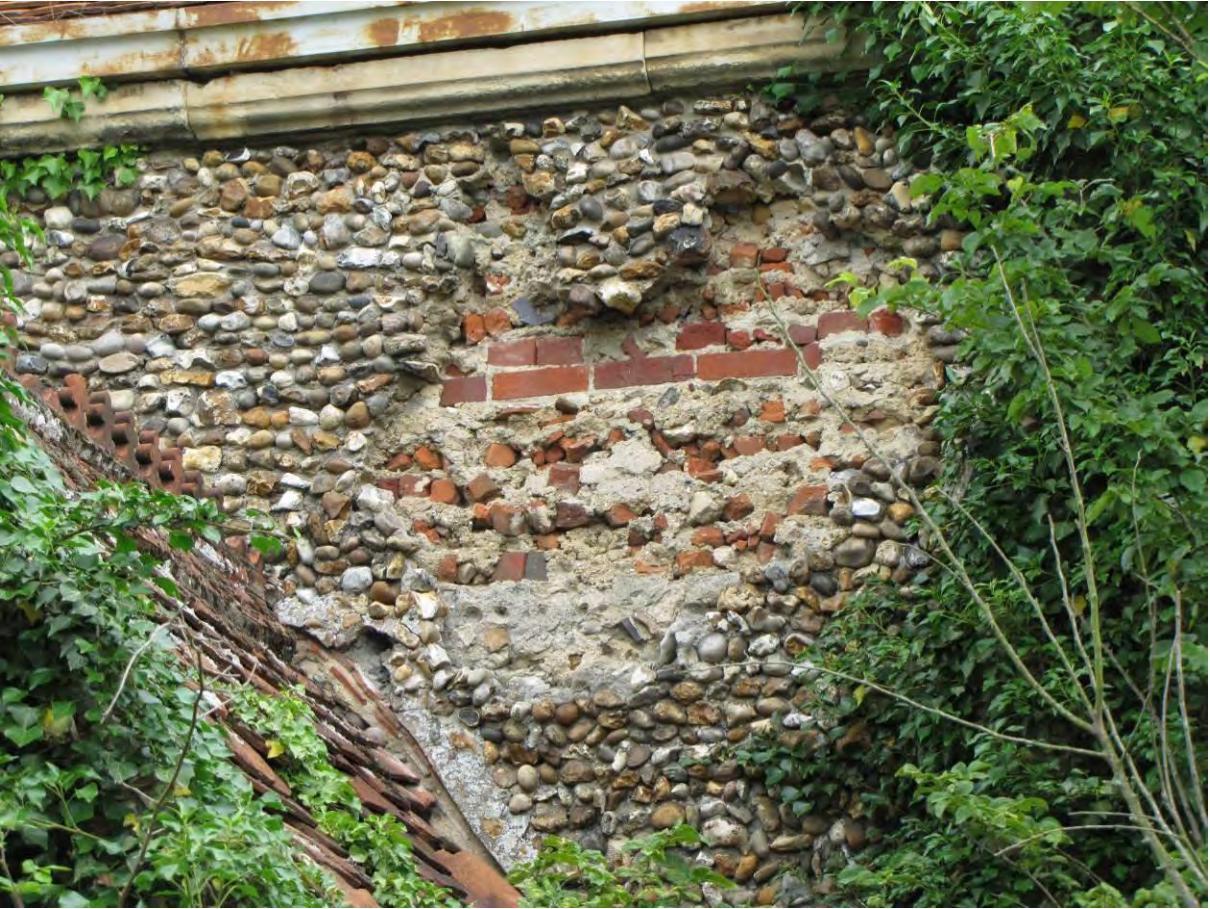
It was difficult to inspect the other walls of the church externally due to hoardings. It was noted to the south aisle that an area of facing had collapsed (see photograph 50). This reveals a rough random core of masonry, again providing evidence for the re-use of masonry from the previous church. Elsewhere no particularly significant structural defects were noted.

Photograph 50: Collapsed face to south wall of south aisle

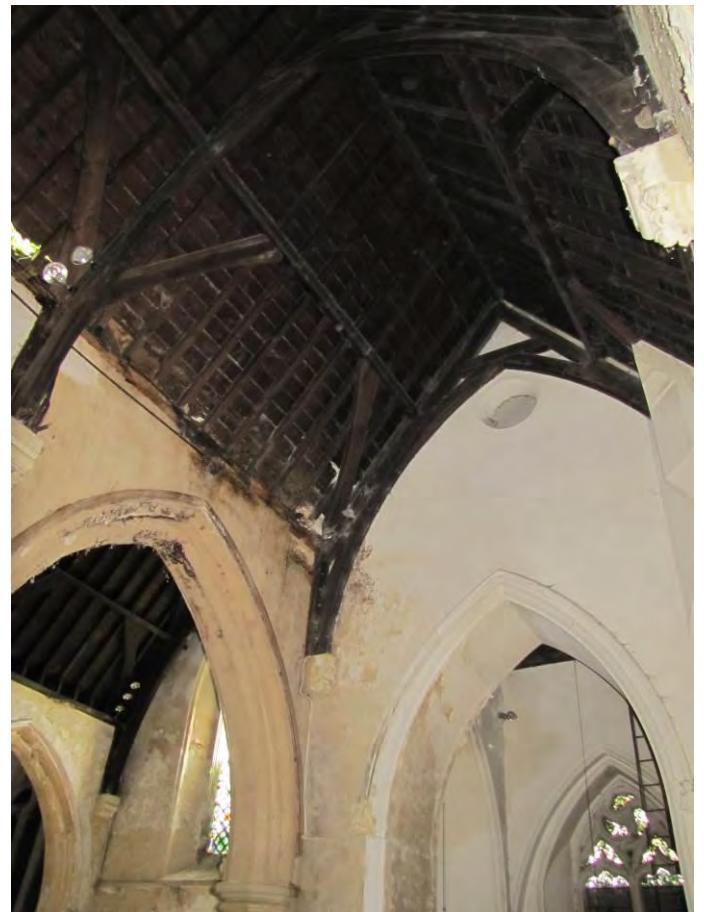
Internally within the main body of the spire it was quite gloomy and, even with torches, assessing the condition was not straightforward. The valley gutter between the north aisle and nave is clearly in very poor condition with much water ingress evident, and in some places vegetation can be seen internally (see photographs 53 and 54). There will be a significant amount of repair needed to these elements with the following likely to be necessary: repair of trusses including wall post, principal rafter foot and arched braces; repair of common rafters say up to first purlin level, and then replacement of entire rafter wall plate; replacement of arched wind braces on underside of common rafters. This will be for both the retained section of north aisle and nave, and will need to include temporary works to support the structure whilst these works are undertaken. A close level survey would be necessary to identify the full extent of the works accurately.

Photograph 54: North side of nave roof and valley to north with decayed structure obvious

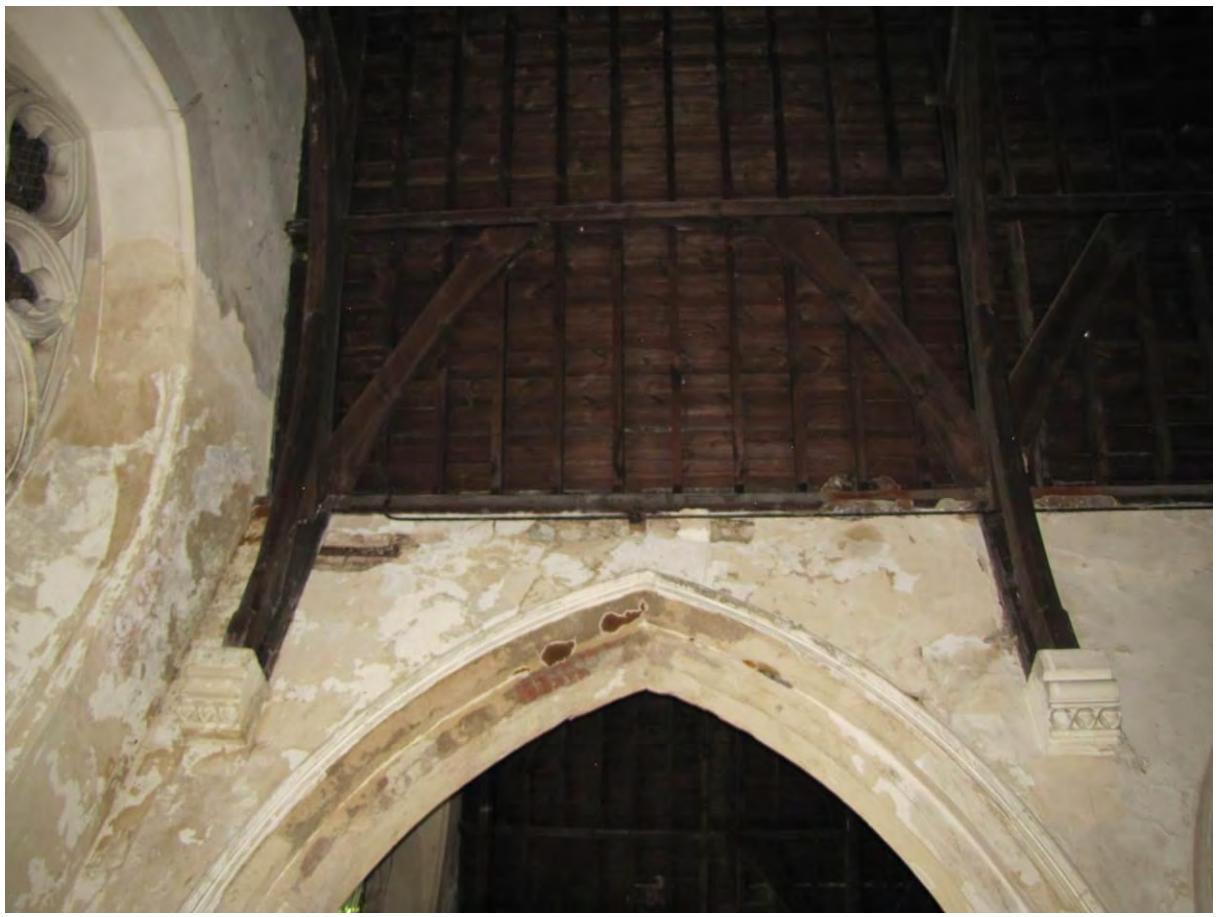
The south aisle roof does not appear to be in such poor condition from the underside (see photograph 55), however it would be prudent to clear to valley to help reduce water ingress and therefore decay in these areas. This would need to be undertaken with great care and with appropriate safety equipment and harnesses, as the condition of the gutter sub-structure is not known. Similar access to the north valley gutter is not suggested due to the condition of the structure.

Photograph 55: North side of south aisle at west end

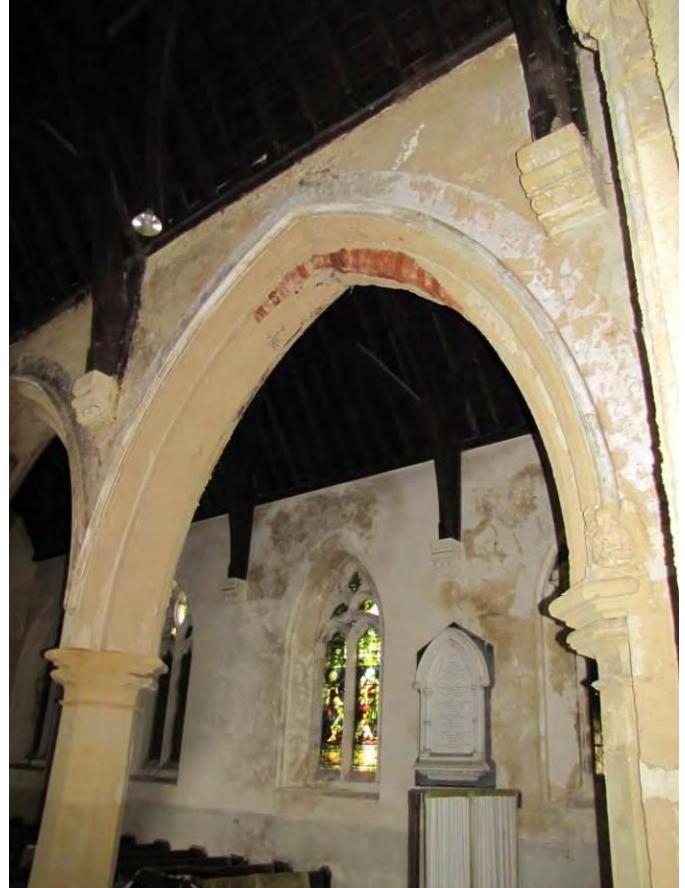
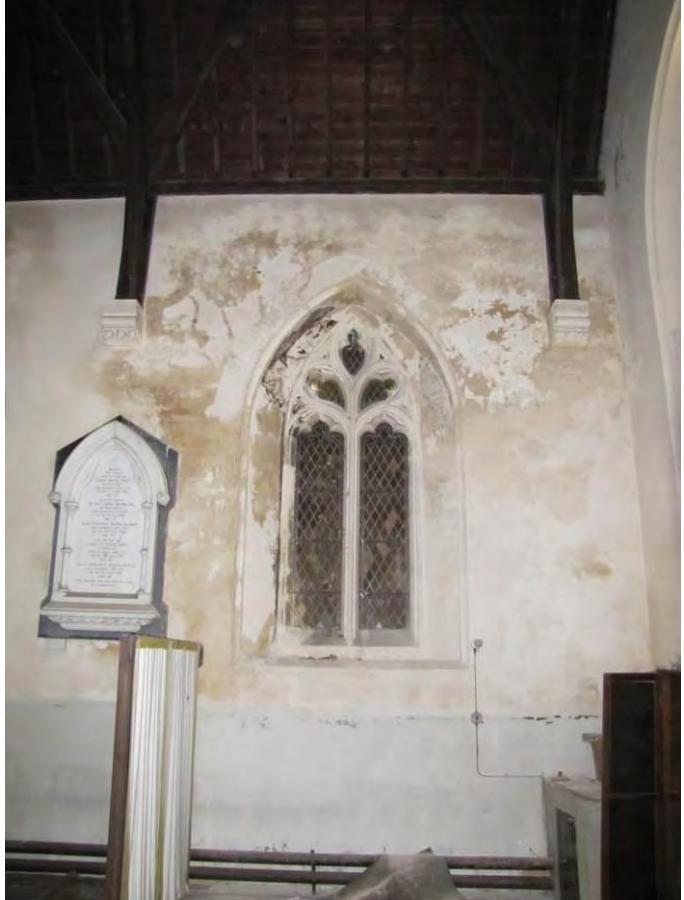
The north wall of the north aisle to the east end is also suspect, due to water ingress as evidenced from the water staining to the external wall and plaster failure (see photographs 56 and 57).

Photograph 56: North aisle at east end

Photograph 57: North aisle external wall at east end
