**Colchester Conservation Area 4:
North Station Road and Environs
Character Appraisal and Management Proposals**

February 2024

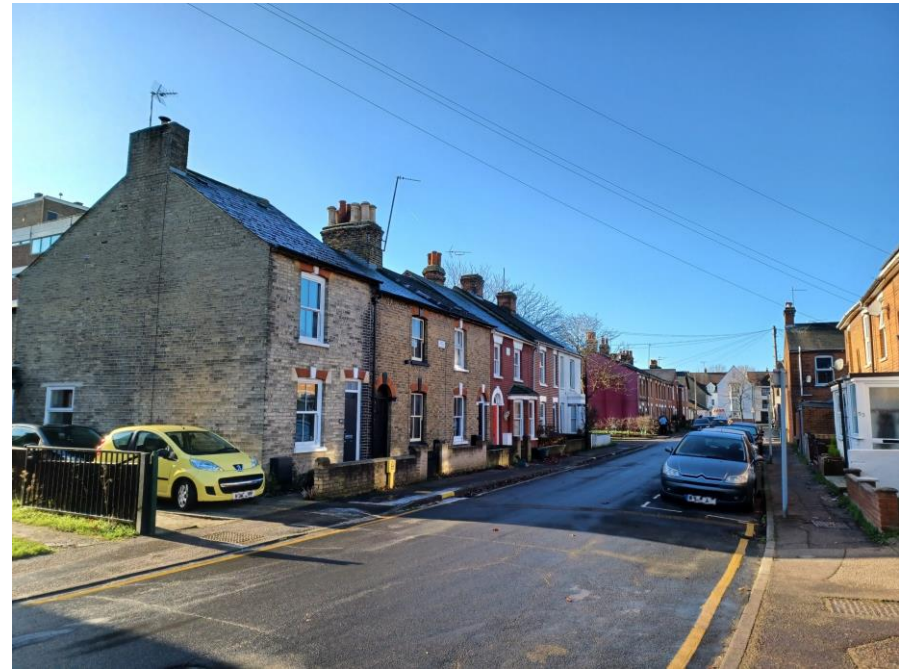
Fig. 13: View of Causton Road (south front) , with the terrace of nos. 12 to 18 in the foreground

The present report proposes the amendment of the boundary on Causton Road, to include the terrace of nos. 12 to 18 Causton Road. By virtue of its date, style and quality, these properties form a group with the buildings on Causton Road within the existing boundary despite the disruption from the access to the site of the Riverside Office Complex that interrupts the continuity of the street frontage (Fig.13).

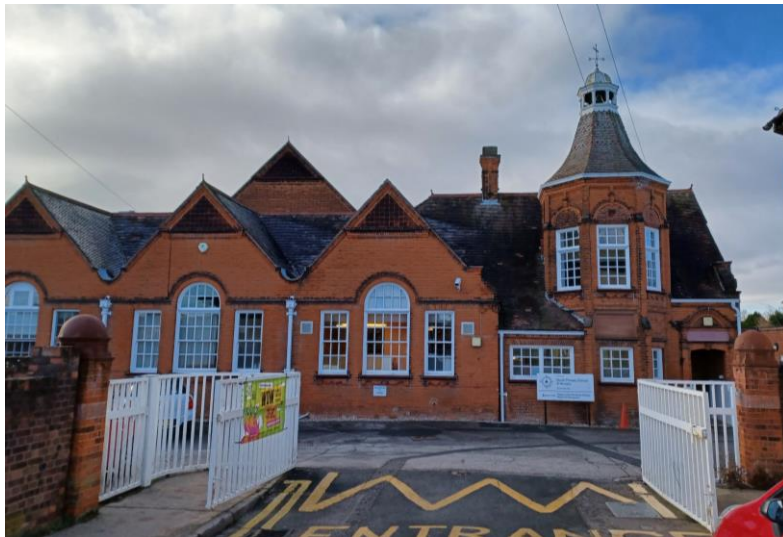
Fig. 23: North Primary School, John Harper Road.

The North Primary School is an exceptional example of a later Victorian Board School with eclectic freestyle elevations in a Queen Anne derived style with elevations faced in red brick with terracotta aprons below the windows and panels of moulded terracotta tiling inset into the peaks of the gables. The whole composing a lively roofscape featuring a terminating faceted turret (Fig.23).

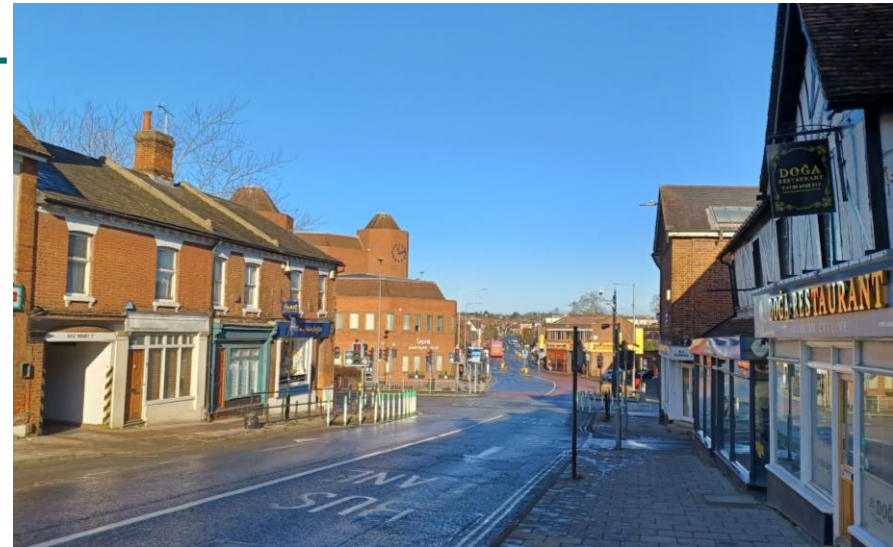
Fig. 24:View of the Conservation Area from North Hill.

Dynamic view of the Conservation Area from North Hill. Although this impression would have been different prior to the removal of the North gate, today the uninterrupted view of North Station Road illustrates its role as the main access road into the historic walled town from the north.

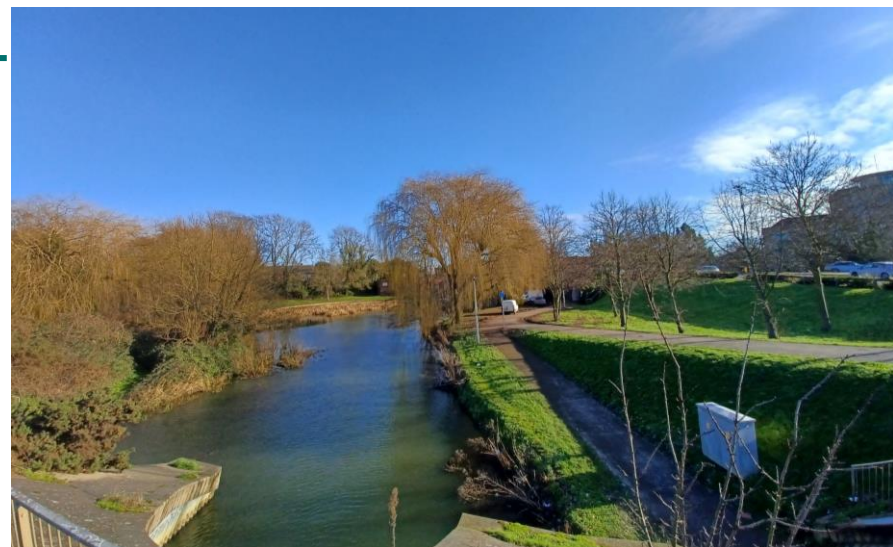
Fig. 25: View of the former Open Air Swimming Pool form the north-west.

Fixed View down into the River Colne's former Outdoor Swimming Pool (The Lido), from Station Wy (A134) that, being largely intact, offers a historically relevant view of this important connecting feature linking and interconnecting the rural landscape and urban townscape.

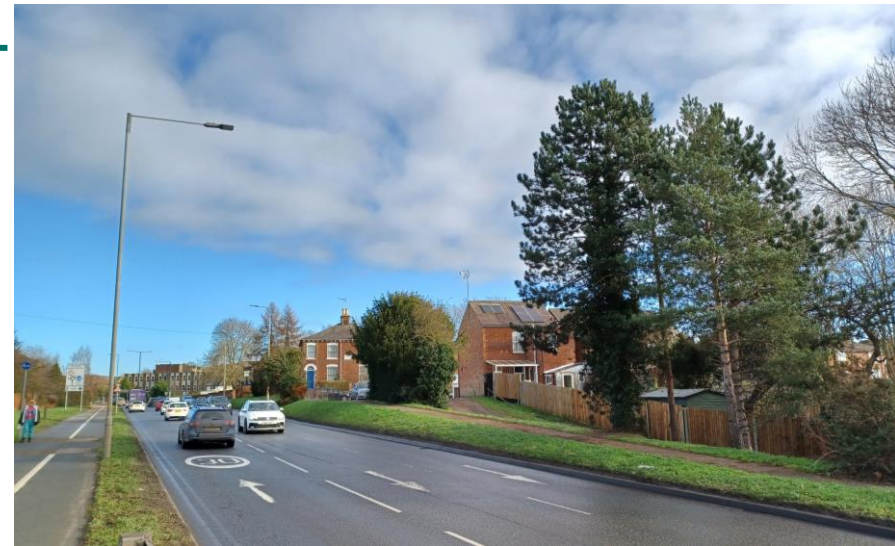
View 3

Dynamic views of the Conservation Area, unfolding along the elevated south sidewalk of Station Way (A134). They mainly reveal the unattractive rear views of the buildings that front onto Belle Vue Road and North Station Road but also afford glimpses of good fronts on the east side of Belle Vue. (Parked cars and the railings of the car park that interfere with these views would benefit from some local landscaping that would improve the north end of Belle Vue Road.)

Fig. 26: View of the Conservation Area from Station Wy (A134).

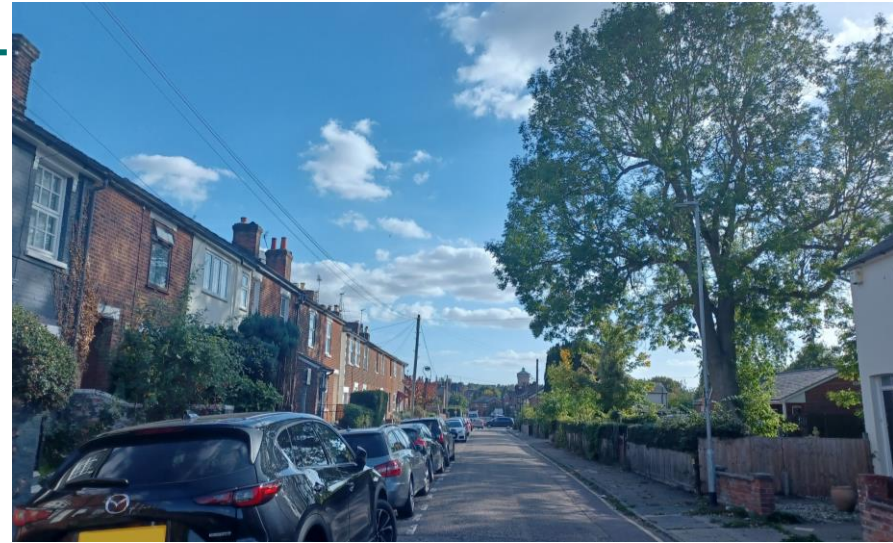
View 5

Fixed view from the north end of Belle Vue Road looking southwards. The Jumbo Water Tower is the focal point that helps to place the Victorian estate in relationship to the historic city centre, while the graveyard to the acts as a discreet connection with the rural hinterland to the west. The protected tree in the foreground is a significant feature of the street scene. St Paul's Road is viewed in continuity to Belle Vue Road, but the link is only visual; Colne Bank Avenue disrupts their physical connection.

Fig. 28: View form the north end of Belle Vue Road towards the city centre.

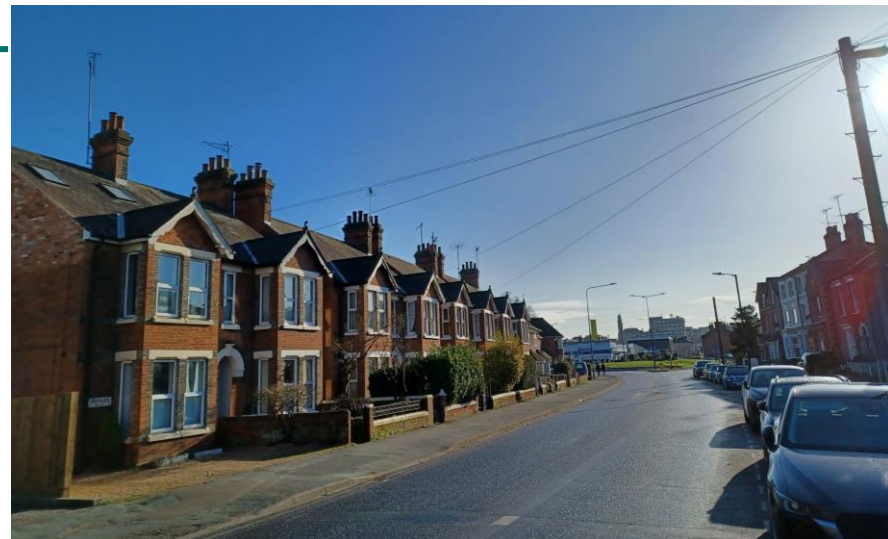
View 6

Dynamic view from the north end of North Station Road towards the city centre. The tower of the Town Hall is the focal point, although its prominence is challenged by the Telephone Exchange building. This is the first sighting of a key Colchester landmark on the route from North Station that helps visitors to navigate their way towards the city centre.

Fig. 29: View from the north end of North Station road towards the city centre.

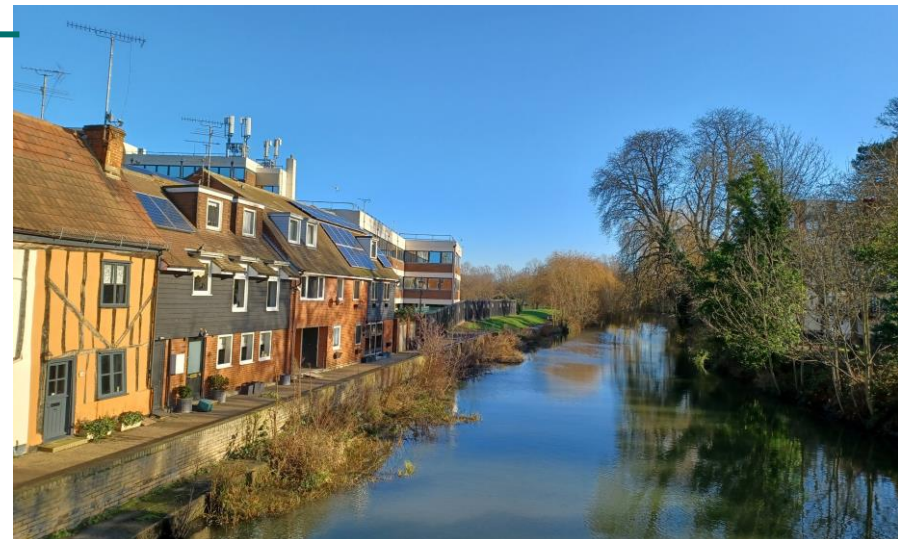
View 8

Fixed view from North Bridge looking eastwards which illustrates the role of Riverside Walk that links the Conservation Area to Castle Park. The views of the park at the backdrop are framed by the belt of mature trees on the south bank and the Riverside Cottages to the north. The modern dwellings to the south of the cottages and Digby House detract from the view but the main offender is the six-storey volume of Fairfax House, topped with telecommunication poles that exacerbates its adverse visual impact.

Fig. 31: View from North Bridge towards Castle Park to the East.

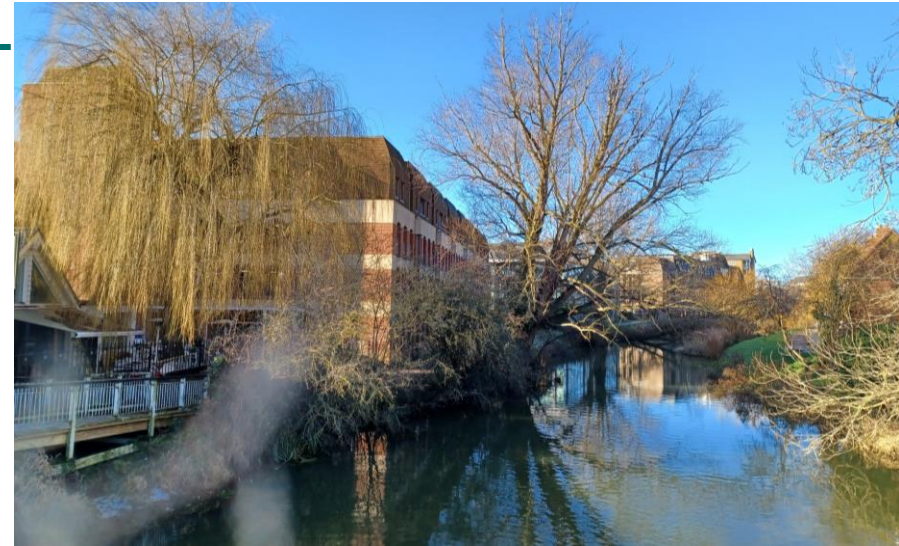
View 9

Fixed view from North Bridge, looking westwards. The volume of the Multistorey Car Park intrudes in the picturesque views of the river but the protected trees on the south bank soften the impression.

Fig. 32: View from North Bridge looking westwards.

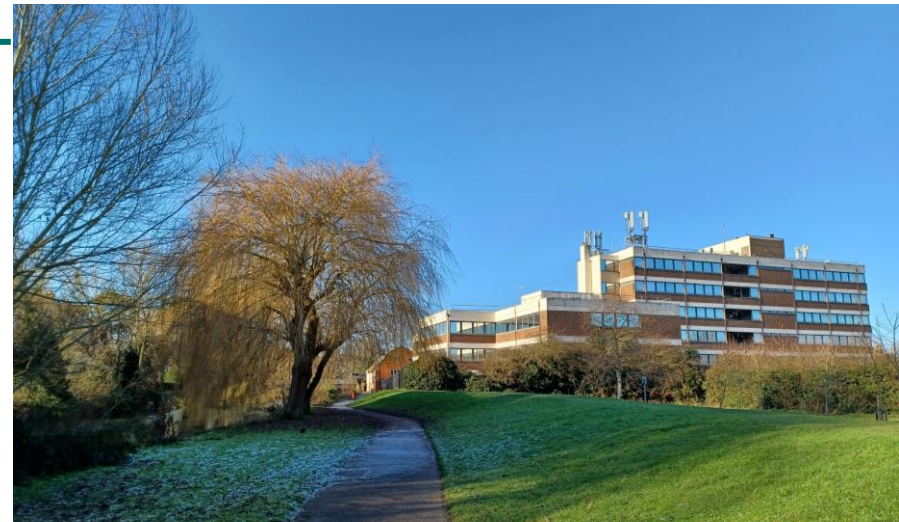
View A

Dynamic view towards North Bridge that unfolds along the Riverside Walk. The tranquil and picturesque setting of the Colne is marred by the views of Digby and Fairfax House, the latter being the most intrusive element by virtue of its height and bulk that can be better appreciated as the viewer approaches the site.

Fig. 33: View from the Riverside walk towards North Bridge to the West.

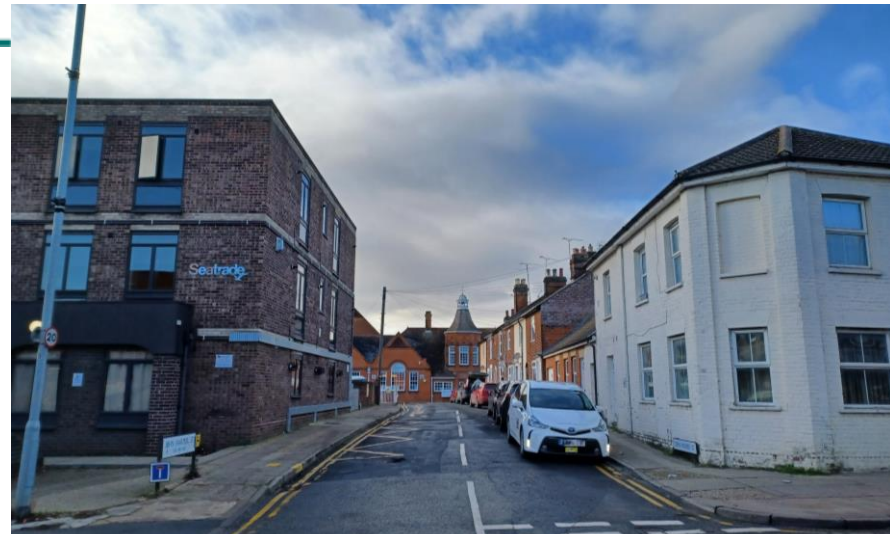
View E

Fixed view from the east end of John Harper Street that frame the listed North Primary School. Seatrade House has a volume that detracts from the views of the North Primary School that is seen from the east end of John Harper Street.

Fig. 37: View from the east end of harper Street towards North Primary School.

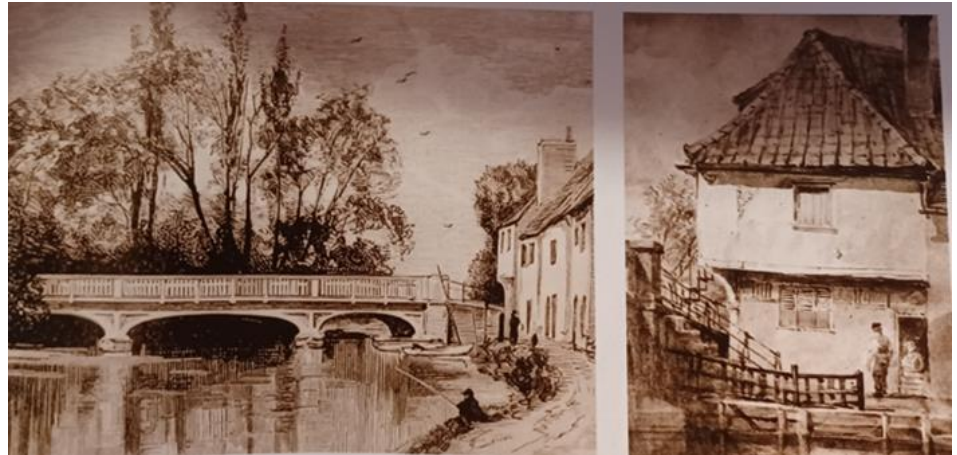
Figure 38: a (L). View of North Bridge and the Riverside Cottages in 1880 , prior to demolition of the westernmost cottage. b (R). The cottage that was demolished for the widening of the Bridge.

he 17th century Riverside Cottages on the north bank were truncated when North bridge was widened (see Fig.38), and two dwellings replaced a modest house to their east (Fig.41 and 42). The two office blocks further east, three storey Digby House and six-storey Fairfax House are part of the Riverside Office Complex that was erected in the later 1960's.

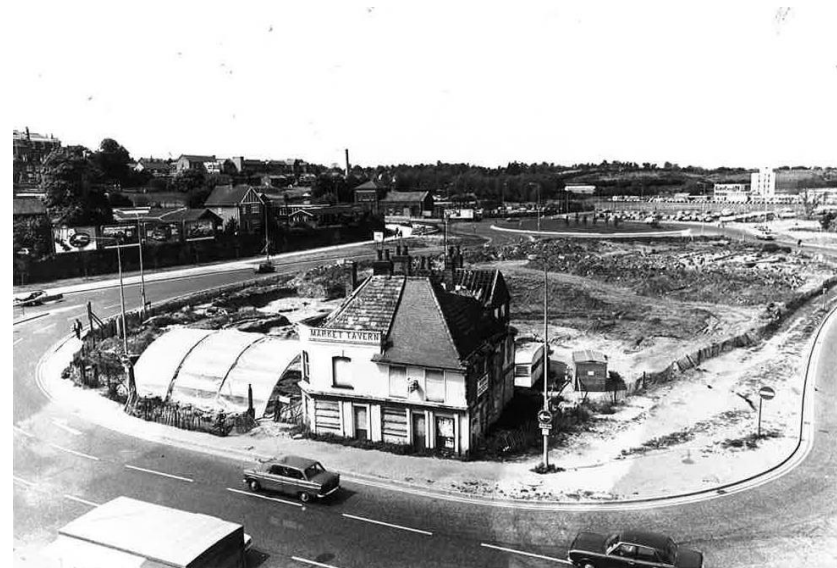
Figure 41: The site of the Cattle Market when it was cleared for the erection of the Octagon. The Market Tavern in the foreground was demolished as well.

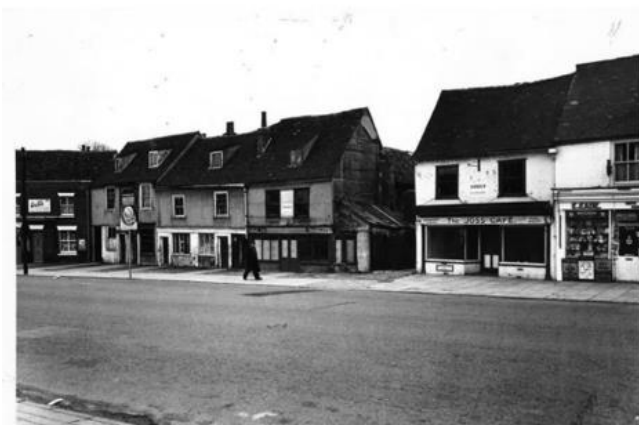
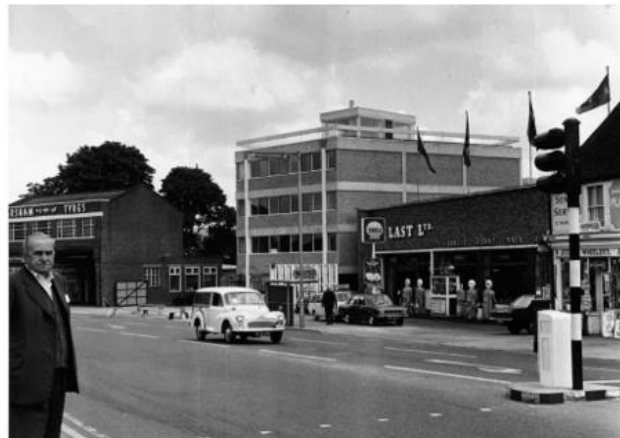
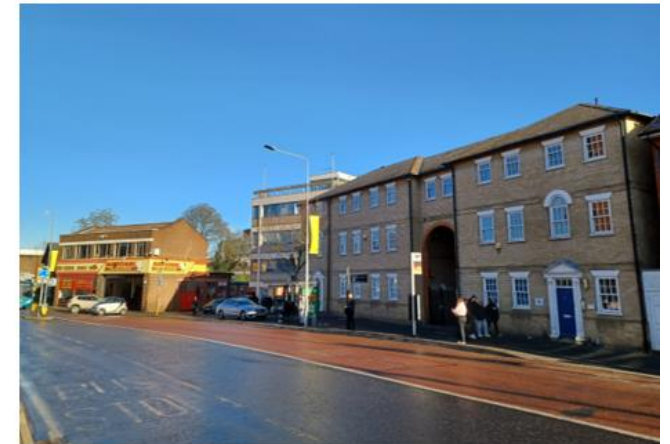
Figure 40:(L-R)a. nos 10-15 Middleborough in 1951 (©National Buildings Record & Historic England),b. approximately the same view in 1965, c. the same view in 2022.

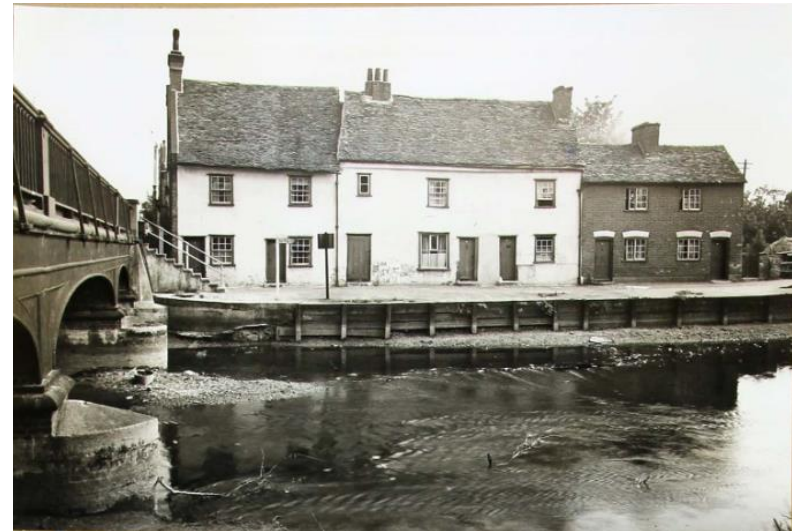
Figure 42: The Riverside Cottages in 1951((@National Buildings Record & Historic England),

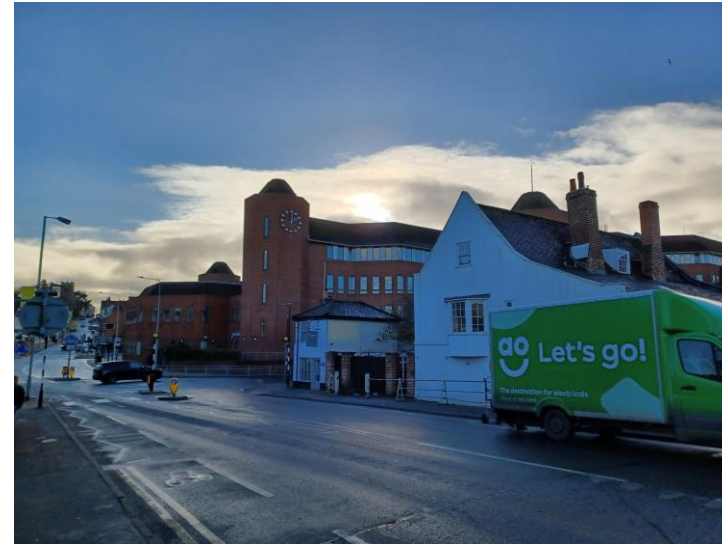
The southern approach to the Conservation Area is dominated by the post-war development at Middlesborough. The Octagon fronts onto the road with a octagonal two storey volume that does not appear overbearing in context. However, the scale gradually steps up to four and five storeys and is punctuated by massive towers at the corners. When seen from the north, the complex dominates the views to and from the south end of the Conservation Area and dwarfs the group of 20-21 and 22 Middleborough (Fig.44) .

Fig. 44: Views of the Octagon from the north east (photo to be replaced)

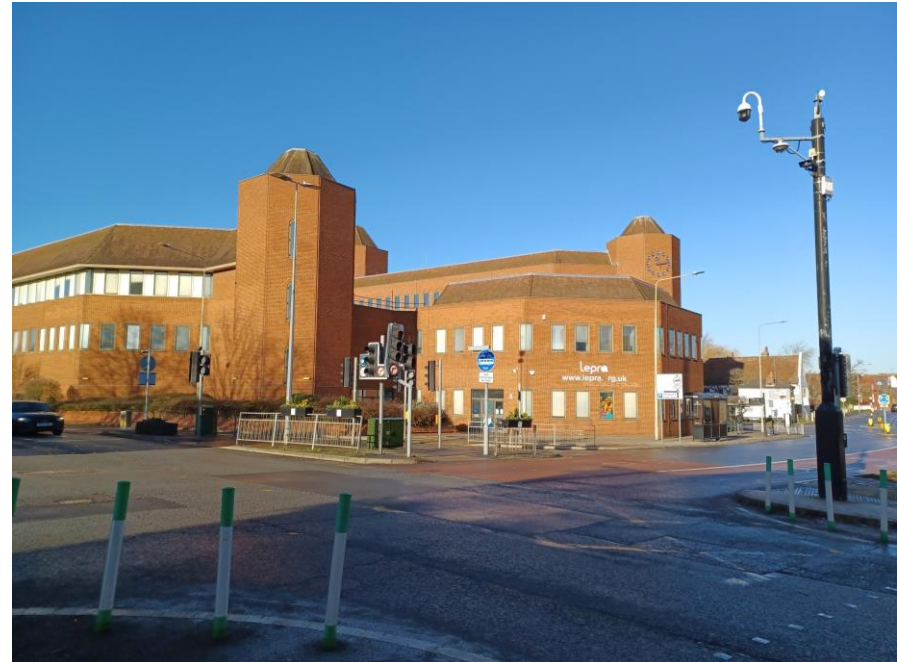
Fig. 47: Pedestrian junction at Middlesborough. View from south-east.

Street clutter is abundant, including traffic lights, railings, traffic signs, cameras, lighting columns, bus stops, bins and bollards. Zebra crossings, road markings yellow lines and the painted bus lane exacerbate the junction's appearance. The pavements comprise different materials in variable condition. The attempts at improving the appearance of the junction with planters and some poorly kept planting on Middleborough lack a coherent design approach and rather exacerbate the issue of visual clutter.

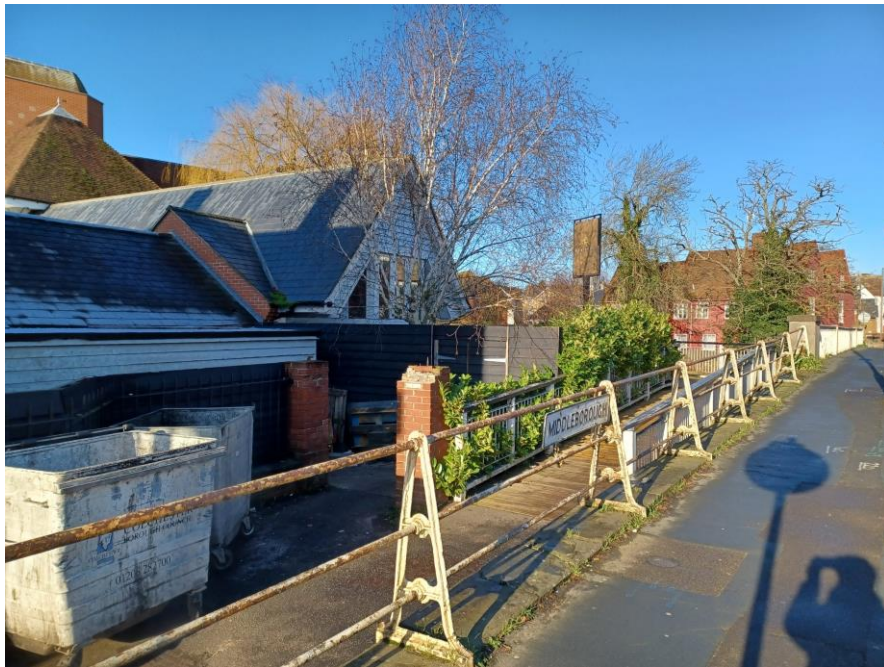
Fig. 48: The historic railings at nos.20-21 Middleborough.

Moving further north after the roundabout, a key feature of the public realm are the historic railings that line the pavement before and after the North Bridge. Their state of repair is poor and detracts from the appearance of the area and the setting of the heritage assets in that location. The railings before nos.20-21 Middleborough are seen in conjunction with the railings at the riverside walk to the north of the building (Fig.48). The railings of the bridge are also in need of repairs and maintenance.

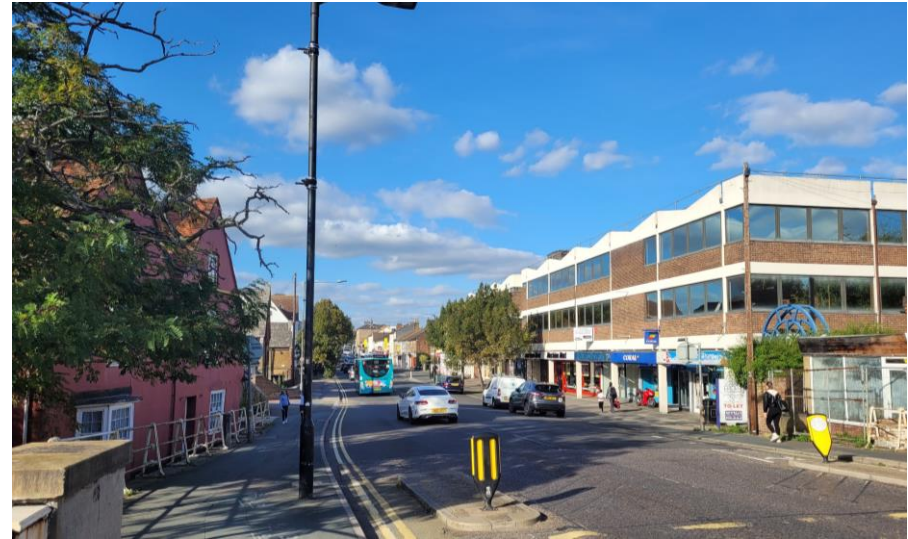
The south end of the Character Area is dominated by the alien scale and massing of Century House (Fig.57). The 1960s block relates very poorly with the nearby buildings in terms of scale, form, design and materiality. The contrast is notable when the block is viewed from the south in conjunction with the former Railway Mission on the opposite side but is even more striking when the office building is seen together the modest Fifteenth century timber framed 25-27 North Station Road from the northwest; the impact is further aggravated by the glimpses of the six-storey Fairfax House at the backdrop (Fig.58). Some localised tree planting only serves to screen the jarring effect from certain viewpoints to the south but does not effectively mitigate the overall impact of the block.

Fig. 57: View of north Station Road from North Bridge with Century House in the foreground.

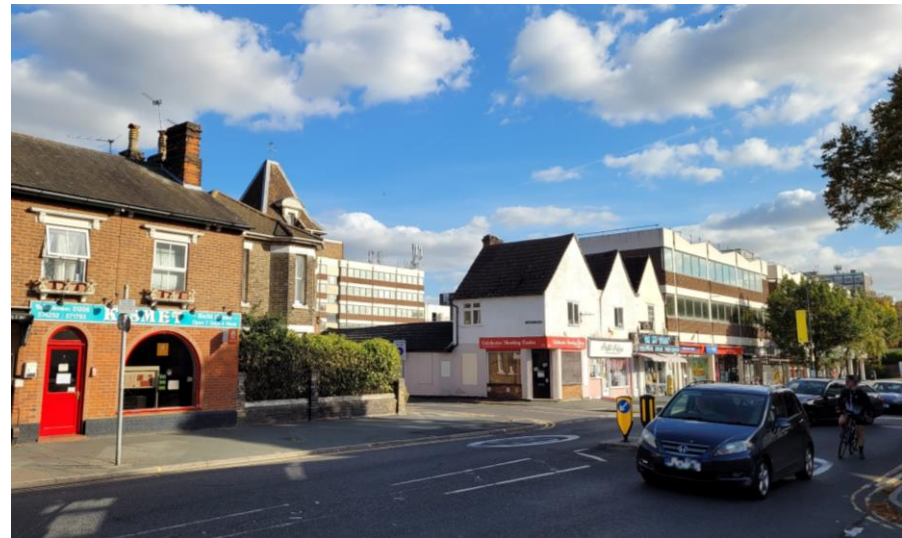
Fig. 58: View of 25-27 North Station Road from the north-west.

The Grade II listed timber framed 25-27 North Station Road comprises the former jettied cross wing of a 15th century hall house (No 27) and the gabled 17th or 18th century no 25 which replaced the former open hall. The third gable to the north is probably an 18th century addition as well. The appearance of the building is altered by the 20th century windows and shopfronts which detract from the remaining historic character of the group (Fig.59 and 60).

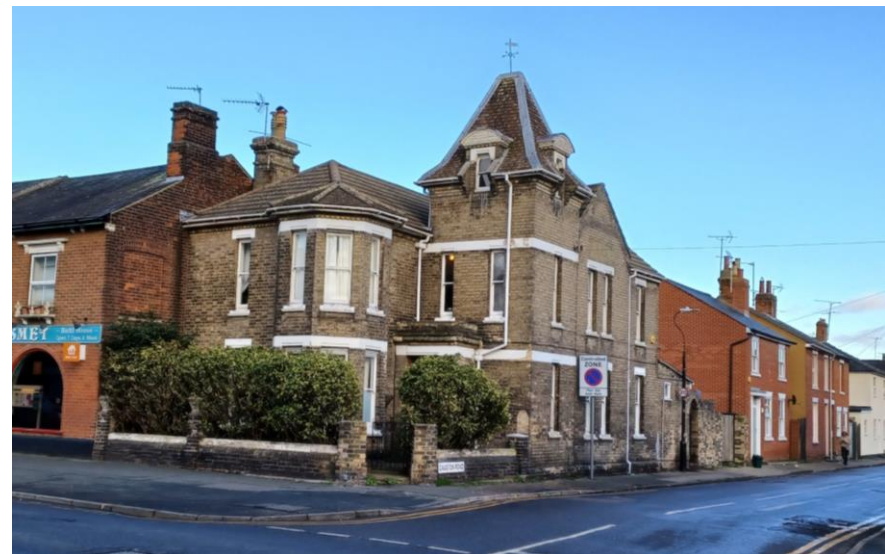
Fig. 60: 29 North Station Road. View from the south-west.

The locally listed no.29 North Station Road is a well-preserved large corner house built in the last quarter of the 19th Century (Fig.61). The use of gault brick reflects the use of gault brick at the Globe Inn and enhances its landmark quality as a prominent corner building

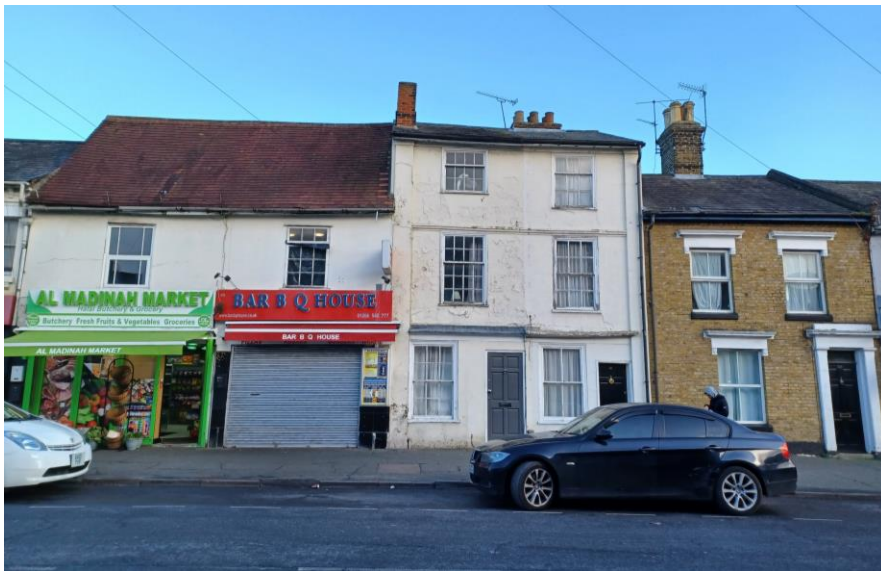
Fig. 62: 41-43 North Station Road (three storey) and the 16th century 45-47 to its left.

To its north, the east front comprises modest two storey terraced properties with modillioned eaves, corbelled window heads (no 31-37) or corbelled cills (no 49- 55); the latter retain original two-over two sashes on first floor. The two terraces are interrupted by the three storey no 41-43 which stands out for its decorative details, original fenestration and original form of the ground floor that has

not been altered with shopfronts. The adjacent timber framed no 45-47 dates from the 16th century (Fig.62). The gabled elevation of the no 57 bookends the terrace before the three storey 59-61, now much altered by the unsympathetic shopfronts, thick cement render and uPVC replacement windows.

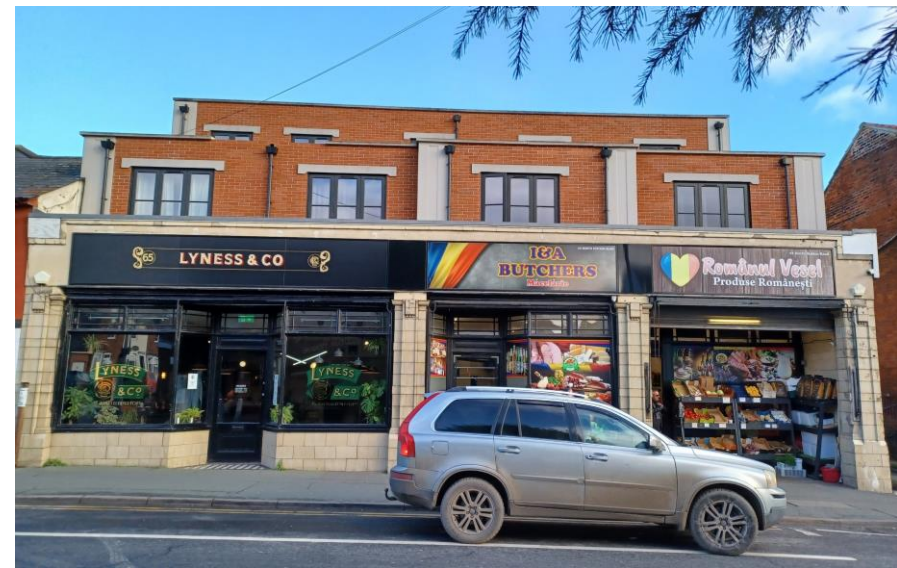
Fig. 63: 63-65 North Station Road.

No 63-65 was originally a single storey building designed by architects Goodey & Cressall in 1924 to provide three shop units for the Colchester Co-operative Society, for grocery, confectionary and

butchery. The front façade is clad in creamy coloured faience, mimicking stone. The pilasters have art-deco decoration, matching the original shopfront which survives intact, including the inset entrance doors with canted flank walls. The large fascia signage area is currently covered with an unsympathetic plastic fascia sign, but the surround appears to be partially present behind (Fig.63).

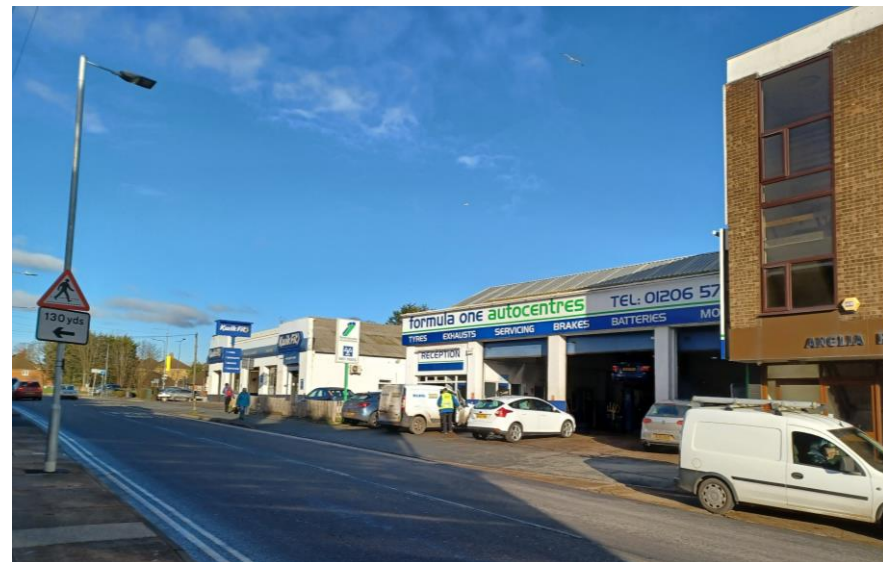
Fig. 65: Anglia House to the right and the garages to the north.

The section up to the Albert Roundabout comprises 20th Century development. The scale of Anglia House challenges the prominence of Globe Hotel. The signage of the ground floor commercial units exacerbates the adverse impact. The two garages between Anglia House and Serpentine Walk are significant detractors. The buildings appear incongruous in that location and their negative effect is amplified by elements that are usually associated with this type of business, including the brush signage and tarmac parking and the picket fence at Kwik Fit.

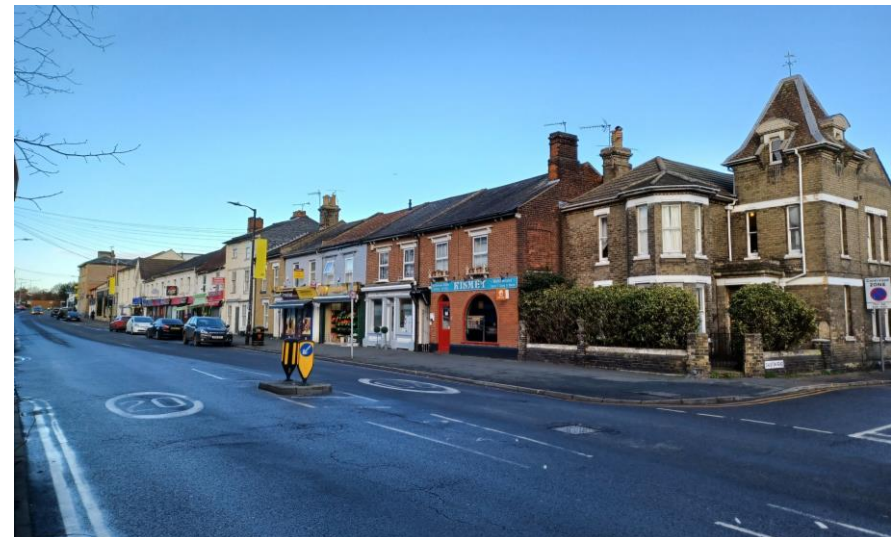
Fig. 67: The same view in 2022.

The appearance of this section (from North bridge to the roundabout) is compromised by the modern development at each end. However, the character of the surviving section between 29 North Station Road and Globe Hotel has eroded by unsympathetic alterations, including the introduction of modern shopfronts and unsympathetic signage, painting of brickwork, the loss of original architectural details and the replacement of the timber fenestration by uPVC windows. The loss of the chimneys is also a notable change that detracts from the street scape (Fig. 66 and 67).

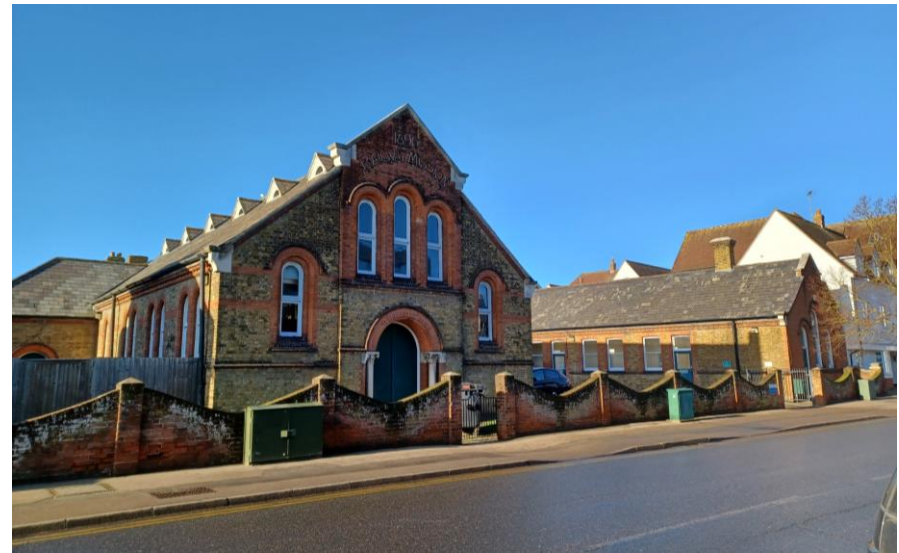
Fig. 68: The former Railway Mission on North Station Road.

The former Railway Mission is the first notable building on this frontage. Built by William Willett in 1896 in stock brick with red brick dressings, arched windows and doorway, the building is part of Colchester railway heritage. The main block and the Sunday School, to the north were linked with a reception block of c. 1998 to accommodate healthcare services. The boundary wall of the Railway Mission contributes positively to the street frontage but a close boarded timber fence behind the street boundary and the tarmac parking forecourt are negative features.

The locally listed building is flanked by modern, rather nondescript development. The dwelling to the south is part of the development of 13 dwellings at the Old Poultry market. The building to the north dates from the development of the land adjacent the Victoria Inn c.2001 with 12 flats distributed in two blocks, to the south and west of the listed building. The height of the southern block could have been made more subordinate, to enable a smoother transition

between the three storey Victoria Inn and the single storey Railway Mission and preserve the prominence of the listed building which is challenged by the three-storey gable elevation.

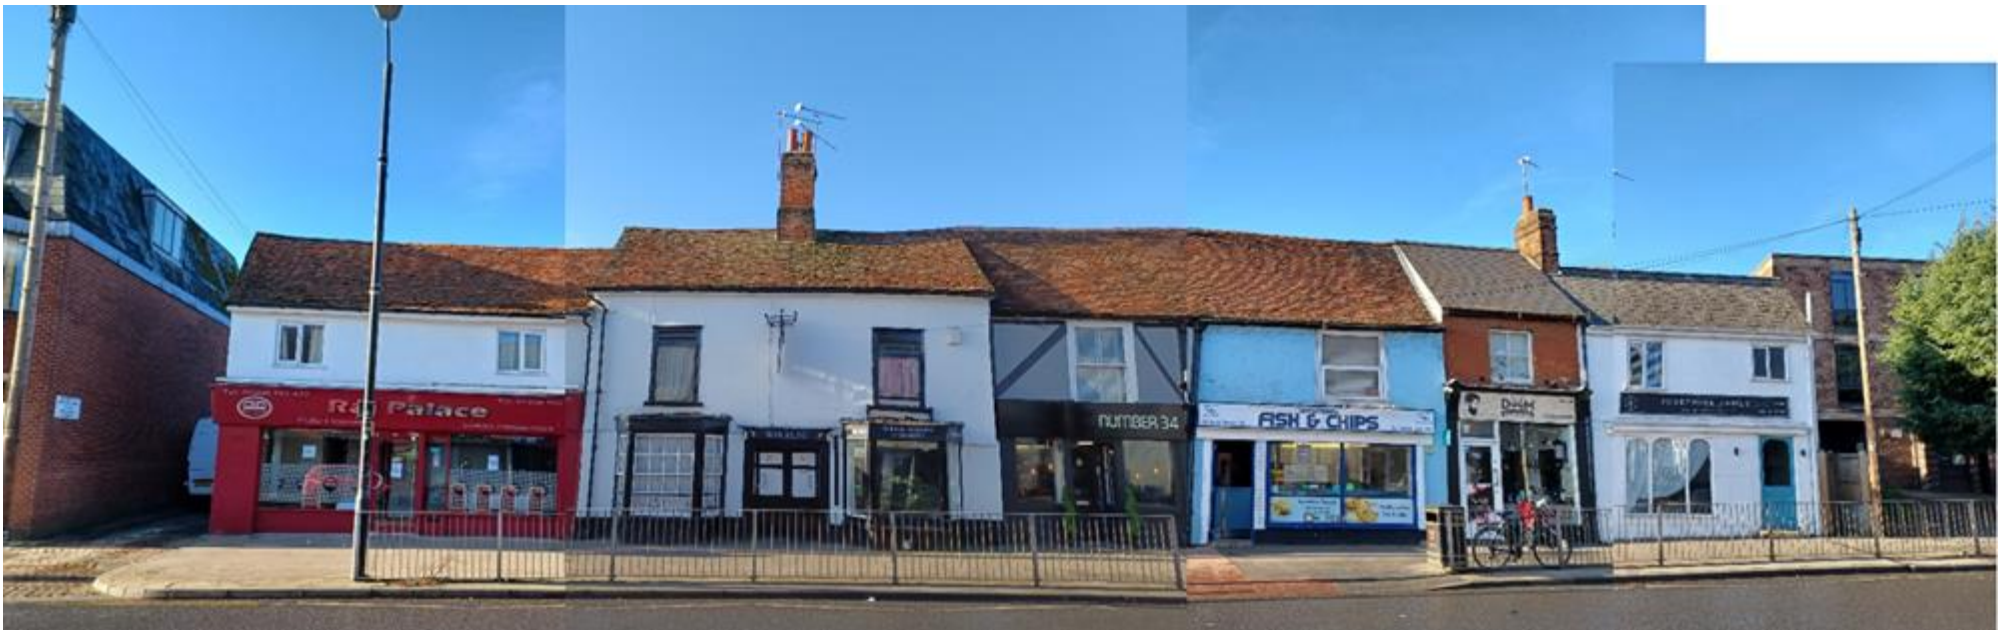
Fig. 69 : no 28 to 38 North Station Road (to be replaced with better resolution).

The modest two-up, two-down red-brick house at no 38, is also included in the local list. Built circa 1860-1870, has an original double two-pane sash window with horns at first floor and an early 20th century shopfront(Fig.69).

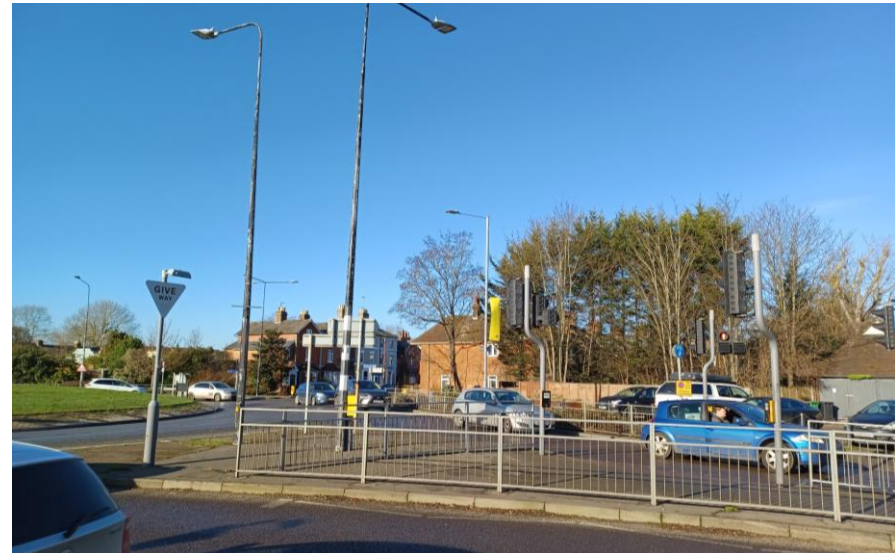
Fig. 72: Pedestrian crossing on the Albert Roundabout.

The Albert Roundabout suffers from similar abundance of street clutter as seen at Middleborough, further exacerbated by the extent of the area it covers and the heavy traffic on Colne Bank Avenue that create an intense environment that is not particularly pedestrian friendly (Fig.72).

- Poor quality of the public realm, including condition of pavements and railings.
- Street clutter on the Albert Roundabout.
- Poor quality 20th century development that failed to integrate well into the area.
- Incompatible uses (garages) that detract from the street scene
- poor quality shopfronts and unsympathetic signage.
- unregulated external changes, including the loss of chimneys and other architectural features, replacement of roofing materials, loss of original fenestration and replacement with uPVC windows and composite doors, external painting (of previously unpainted surfaces) with inappropriate colours.
- management and use of vacant commercial properties.

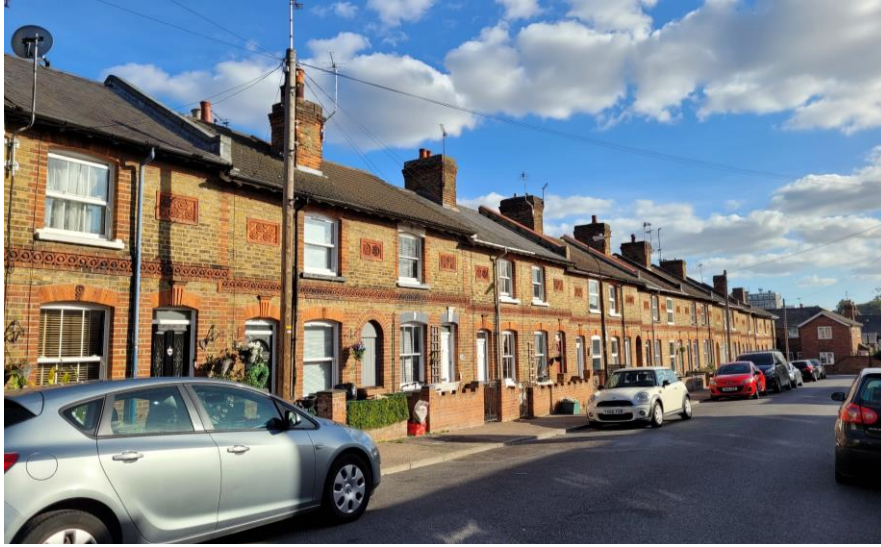
Fig. 76: 1-17 Morten Road, view from the north-west.

Continuing west on Morten Road, the character of the street is defined by the good quality locally listed terrace of nos. 1-17 Morten Road (east side- Fig76). The terrace is decorated with picturesque details, including as string course with guilloche pattern, terracotta plaques, fluted and sunflower keystones (. The raised parapet walls add interest to the roof but the replacement of the original slates by concrete tiles detracts from the appearance of the terrace, together with the loss of the original windows and doors and the modification or replacement of the low garden walls.

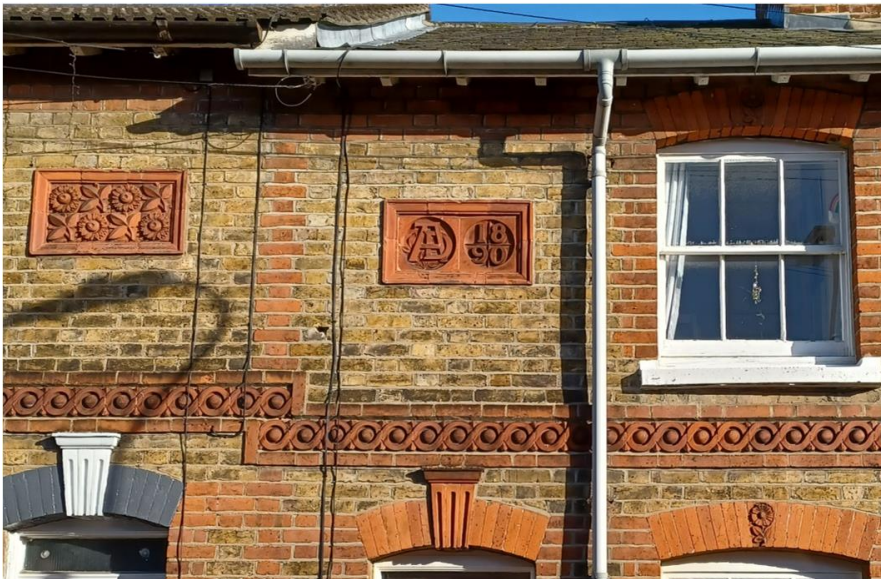
Fig. 77: 1-17 Morten road. Decorative details , including tile with the year of construction (1890) and initials for builder A. Diss.

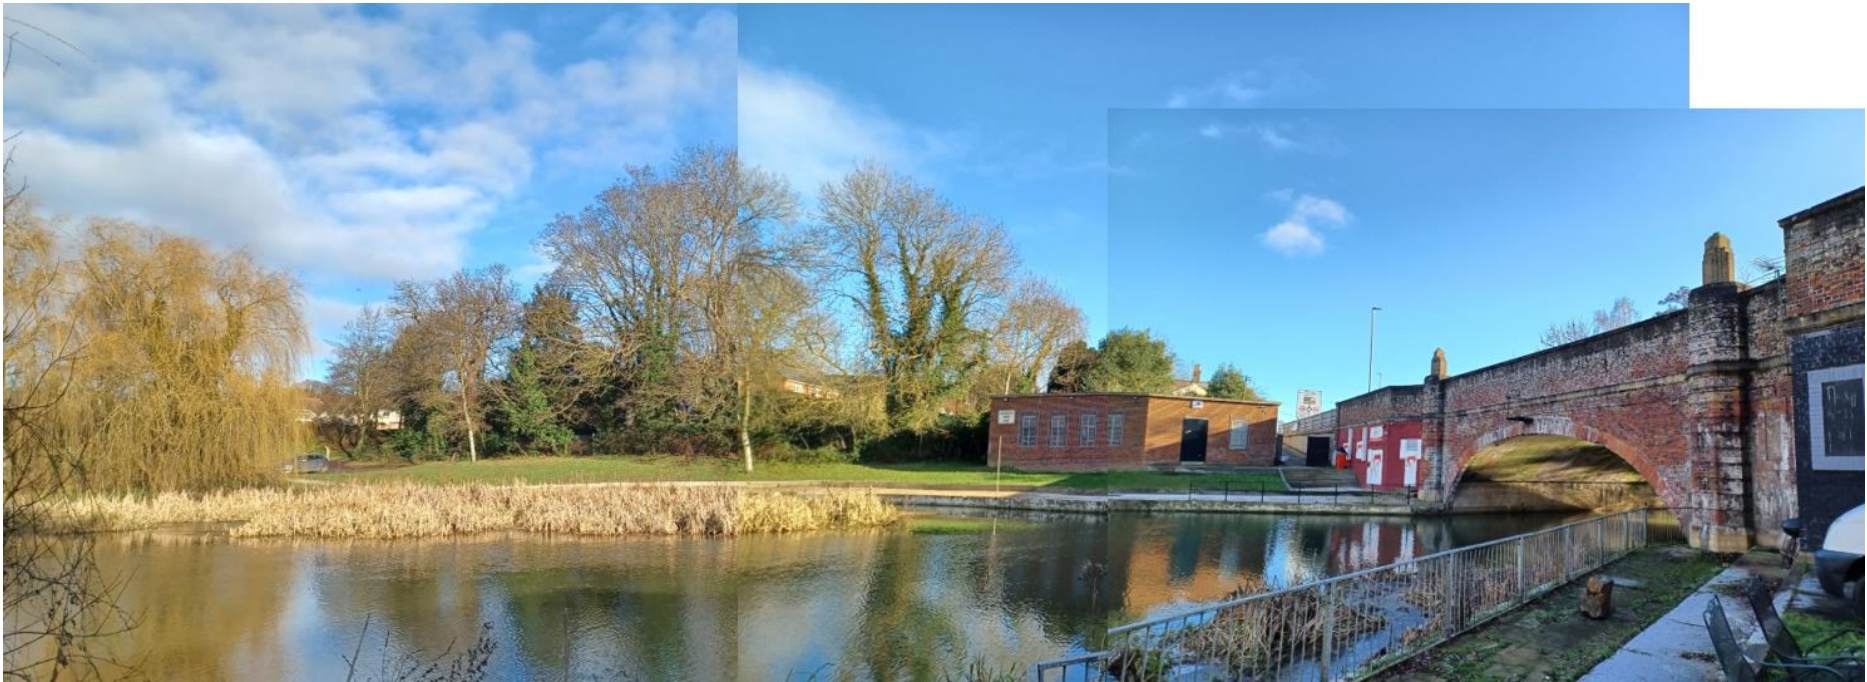
Fig. 83: The site of the former Open Air Swimming Pool.

The area of the open area swimming pool has become a tranquil natural habitat amidst a very busy environment blighted by highways engineering and heavy traffic (Fig.83). However, this infrastructure affects its connectivity to the surrounding areas; without an anchor communal or leisure activity, the site's potential to serve as key green space within the study area is undermined by the weak link to the main body of the Conservation Area and the rest of Colchester. Colne Bank Avenue and Station Way are not pedestrian friendly environments. Although they benefit from wide pavements and various access points to the site, the public realm is unattractive and does not encourage visitors to venture west of the Albert Roundabout and discover the site of the former Lido.
