Phase I Geoenvironmental Assessment

Land South of Kelvedon Road
Tiptree
Colchester
CO5 0LU

Marden Homes Ltd

1342 R01: Issue 2

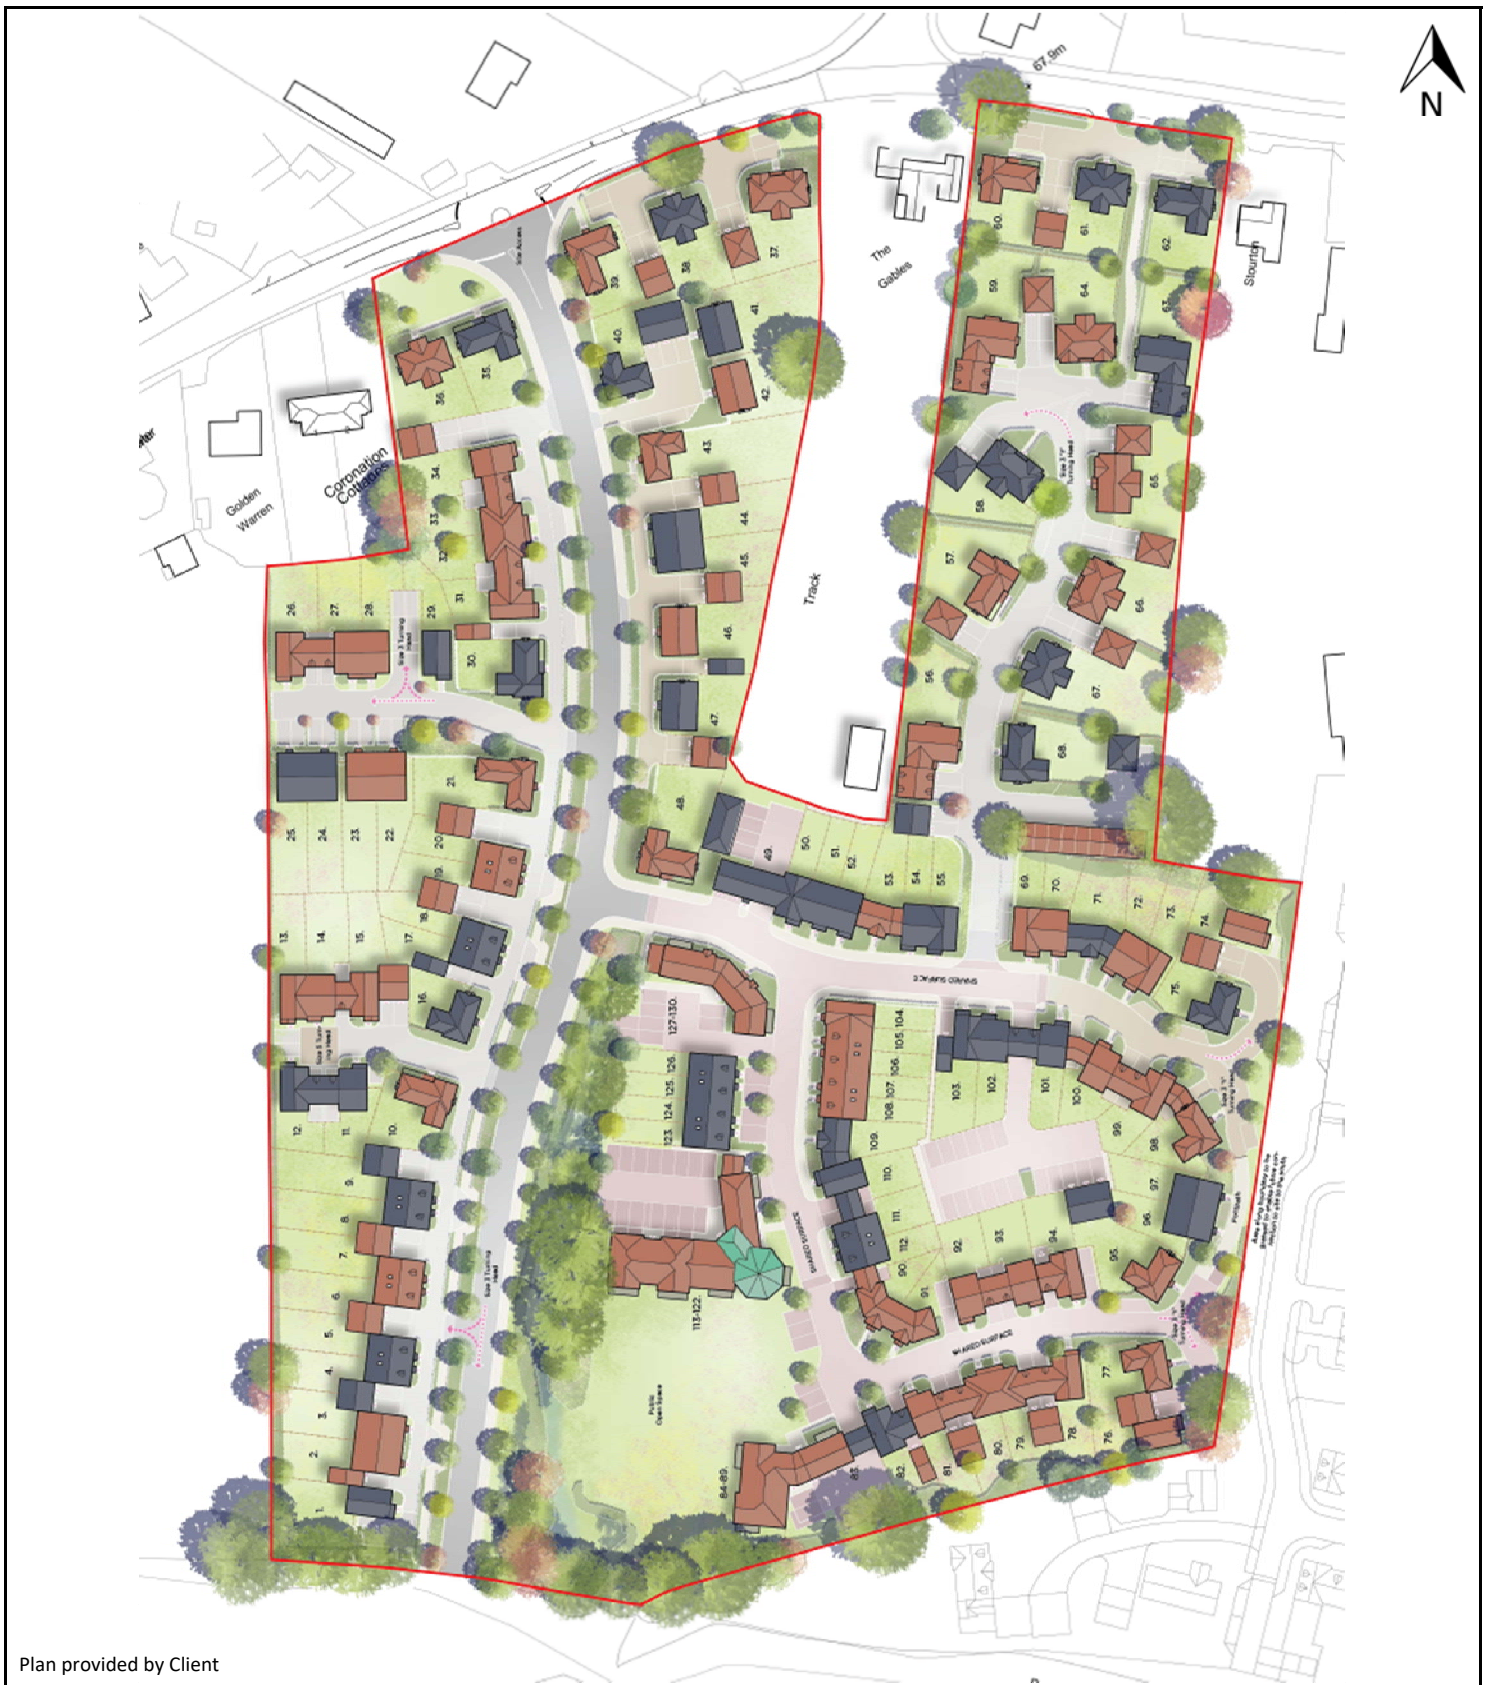
Proposed Development Plan

It is understood that the proposed development will comprise the construction of 130 (no.) dwellings with associated landscaping, access and infrastructure. A copy of the proposed development plan is presented in Figure 2.

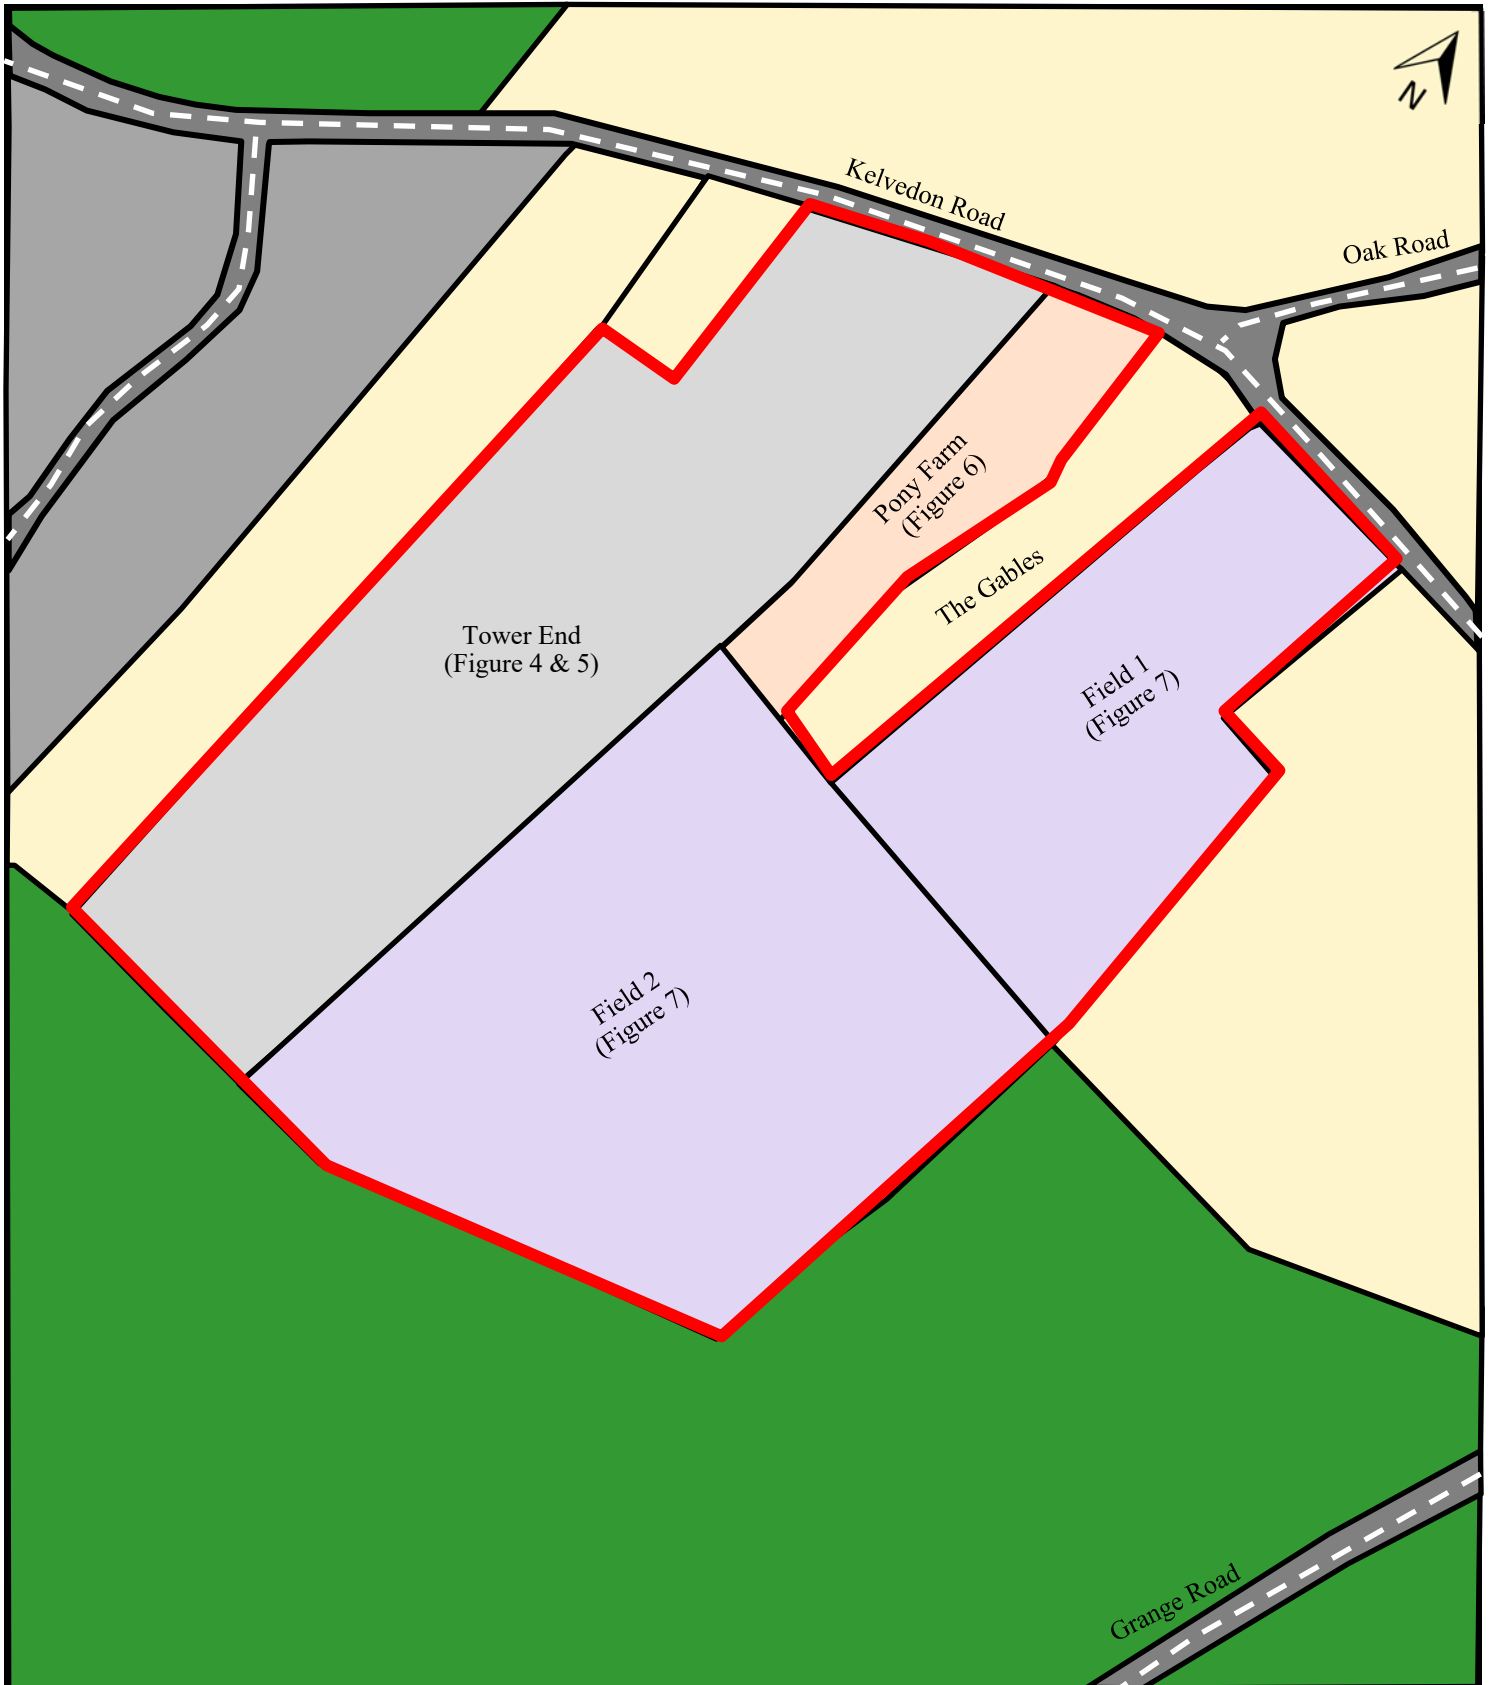
Site Layout Plan (Overview)

GEMCO visited site on the 12th November 2020 to undertake a site walkover. The site layout at the time of the walkover is indicated on Figures 3-6 and a selection of photographs taken at this time are included in Appendix 2.

The development site was irregular in shape measuring approximately 5 ha in area and 270 m north-south by 205 m east-west at its widest points. The site comprised three connecting parcels of land, primarily composed of soft landscaping (disused fields, laid to grass), horse paddocks and residential dwellings bounded to the north by the B1203 Kelvedon Road, to the east by a residential dwelling and fields, to the south by a public footpath and fields and to the west by residential properties, the Water Tower and fields.

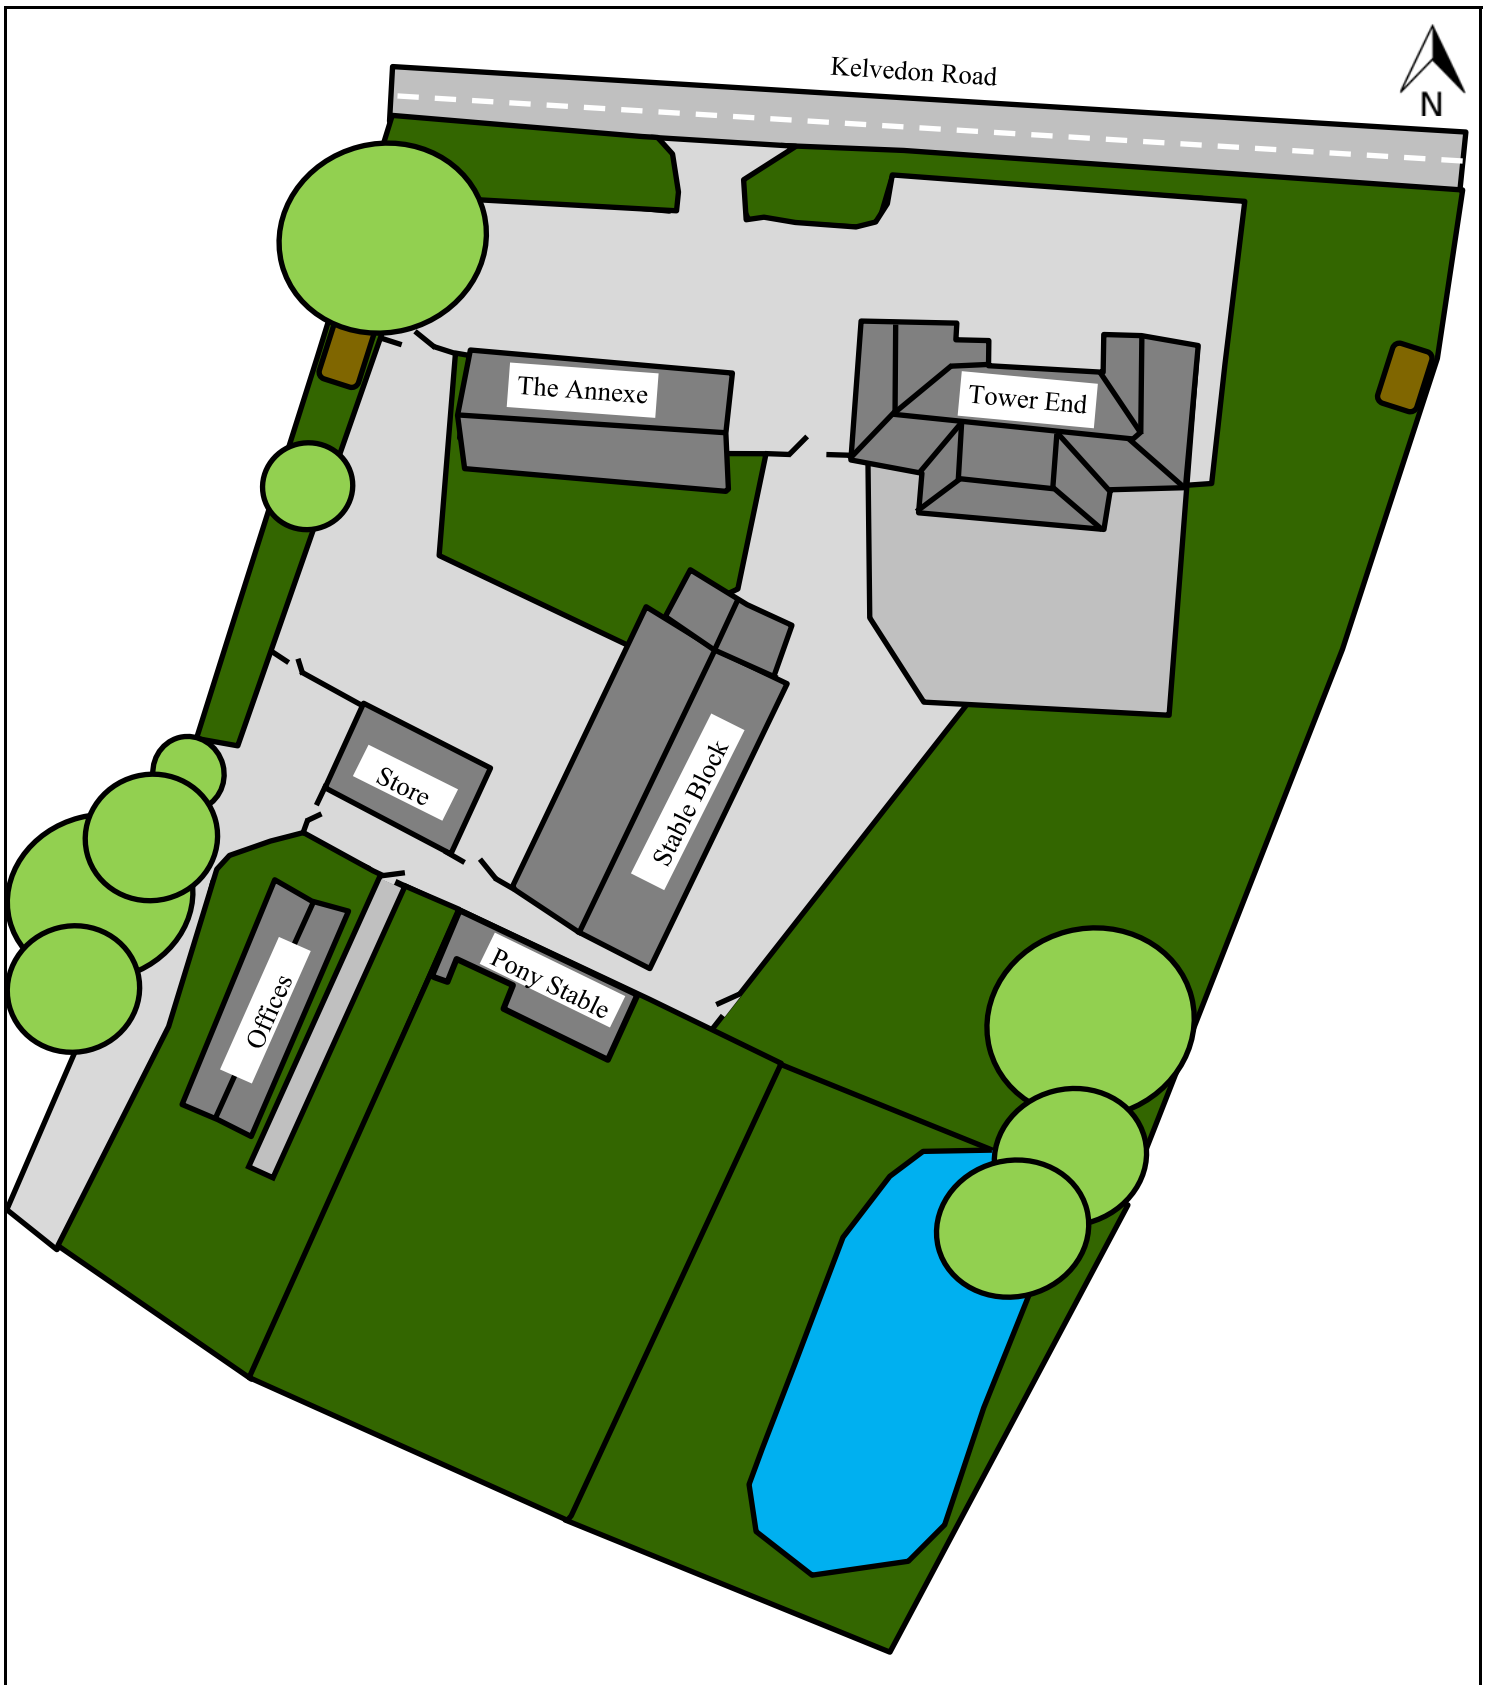
Tower End Layout Plan 1

The western parcel of land consisted of two single storey residential dwellings (Tower End and The Annexe), accessed from the B1203 Kelvedon Road. The properties both had areas of private garden and ancillary buildings including a stable block, office and shed. In the rear garden of Tower End there were two ponds. The garden areas backed on to paddocks which were bounded to the east and south by a ditch containing ponded water. Anecdotal evidence (Tower End resident) suggests that a water main recently leaked at the southern end of the paddocks causing localised flooding and was recently repaired. One small heating oil tank (1,800 litre) was present to the west of the Annexe; and two small tanks (<1,200 litre each) were present to the east of Tower End. All tanks were noted to be in a good condition with no evidence of recent or historical leaks identified. A site layout plan for Tower End is presented in Figures 4 & 5.

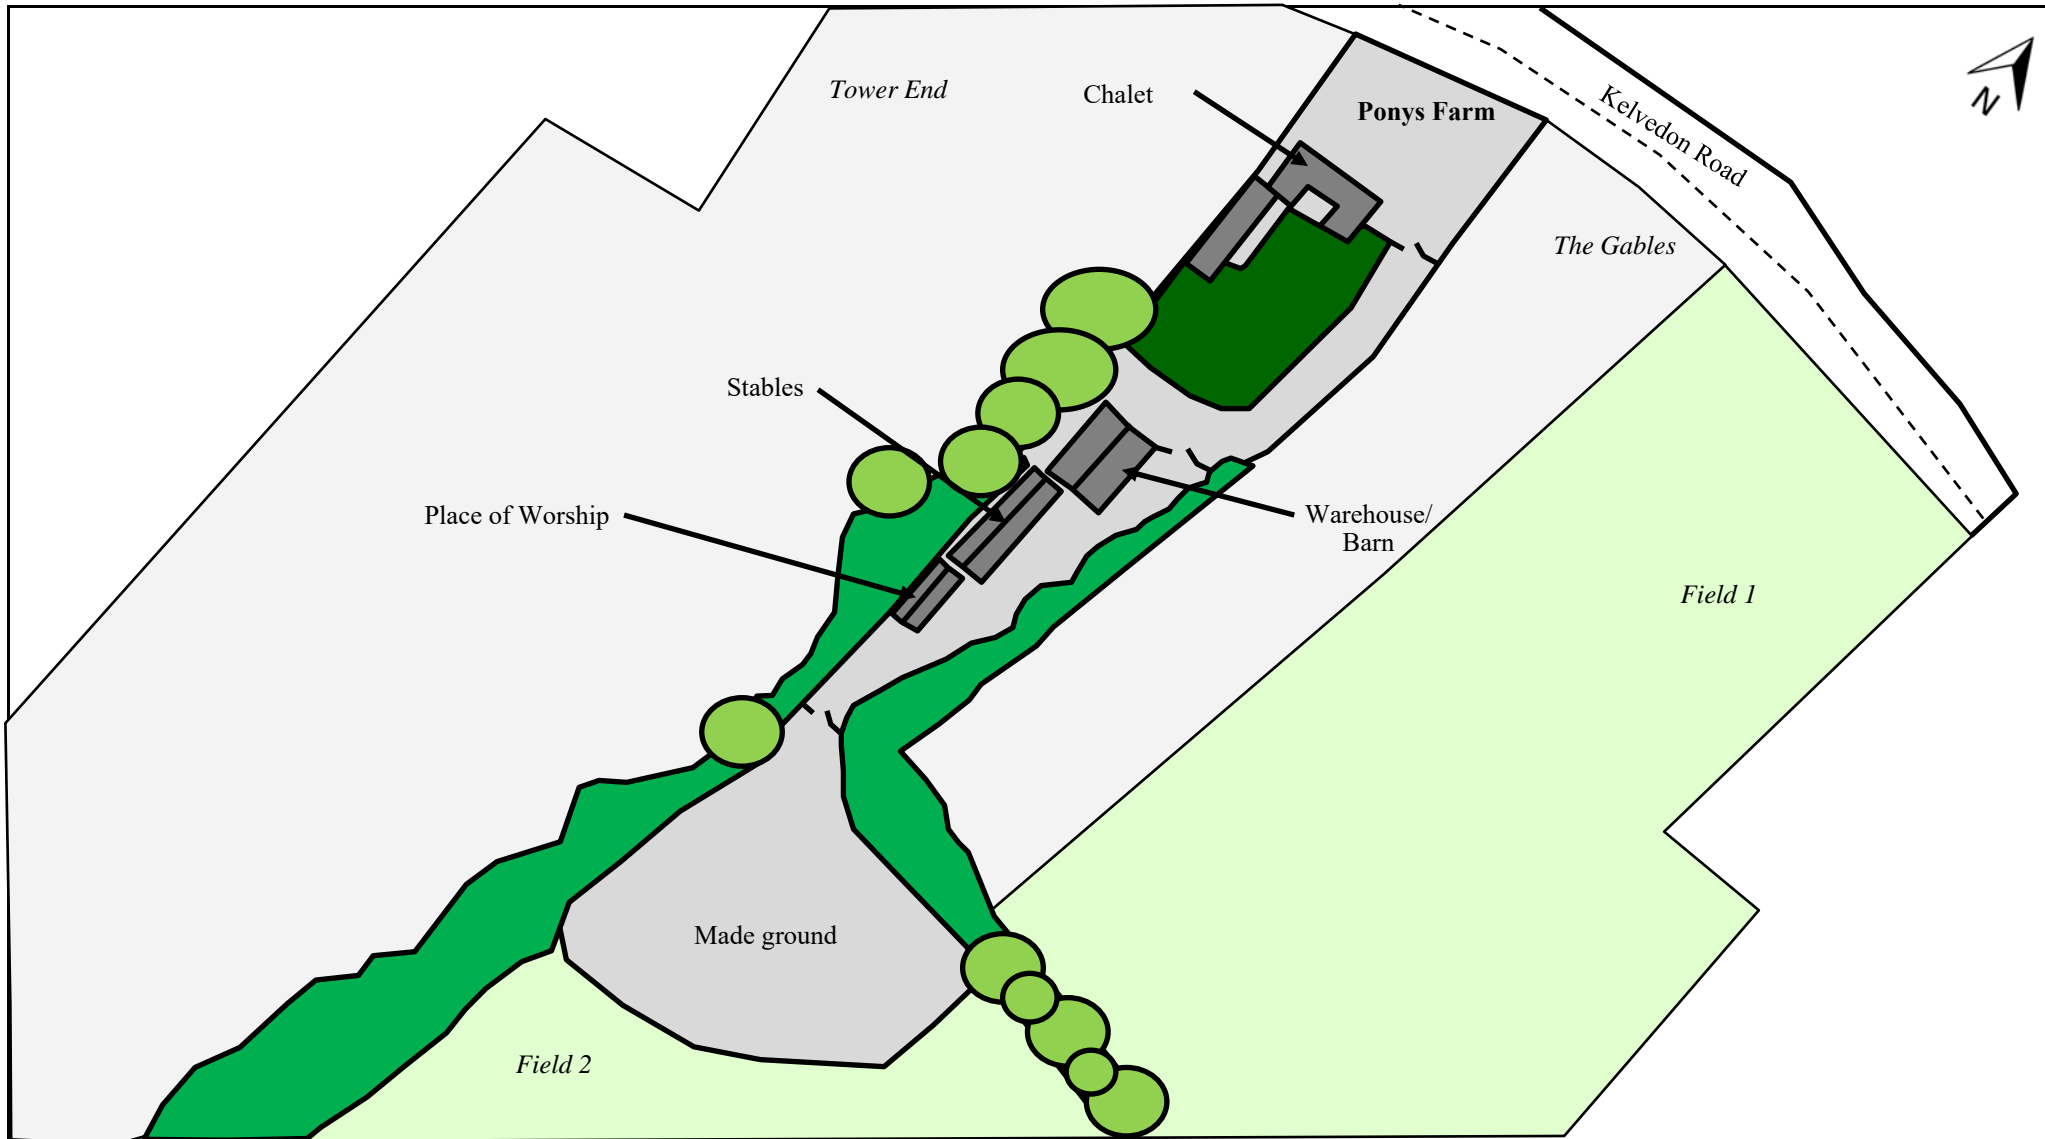
Ponys Farm Layout Plan

The central parcel of land consisted of a single storey chalet-type residential dwelling accessed from Kelvedon Road. No heating oil tank was identified and anecdotal information (Tower End resident) suggests that this property is heated by gas. A concrete track ran along the eastern property boundary to a small hardstanding courtyard providing access to a large warehouse/barn building (inaccessible) noted to be clad in suspected asbestos containing materials (ACMs) comprising fibre-cement sheeting, downpipes, guttering and render. South of this was a brick built stable building and wooden annexe (currently used as a place of worship). The concrete track ended at the entrance to a large field (Field 2 – see below) at the rear of the property, the northwest corner of which was fenced off and apparently associated with Pony's Farm. This corner of the field was covered with asphalt/rubble surfacing to approximately 0.5m higher elevation than the remainder of the field. There was also evidence of recent localised burning.

During the previous site walkover (15th January 2019) the gravel area was noted to be used for the storage of caravans and other vehicles, and included a large stockpile of gritting salt. A site layout plan for Ponys Farm is presented in Figure 6.
