Victoria Esplanade (West Mersea)

## **Beach Risk Assessment**

RLSS UK was contracted by Colchester City Council to risk assess a stretch of beach along Victoria Esplanade in West Mersea. A site visit was undertaken on 02/03/26 by RLSS UK Consultant Vincent Pank.

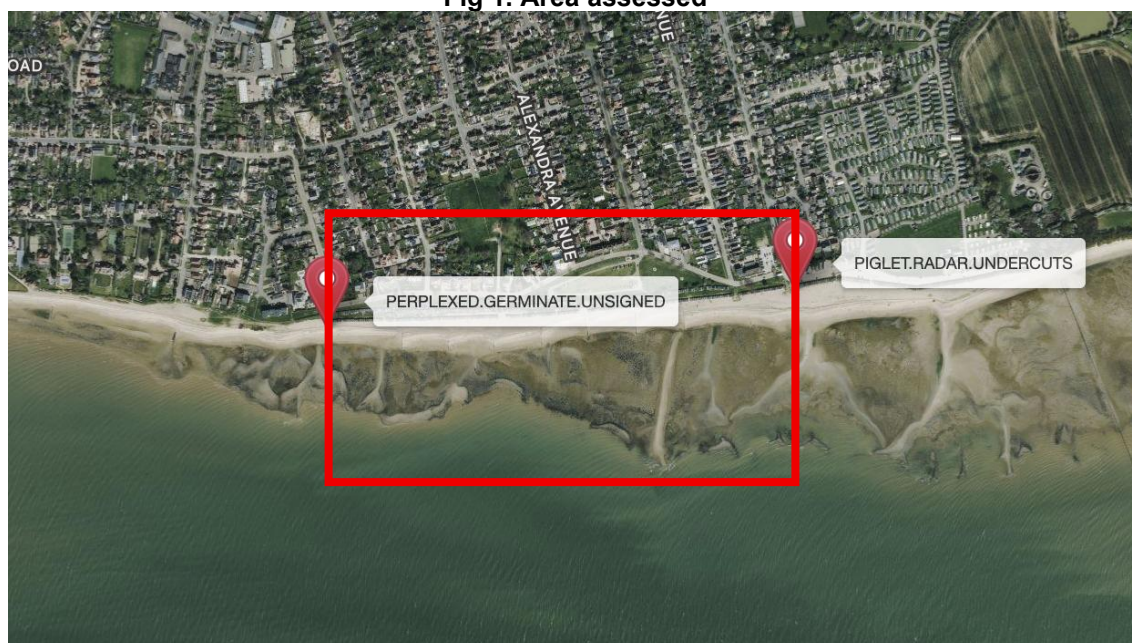
Fig 1. Area assessed

Victoria Esplanade in Essex forms part of the popular West Mersea coastline, known for its colourful beach huts, family-friendly play areas, and shingle beaches. Although the Esplanade is owned by several parties, Colchester City Council is responsible for approximately half a mile of the beachfront. This includes two spits adjacent to Victoria Esplanade Road.

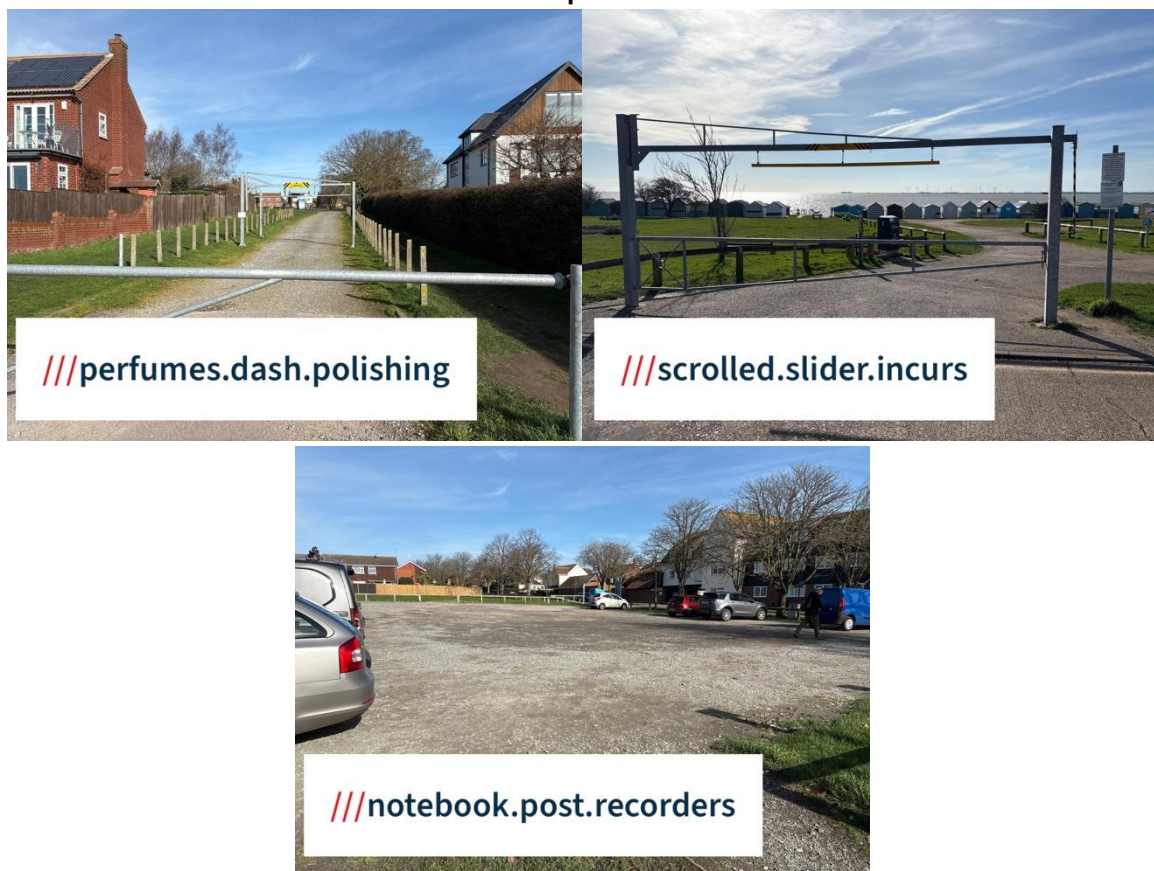
**Photos 1 to 3. Car parks close to beach**

At the time of assessment, the weather was dry and sunny but footfall around the assessed area was low. Members of the public were seen walking/dog walking and windsurfers/wing foilers were seen using the water. There are 3 large car parks close to the beach, the Victoria Esplanade and Willoughby Avenue car parks are closed in the winter, but roadside parking is available along Victoria Esplanade out of season (no stopping on roadside 8am to 6pm 1<sup>st</sup> Apr to 30<sup>th</sup> Sept).

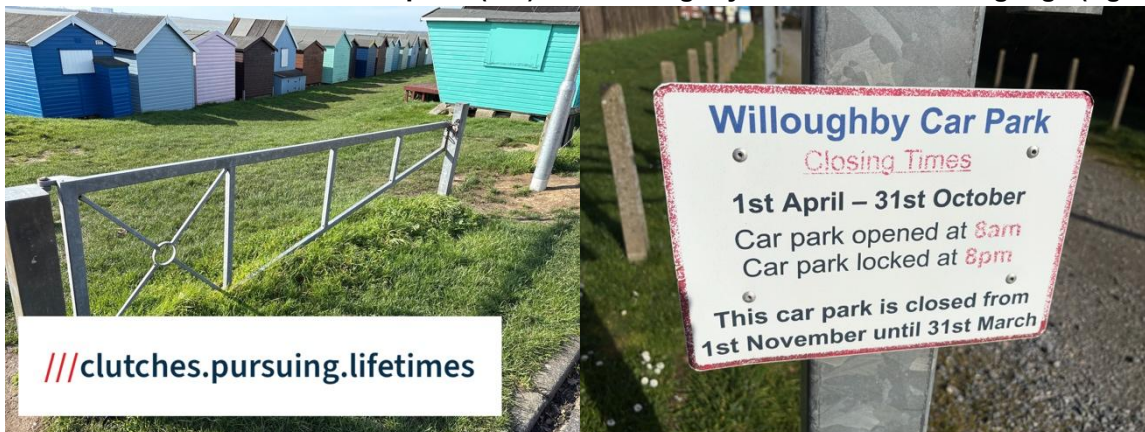
**Photos 4 and 5. Vehicle access point (left) and Willoughby Avenue Car Park signage (right)**

The gates to the Victoria Esplanade Car Park and a secondary access point were seen to be padlocked shut at the time of assessment restricting vehicular access to the beach. However, when the Victoria Esplanade Car Park is open it is possible for vehicles to access the beach. The assessor was informed that CCC is looking into a PSPO to restrict beach access and prevent the launching of Personal Water Craft (PWC) from within the assessed area. Although there is a speed restriction in place, the assessor was informed that there are sometimes issues with craft getting close to bathers and using excessive speed close to shore. It was noted that car park opening times listed on the CCC website are not consistent with information shown on the site signage. For example the Willoughby Avenue Car Park opening times are listed as 6am to 8pm, March to October subject to weather conditions on the [CCC website](#), but signage on site states 8am to 8pm 1<sup>st</sup> April to 31<sup>st</sup> October (see Photo 5 below).

- Ensure continuity between car park signage and website
- Ensure up to date water quality data is displayed at the beach (Photo 10)
- Discuss posts (one of which has a missing marker) with relevant party (Photo 37)
- Consider water safety in job specific risk assessments
- Remove CBC sign (Photo 59)
- Upgrade kite surfing and windsurfing launch area signage (Photos 40 to 43)
- Upgrade signage on groynes (Photos 44 to 53)
- Remove/replace faded/illegible/missing signs (Photos 59 to 63)
- Take care not to clutter the area with unnecessary signage, if possible co-locate signage or combine onto one board
- Consider how to monitor and enforce PSPO
- Create a water safety page on website
- Review RA in 12 months or sooner following serious incident

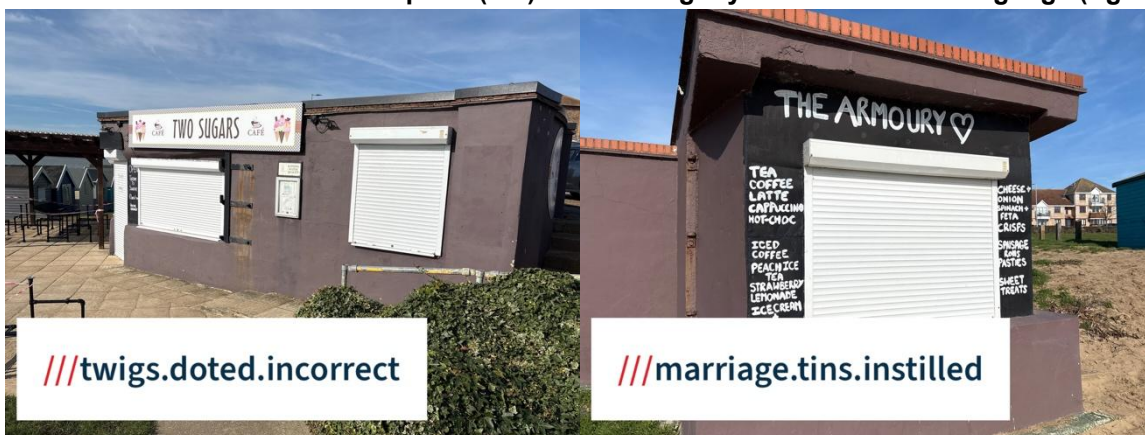
**Photos 8 and 9. Vehicle access point (left) and Willoughby Avenue Car Park signage (right)**

There are 2 cafes within the assessed area. Both were closed at the time of assessment, but these do not appear to sell alcohol.

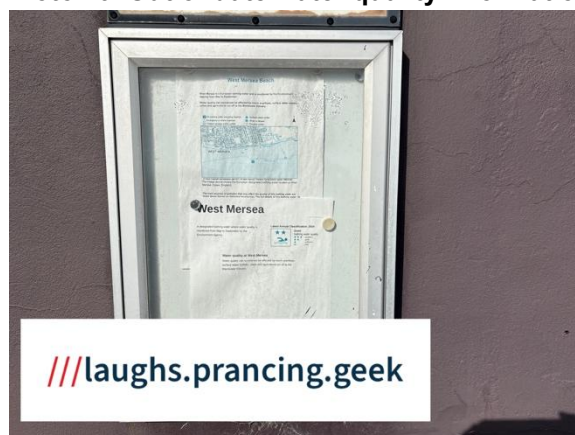
**Photo 10. Out of date water quality information**

West Mersea is a Designated Bathing Water. Water quality test results are displayed on the side of the Two Sugars Café. However, the data displayed is out of date, at the time of assessment the 2024 data was displayed (2025 classification is Good).

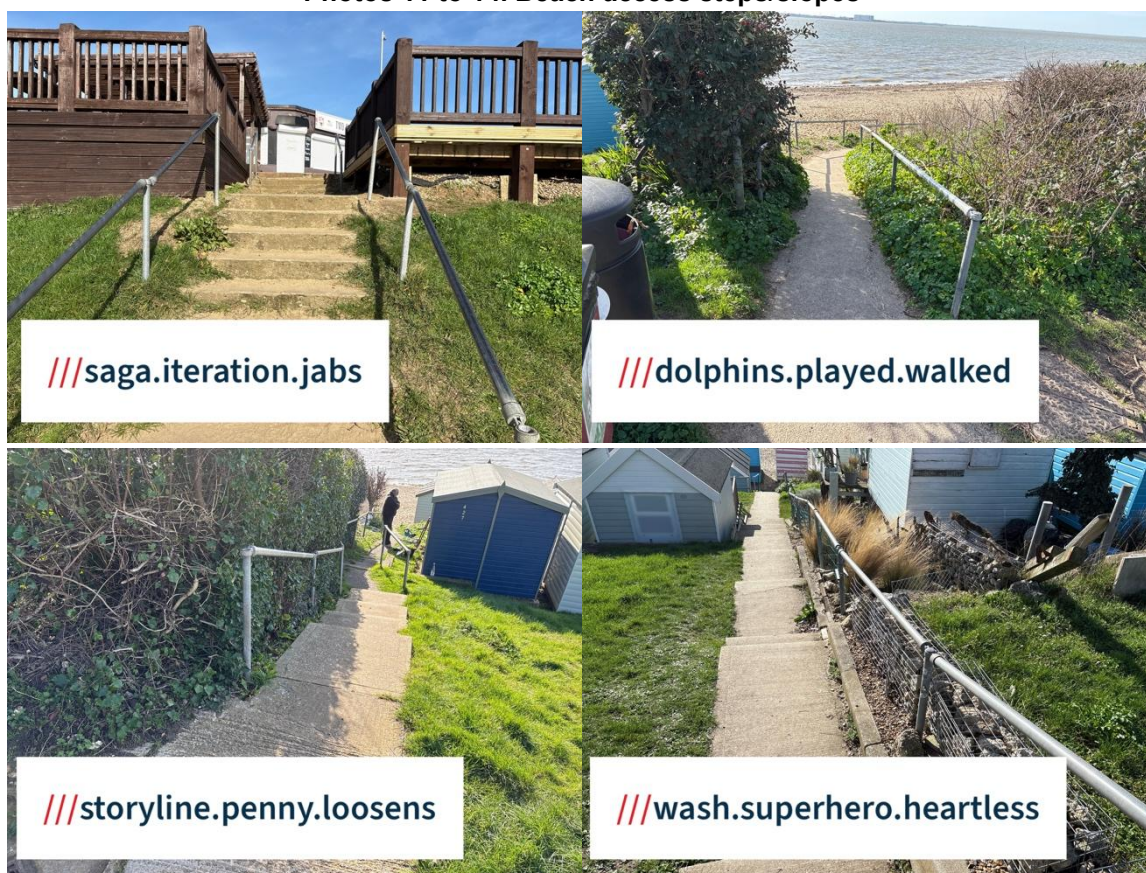
**Photos 11 to 14. Beach access steps/slopes**

There are lampposts beside the road along Victoria Esplanade, but no artificial lighting on the beach itself. Litter bins, dog waste bins and BBQ disposal pits are present close to the beach. Handrails are present beside beach access steps/slopes.

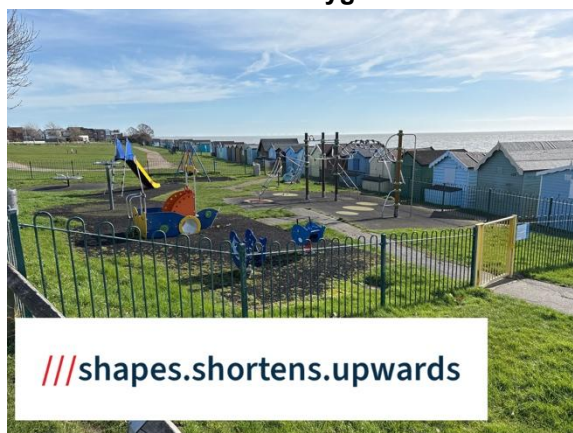
enclosed with barriers which appear (although these were not inspected) to comply with BS 1722 and EN 1776 as recommended by [RoSPA](#).

Photo 15. Playground

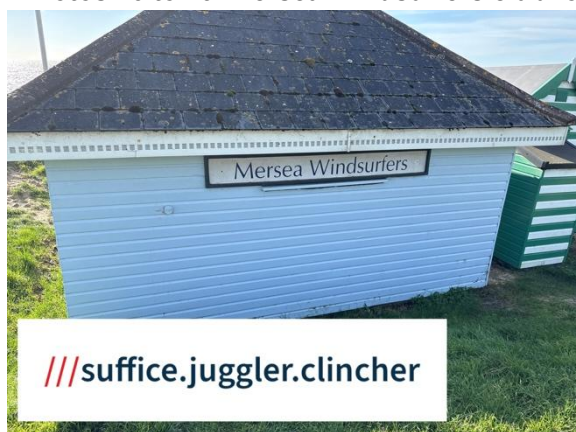
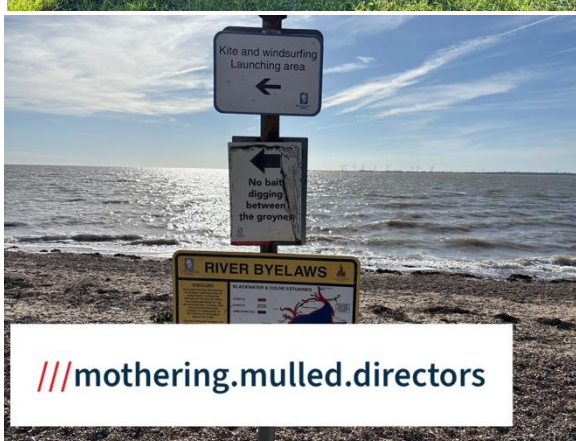
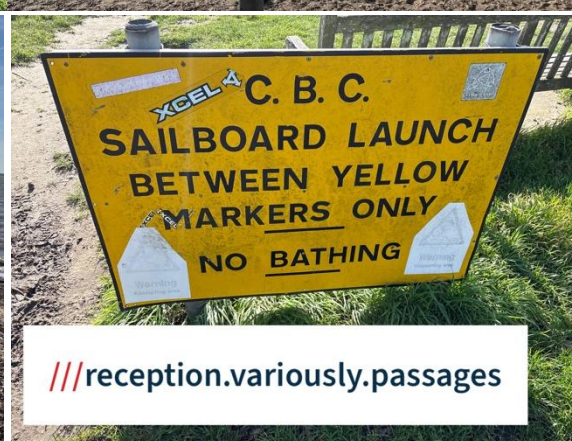
Photos 16 to 19. Mersea Windsurfers clubhouse and kite surfing/windsurfing launch area

At the eastern end of the assessed area is the Mersea Windsurfers' clubhouse. The kite surfing/windsurfing launch area is marked by signs on the beach.

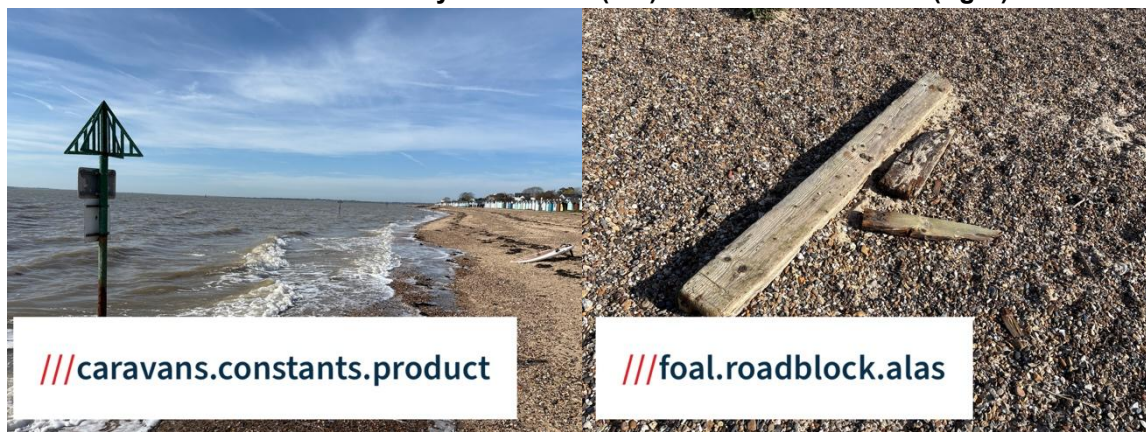
There are timber groynes on the beach. The ends of the groynes are marked as they are submerged at high tide. The beach was generally clear from waste, but large debris may be present in the water/be deposited on the beach by the tidal movements.

Photos 20 and 21. Groyne markers (left) and debris on beach (right)

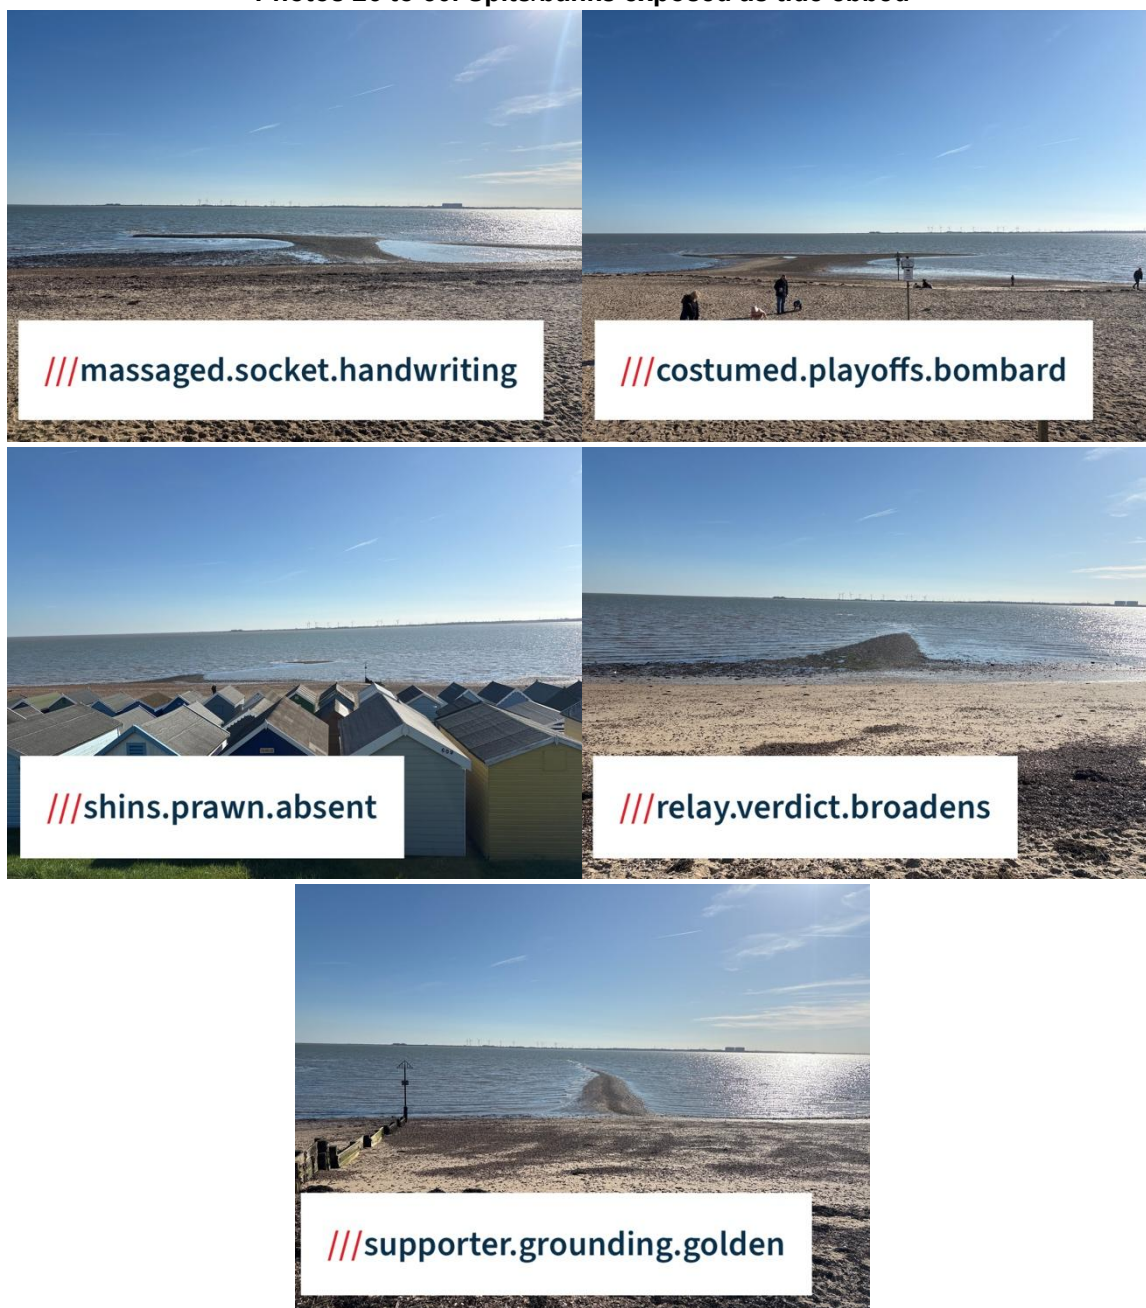
**Photos 26 to 30. Spits/banks exposed as tide ebbed**

As the tide drops sand/shingle banks and spits emerge from the water. These features are semi-permanent, they are always present, but positions and shapes may change. These features affect water currents during both ebbing and flooding tides. At the time of assessment members of the public were seen walking out to the ends of the spits as they emerged from the water. Whilst it would theoretically

be possible to get cut-off by an incoming tide whilst standing on one of these features, it is currently unlikely that a person will become trapped due to the profile of these features (spits are generally higher at the beach end) and the speed of tidal movement (which is less rapid than other areas on the east coast e.g. Wells-next-the-sea where alarms and patrols are used to clear the beach as the tide floods due to the speed of tidal inundation).

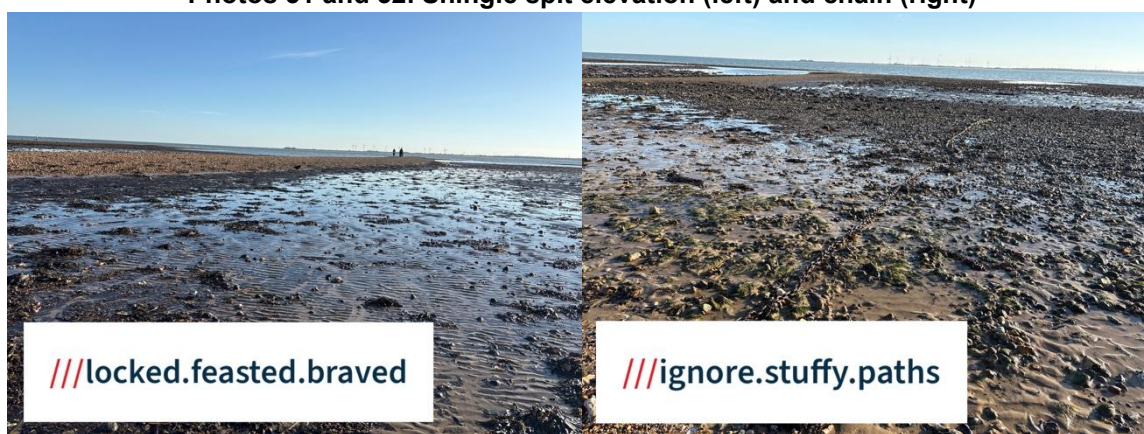
**Photos 31 and 32. Shingle spit elevation (left) and chain (right)**

As the tide dropped further it was possible to see the height differences between the spits and surrounding beach/mud. If people are standing on a sandbank and it collapses then they may end up in the water and out of their depth. The collapse of a sandbank can also create a flash rip. These scenarios can occur quickly, without warning and result in a mass rescue situation. However, sandbank collapses are much more likely in large surf/storm conditions (although West Mersea may experience wind chop it is not considered as a surf beach) and where the features are primarily composed of sand or fine sediment (the spits at West Mersea are shingle and are likely to be quite resilient to rapid

collapse, particularly in times of fine weather when the beach will be most populous). The spits/banks are likely to pose the highest risk to members of the public who choose to enter the water as the tide ebbs or floods where the features interfere with lateral tidal currents creating rips (the features will create barriers to lateral tidal movement so bathers may be taken out to sea, as the water finds its way around the obstruction) and unseen depth changes (a person may unknowingly become out of their depth by stepping off a spit/bank or by remaining in the water as the tide floods/depth increases).

Due to the turbidity of the water along the east coast, stinging jellyfish are unlikely to be a significant risk to water users. The assessor was informed that there is no significant history of stings from weeverfish in this area. It is possible that unexploded ordnance may be washed-up/exposed, but this is not thought to be a significant issue with no known incidents in recent history. A heavy-duty chain was observed (W3W:///ignore.stuffy.paths) anchored to the bed, but it wasn't clear at the time of assessment what this was for.

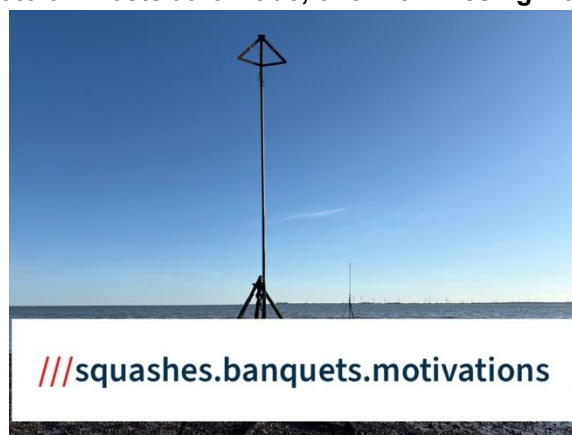
In addition to the markers on the ends of the groynes, there are two posts at the low tide mark (these are partially submerged as the tide rises). One of the posts has a marker on top, but the post furthest from the beach has no marker on the top and as such poses a higher risk of collision. These structures are not believed to be the responsibility of CCC, but RLSS UK recommends that the Council raise this to the relevant party.

**Photo 37. Posts at low tide, one with missing marker**

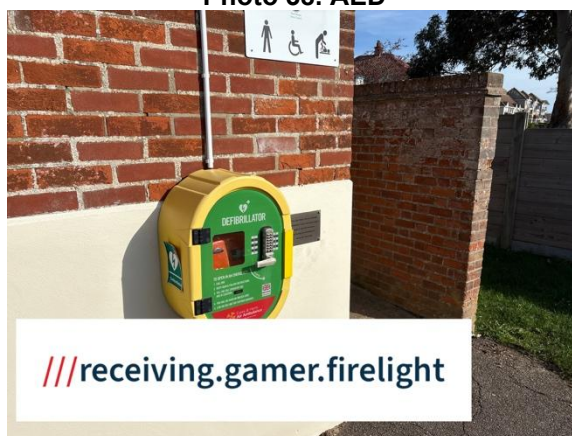
Photo 38. AED

No PRE has been installed on the beach by CCC (there is a piece of equipment attached to the outside of the Mersea Windsurfers clubhouse) within the assessed area. RLSS UK does not recommend installing PRE within the assessed area as, due to the beach profile, lateral currents and tidal range it is unlikely that it would be deployed effectively in an emergency. The highest risk of drowning is likely to be associated with the spits/banks when a person may find themselves out of their depth and/or in a rip. This situation is most likely to occur when the tide ebbs or floods, but PRE would have to be installed above the high tide line to ensure it was not lost or damaged by the elements. In the event of an incident a member of the public would have to identify the casualty in trouble, leave the incident to retrieve the PRE (which is likely to be a significant distance from the incident) and return to deploy the equipment accounting for casualty movement (the casualty will likely be drifting parallel to the beach). If the casualty has entered the water from a spit/ bank but drifted with the tide or been caught in a rip it may not be possible for the rescuer to reach the casualty without entering the water themselves anyway. Spits/banks are present all along the beach so numerous pieces of rescue equipment would be required to cover the entire area.

There is a publicly accessible AED on the toilet block close to the beach.

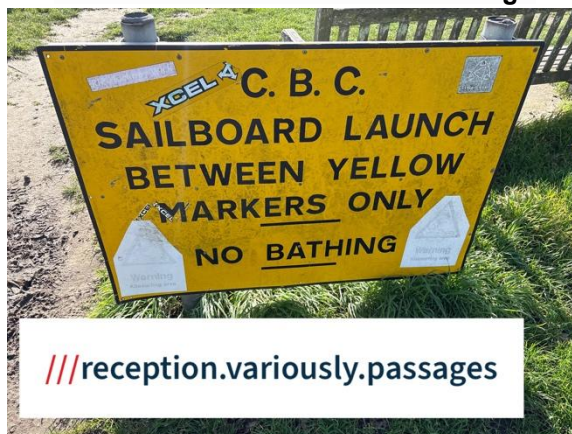
**Photo 39. CBC 'sailboard launch' sign**

There is a 'C.B.C' text sign at the entrance to the beach at the eastern end of the assessed area. 'Warning kitesurfing' stickers have been attached to the sign, but these have faded (and display the incorrect symbol). This sign is likely to cause confusion; the launch area is actually marked on the beach by signs on posts. The assessor was informed that CCC put out buoys between Apr and Oct to mark the 250m speed limit restriction. These were not in situ at the time of assessment, but there were buoys visible offshore (which appear to be special markers and channel markers) which could be misinterpreted as the 'sailboard launch' markers.

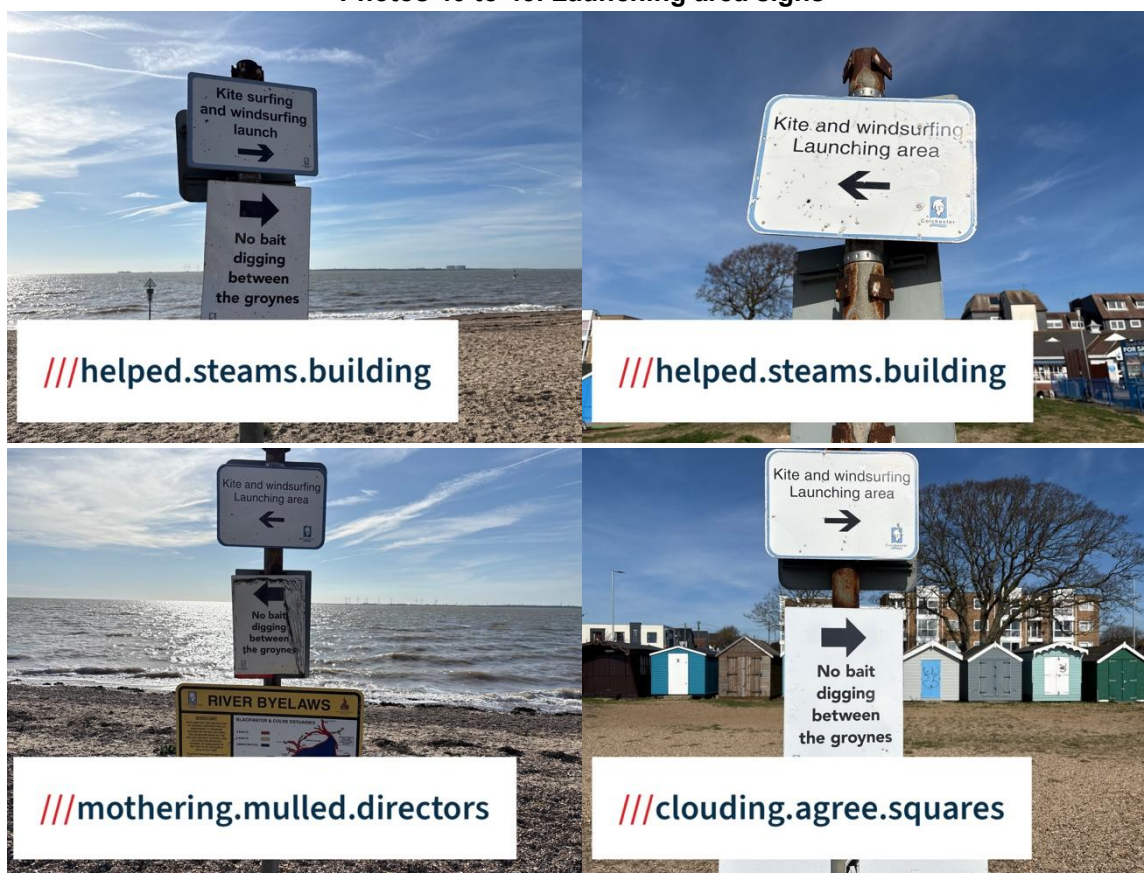
Photos 40 to 43. Launching area signs

There are 'kite surfing and windsurfing launch area' signs on posts on the beach.

To bring these signs up to BS EN ISO 7010 standard the following text/symbols could be used:

- Kite and windsurfing launching area, symbol W062
- No swimming in launching area (or similar text), symbol P049
- No bait digging between the groynes, symbol P001

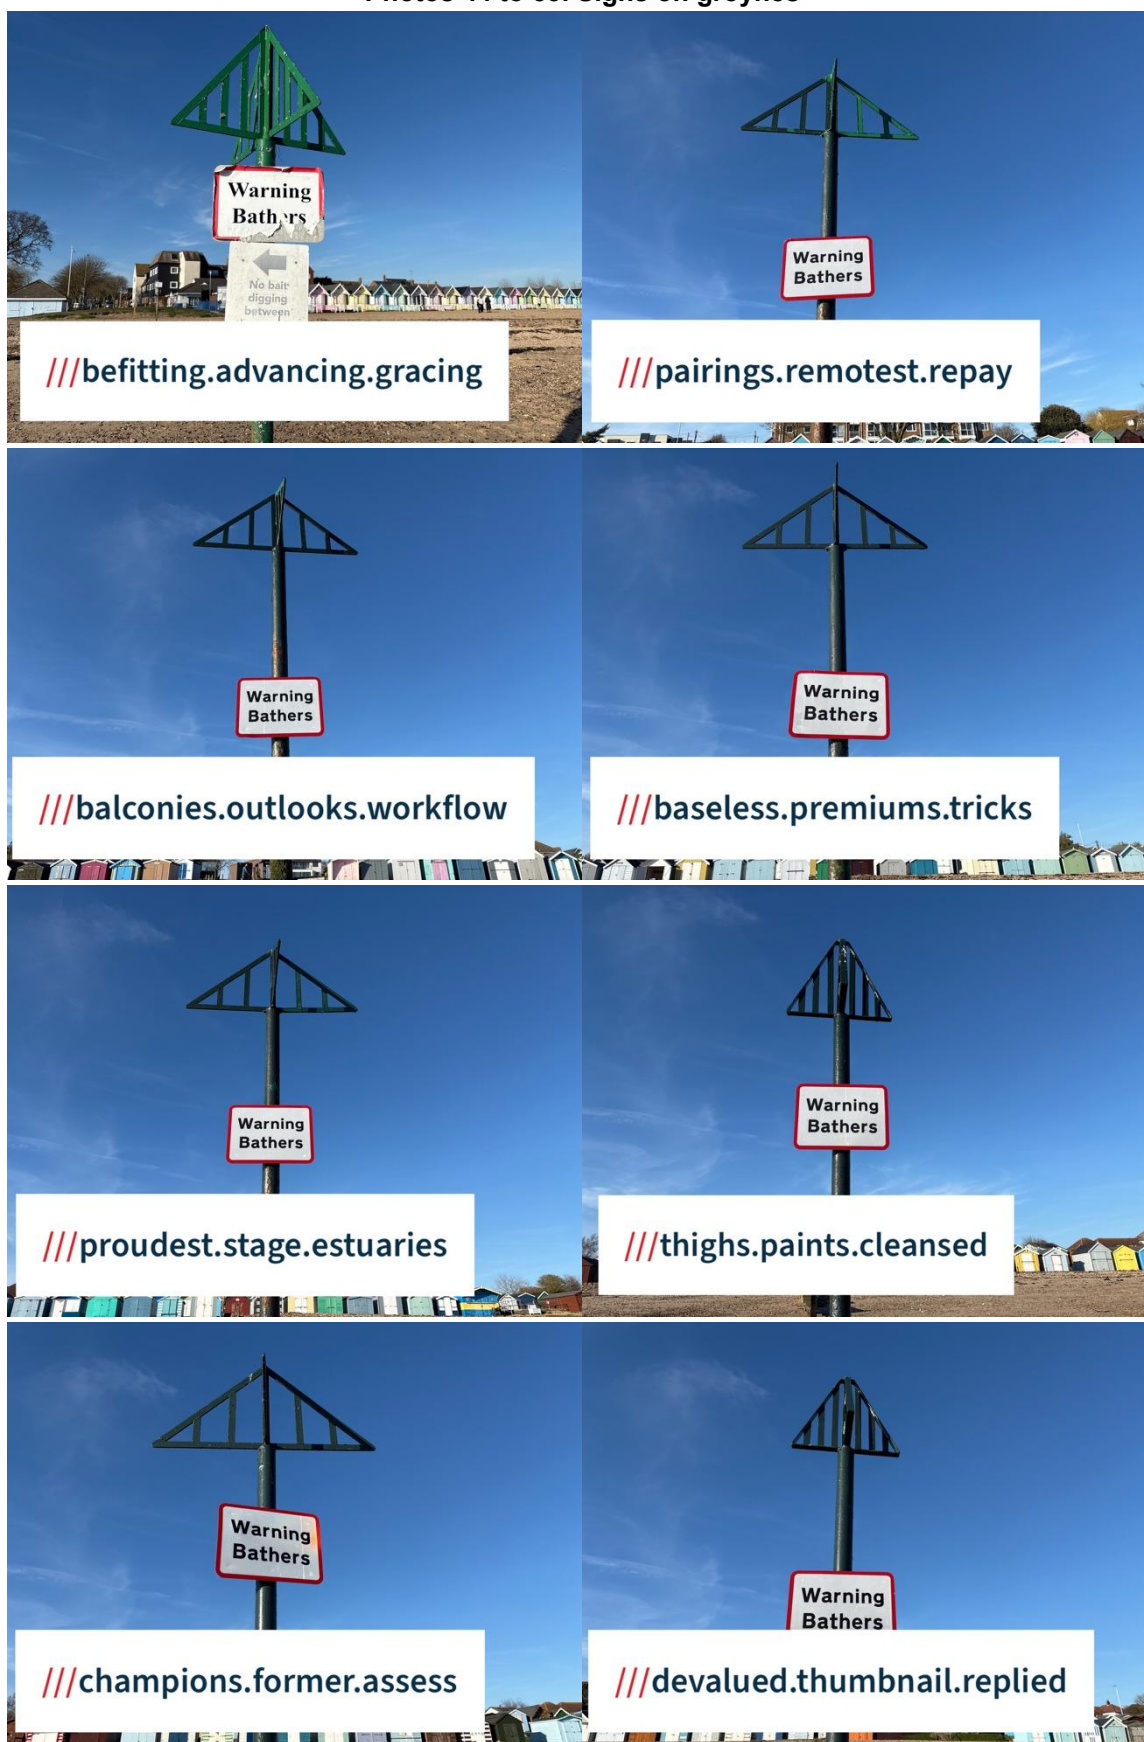
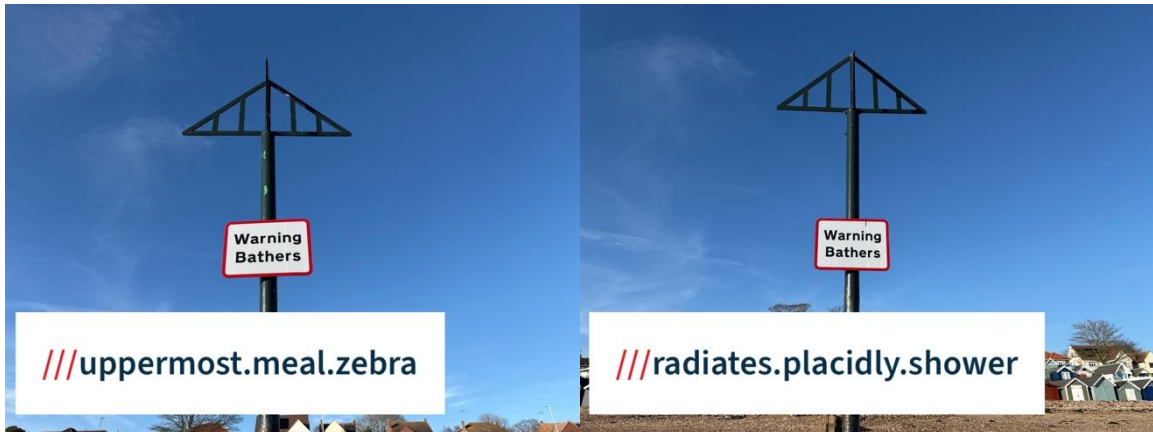
Photos 44 to 53. Signs on groynes

There are 'text only' signs on the ends of the groynes

To bring these signs up to BS EN ISO 7010 standard the following text/symbols could be used:

- Warning bathers, symbol W001  
Note it may also be useful to highlight that these are marking groynes (see no- ISO symbol later in this section that could be used)

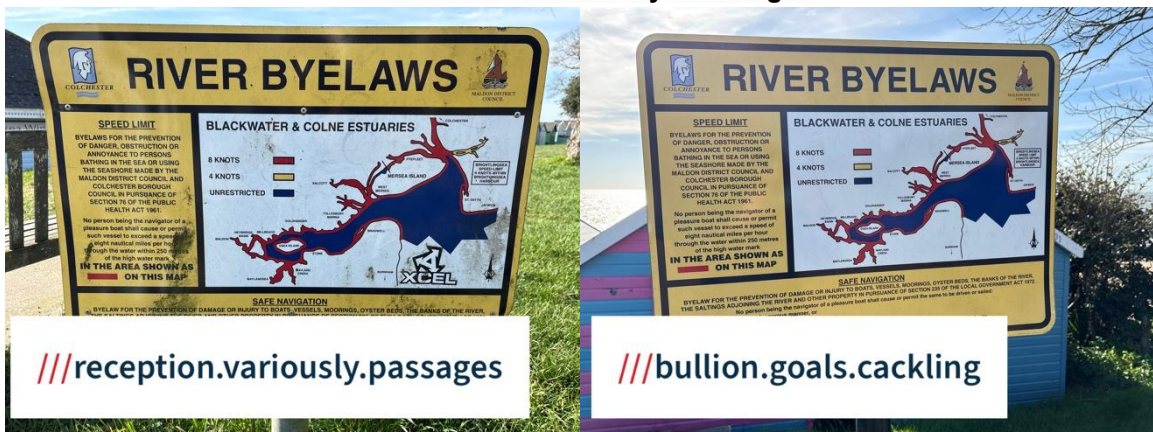
Photos 54 to 58. River byelaws signs

There are 'River byelaws' signs.

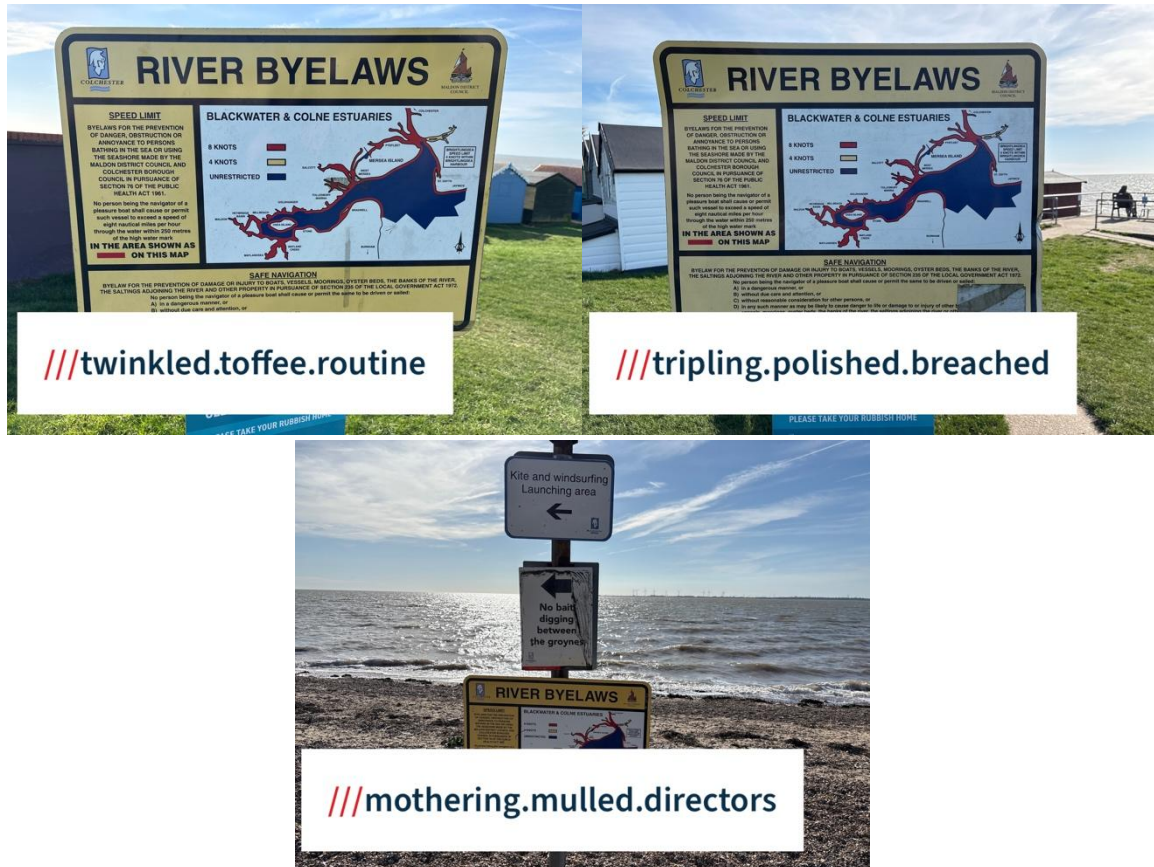
### Photos 59 to 63. Faded/illegible/missing signs

There are several faded/illegible/missing signs. RLSS UK recommends these be removed or replaced (if necessary it wasn't clear what some signs were for).
