**PLANNING STATEMENT**  
Outline Residential Development  
102 East Road  
West Mersea

Appendix XI  
Surface Water Drainage Strategy

**Surface Water Drainage Strategy**  
**Outline Residential Development**  
**102 East Road**  
**West Mersea**  
**Essex**

Revised January 2021

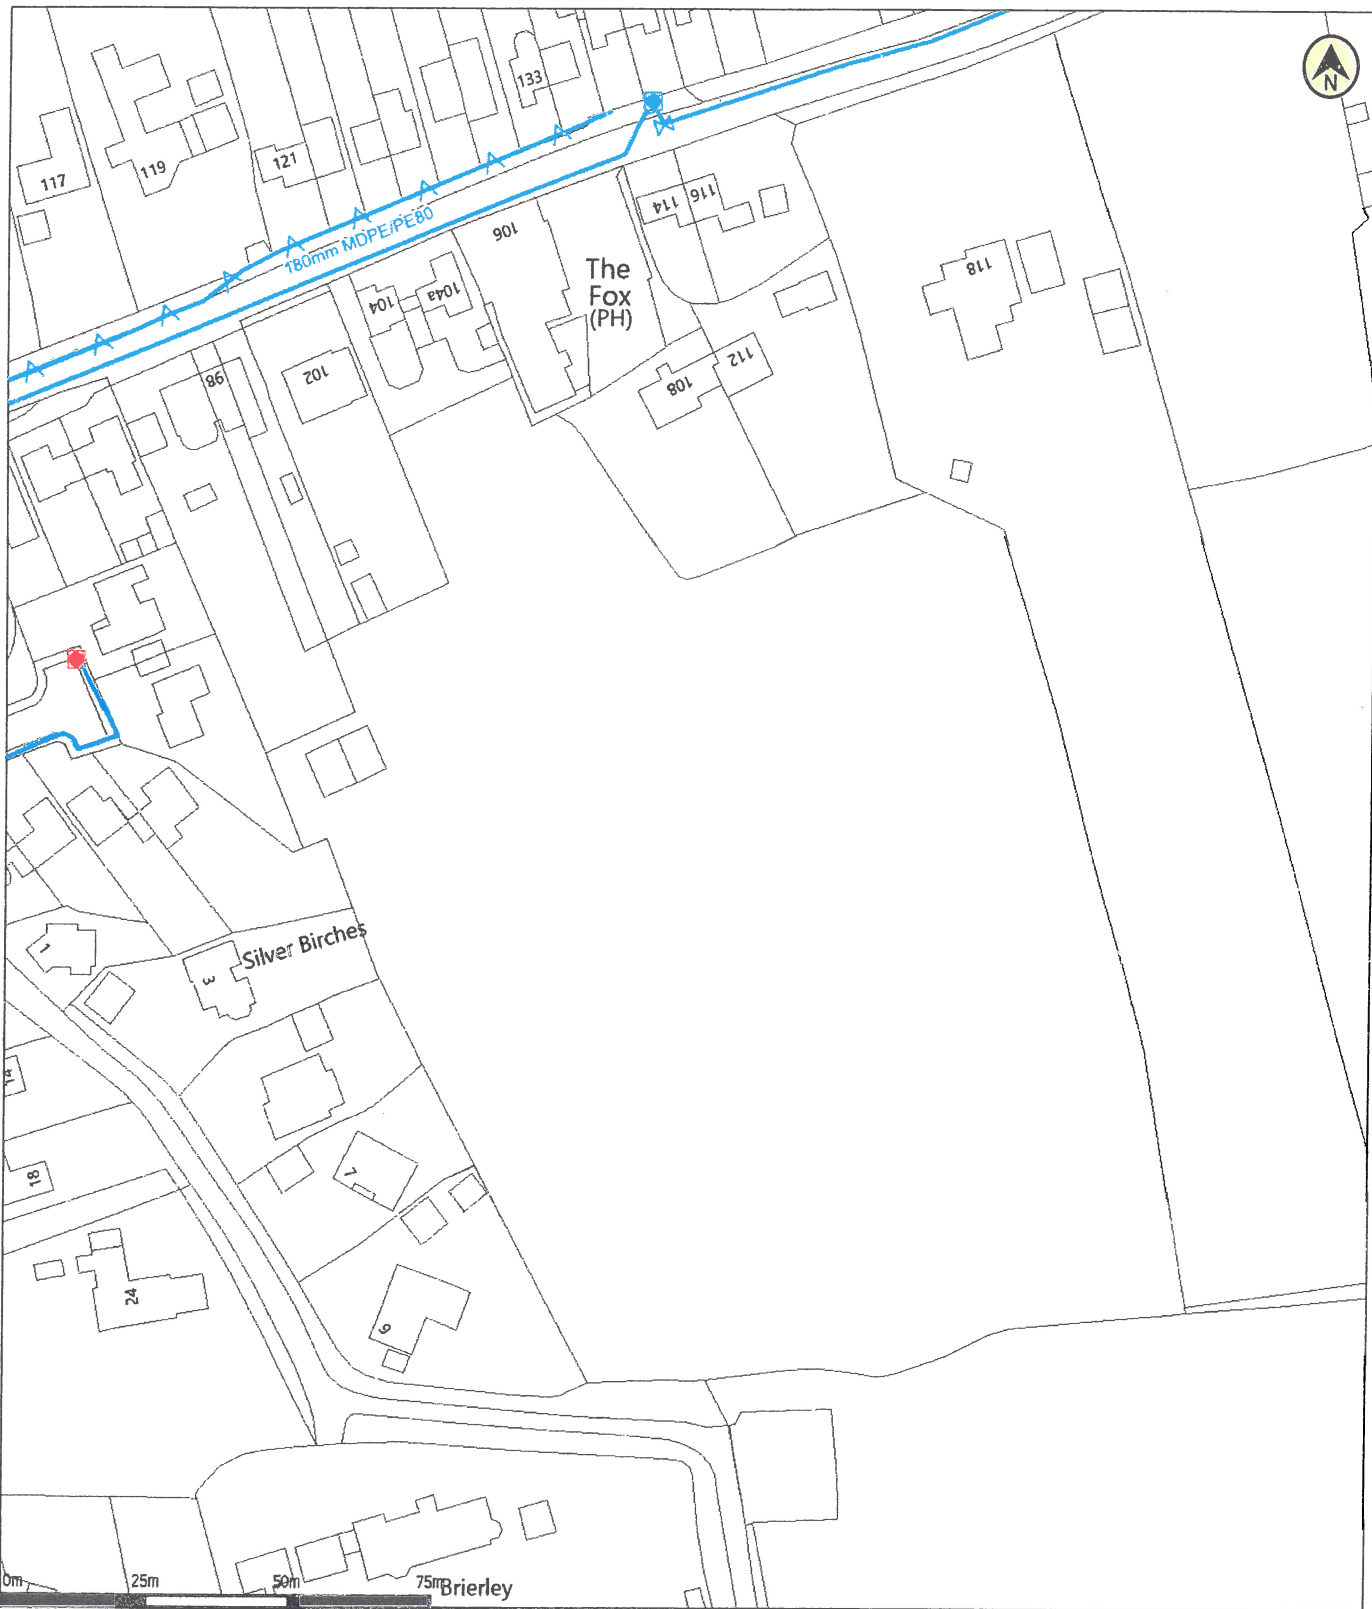
(c) Crown copyright and database rights 2020 Ordnance Survey 100019209      Scale: 1:1250      Date: 17/08/20      Clean Water Plan A4  
 Data updated: 31/07/20      Map Centre: 602552,213411      Our Ref: 427102 - 1      Powered by digdat

<b>Potable Water</b>

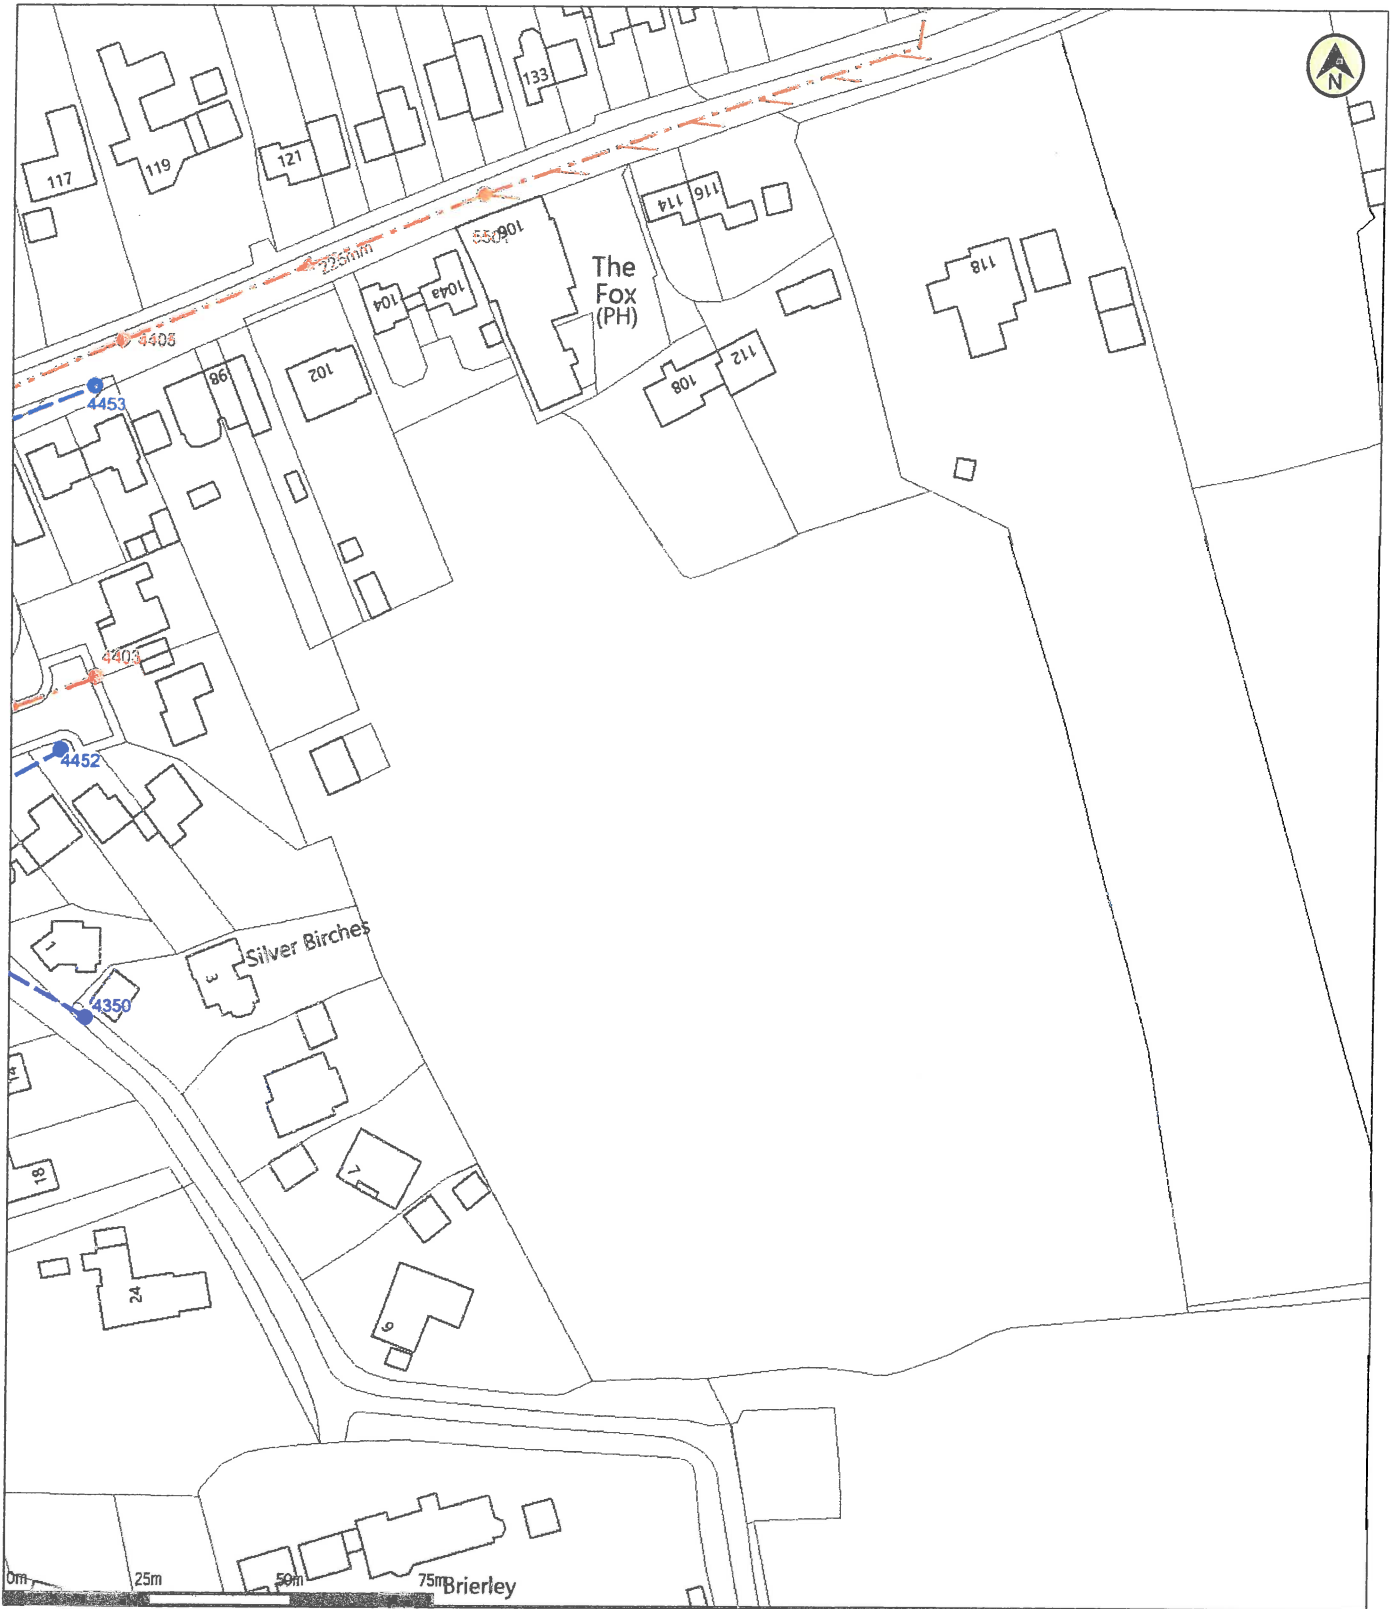
(c) Crown copyright and database rights 2020 Ordnance Survey 100019209      Scale: 1:1250      Date: 17/08/20      Wastewater Plan A4  
 Data updated: 31/07/20      Map Centre: 602552,213411      Our Ref: 427102 - 2      Powered by digdat

Foul Sewer		Outfall*			jdp2@btconnect.com
Surface Sewer					
Combined Sewer					102 East Road
Final Effluent		Inlet*			
Rising Main*					
Private Sewer*					
Decommissioned Sewer*		Manhole*

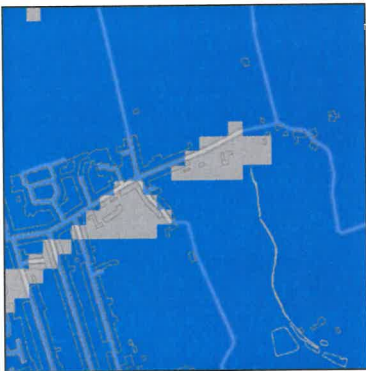
<p><b>In terms of the drainage potential, is the ground suitable for infiltration SuDS?</b></p>

Highly compatible for infiltration SuDS. The subsurface is likely to be suitable for free-draining infiltration SuDS.</p>
	<p>

Probably compatible for infiltration SuDS. The subsurface is probably suitable although the design may be influenced by the ground conditions.</p>
	<p>

Opportunities for bespoke infiltration SuDS. The subsurface is potentially suitable although the design will be influenced by the ground conditions.</p>
	<p>

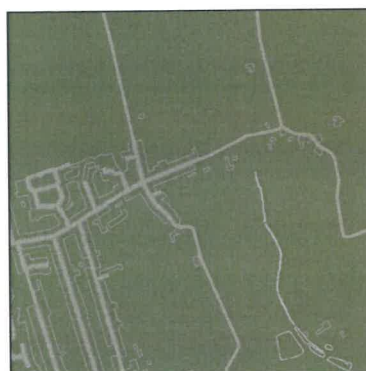
Increased infiltration is very unlikely to result in ground instability.</p>

Ground instability problems may be present or anticipated, but increased infiltration is unlikely to result in ground instability.</p>
	<p>

Ground instability problems are probably present. Increased infiltration may result in ground instability.</p>
	<p>

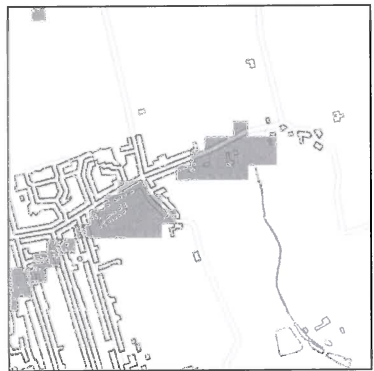
<p>Contains OS data © Crown Copyright and database right 2020</p>	<p><input checked="" type="checkbox"/> Very high likelihood of persistent or seasonally shallow groundwater. Persistent or seasonally shallow groundwater is likely to be present. Infiltration may increase the likelihood of soakaway inundation, or groundwater emergence at the surface. The site investigation should consider whether the potential for or the consequences of groundwater level rise as a result of infiltration are significant.</p>

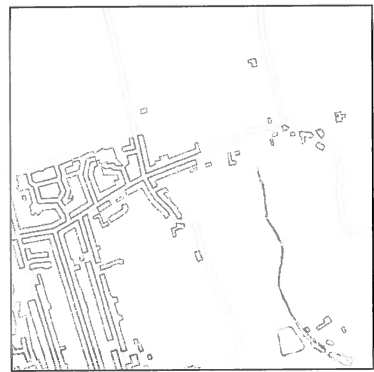
<p>Contains OS data © Crown Copyright and database right 2020</p>	<p><input checked="" type="checkbox"/> Made ground present. Made ground is present at the surface. Infiltration may affect ground stability or increase the possibility of remobilising pollutants. The site investigation should consider whether the potential for or consequences of ground instability and/or pollutant leaching as a result of infiltration are significant.</p>
<p><input type="checkbox"/> None recorded</p>

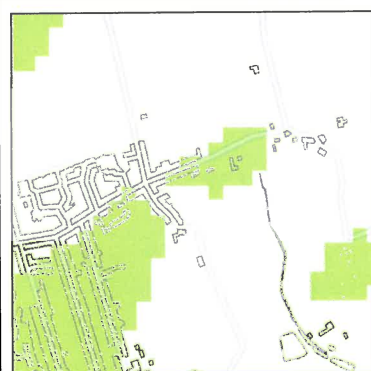
## Superficial deposit thickness

The thickness of superficial deposits is **< 3 m** and hence the permeability of the ground may be dependent on both the superficial deposits (where present) and underlying bedrock (see below).

The thickness of superficial deposits is **> 3 m** and hence the permeability of the superficial deposits is likely to determine the permeability of the ground.

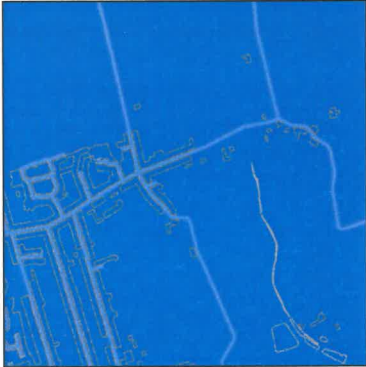
<h3>Bedrock permeability</h3>

The bedrock permeability is <b>spatially variable</b> , but likely to permit moderate infiltration.

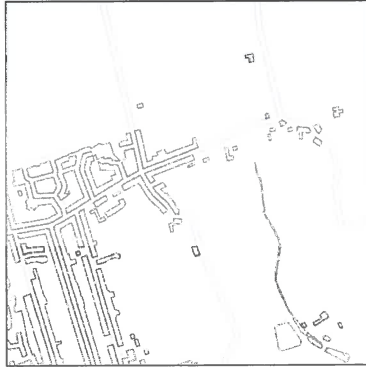
Superficial floodplain deposits or low-lying coastal areas have been identified. Groundwater levels may rise in response to high river or tide levels, potentially causing inundation of subsurface infiltration SuDS.

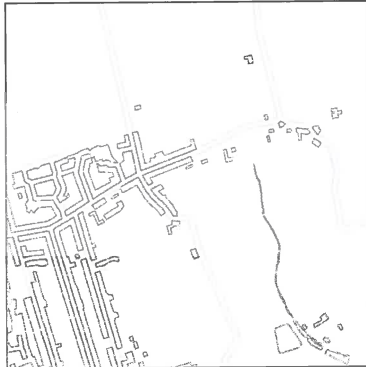
## Made ground

Made ground is present at the surface. Infiltration may increase the possibility of remobilising pollutants.

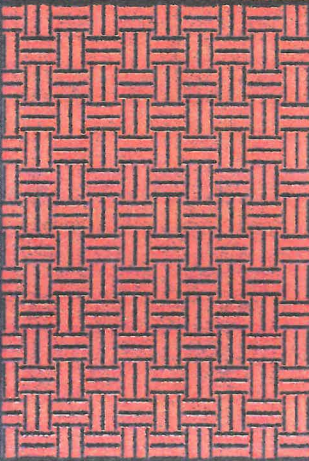
0.708	47.80	
LOOSE ORANGERY BROWN SLIGHTLY CLAYEY FINE TO MEDIUM SAND. SAND IS FINE TO MEDIUM SUBANGULAR TO SUBROUNDED WITH OCCASIONAL GRAVEL OF MIXED LITHOLOGES.

2.100	46.40	1.200

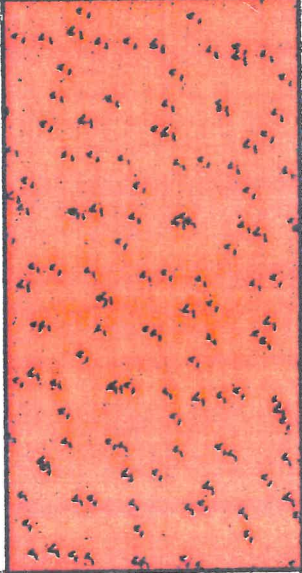
0.500	4.850	
ORANGERY BROWN SLIGHTLY CLAYEY, SANDY GRAVEL SAND IS FINE TO MEDIUM GRAVEL IS COARSE SUBANGULAR TO SUBROUNDED MIXED LITHOLOGES

2.350	4.740 4.615	1.100

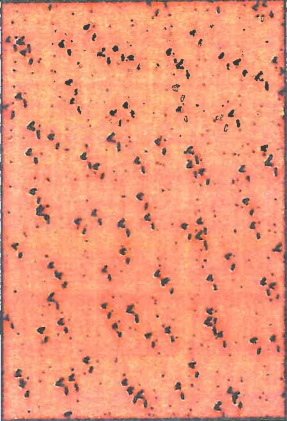
0.500	48.80	
ORANGERY BROWN SLIGHTLY CLAYEY, SANDY GRAVEL. SAND IS FINE TO MEDIUM GRAVEL IS COARSE SUBANGULAR TO SUBROUNDED MIXED LITHOLOGIES

1.900	47.50 46.90	1.300
