Surface Water Drainage Strategy
Outline Residential Development
102 East Road
West Mersea
Essex

Revised September 2020

Appendix V
Outline Surface Water Strategy

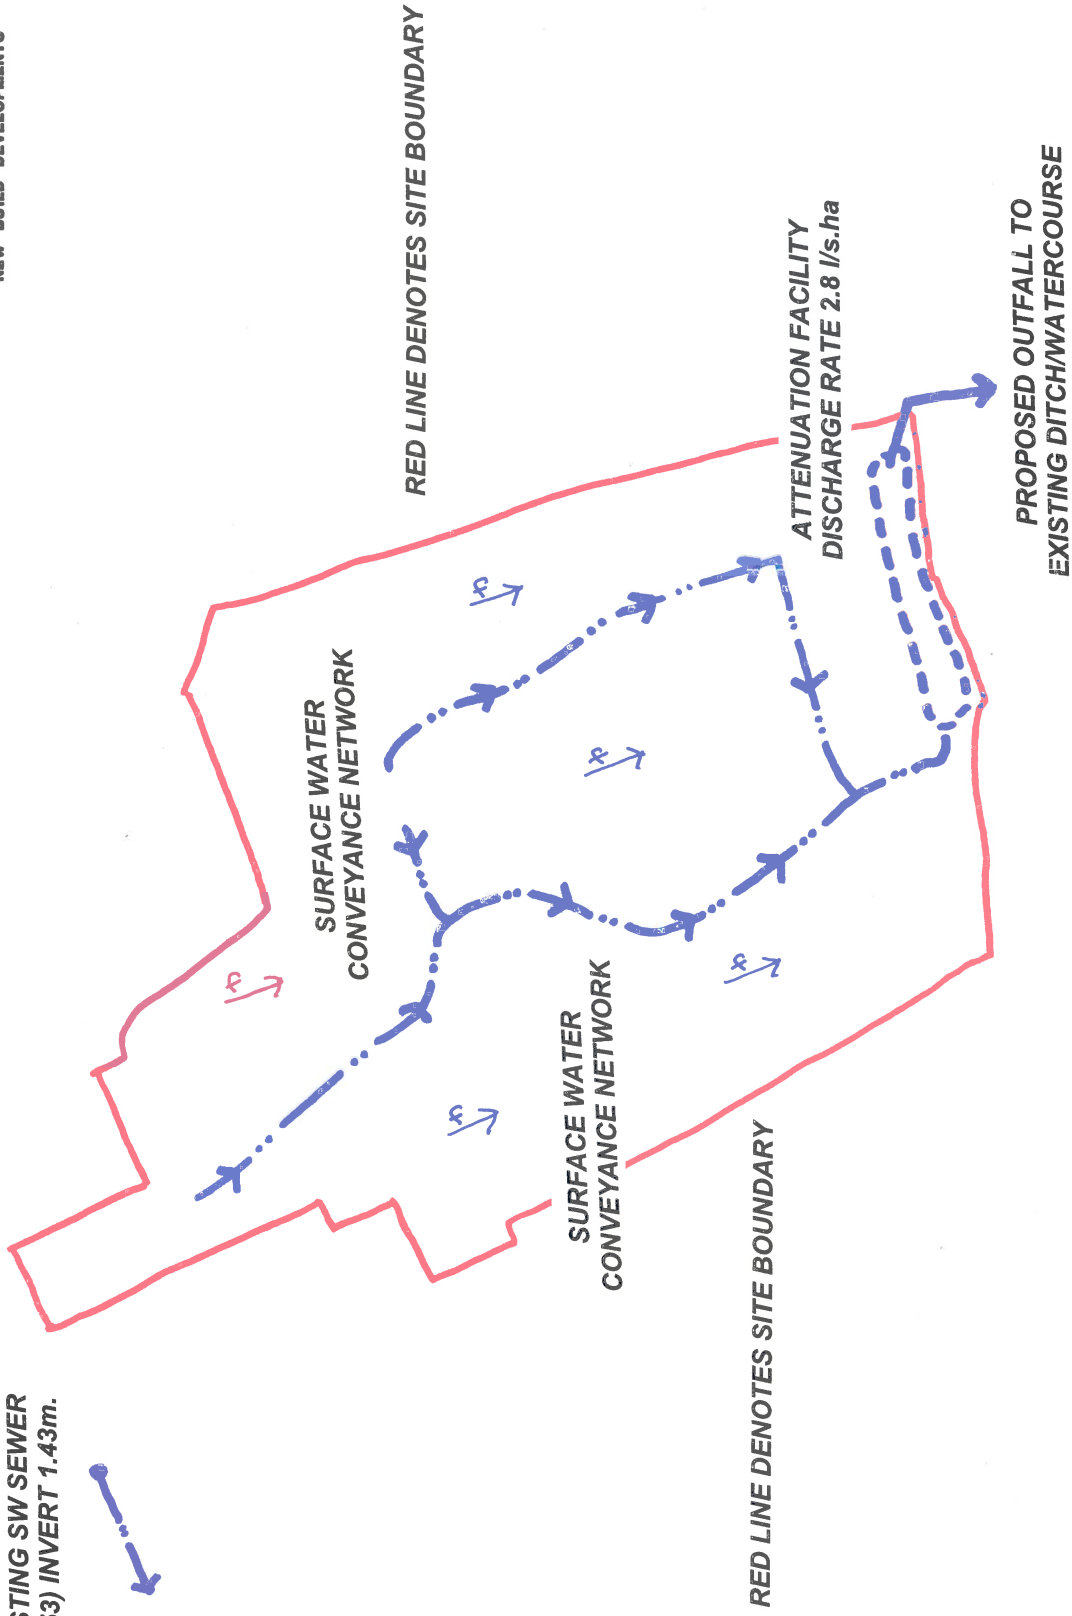
**102 EAST ROAD
WEST MERSEA, ESSEX**

SCALE 1:500 (A1)

**EXISTING SW SEWER
(4453) INVERT 1.43m.**

THE JOHNSON DENNEHY PLANNING PARTNERSHIP LTD. The Coach House, Beacon End House, London Road, Stanway, Colchester, Essex CO3 0NY Telephone: 00 44 1206 763334 Fax: 00 44 1206 763335 E-Mail: jdp2@hconnect.com	PROJECT RESIDENTIAL DEVELOPMENT 102 EAST ROAD WEST MERSEA ESSEX.	TITLE OUTLINE SURFACE WATER DRAINAGE STRATEGY	CLIENT BlueSquare Homes NEW BUILD DEVELOPMENTS	Revisions

- 4.1 Site infiltration knowledge has determined that rates are too low to support the disposal of surface water runoff via infiltration.
- 4.2 It is therefore proposed to discharge surface water runoff from the site via a connection to the existing ditch/watercourse which forms the eastern site boundary.
- 4.3 Sufficient on-site surface water storage will be provided in order to manage the 1 in 100 annual probability storm including the requisite 40% allowance for climate change. The discharge rate will be limited to the annual greenfield rate (Q1) of 2.8l/s/ha.
- 4.4 It is proposed to attenuate flows in a single attenuation arrangement located along the southern boundary of the site. All flow controls will be suitably protected.
- 4.5 All proposals are subject to detailed design and the approval of relevant parties.

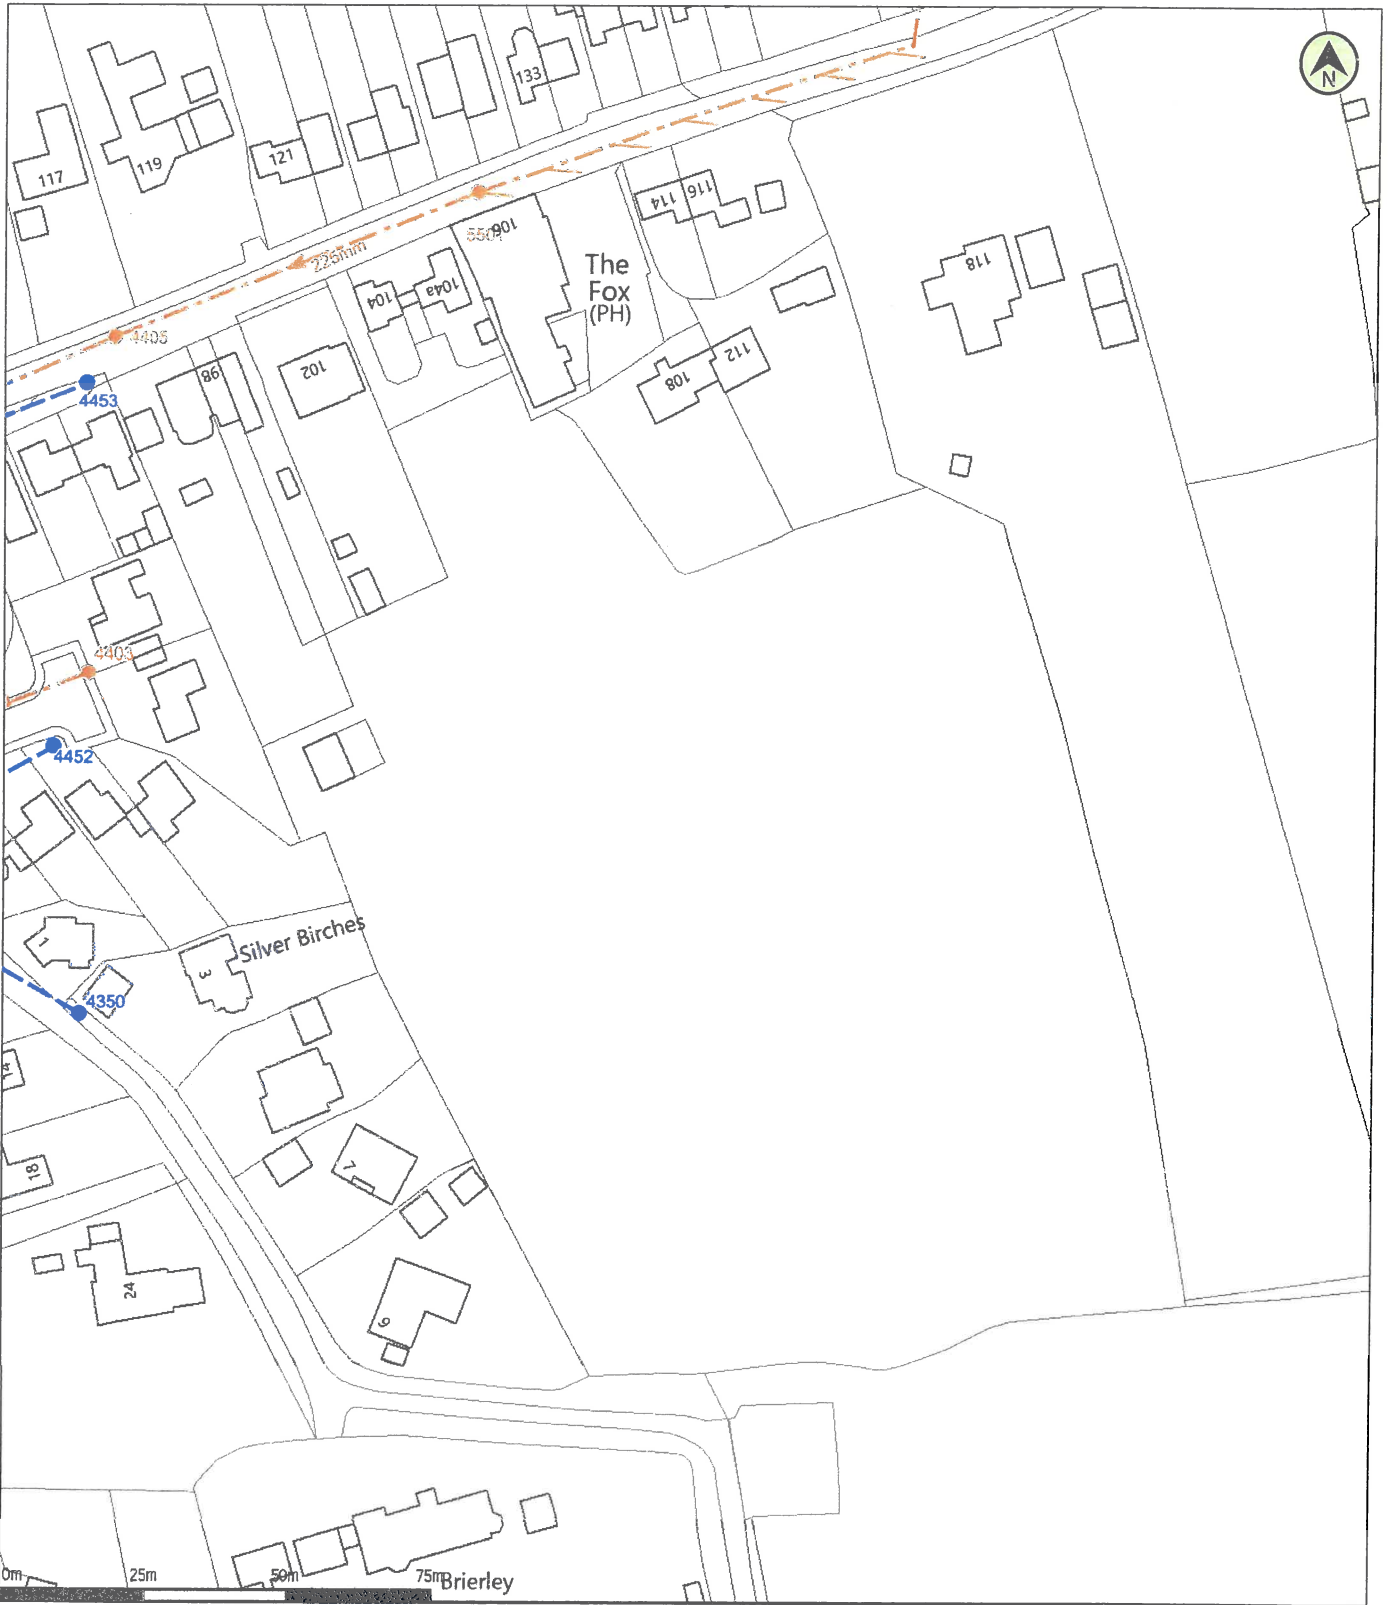
(c) Crown copyright and database rights 2020 Ordnance Survey 100019209 Scale: 1:1250 Date: 17/08/20 Wastewater Plan A4
 Data updated: 31/07/20 Map Centre: 602552,213411 Our Ref: 427102 - 2 Powered by digdad

Foul Sewer		Outfall*		Sewage Treatment Works		jdp2@btconnect.com
Surface Sewer				Public Pumping Station		102 East Road
Combined Sewer		Inlet*		Decommissioned Pumping Station		
Final Effluent						
Rising Main*						
Private Sewer*						
Decommissioned Sewer*		Manhole*

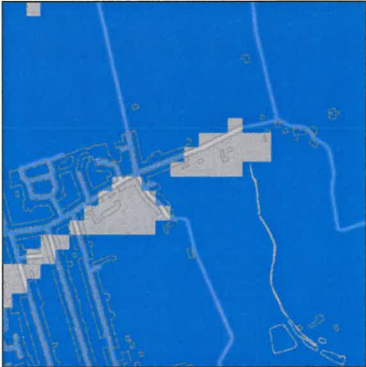
In terms of the drainage potential, is the ground suitable for infiltration SuDS?

Highly compatible for infiltration SuDS. The subsurface is likely to be suitable for free-draining infiltration SuDS.</p>
	<p>

Probably compatible for infiltration SuDS. The subsurface is probably suitable although the design may be influenced by the ground conditions.</p>
	<p>

Opportunities for bespoke infiltration SuDS. The subsurface is potentially suitable although the design will be influenced by the ground conditions.</p>
	<p>

Very significant constraints are indicated. There is a very significant potential for one or more hazards associated with infiltration.</p>
Is ground instability likely to be a problem?

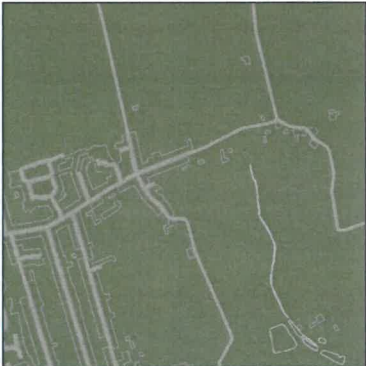
Increased infiltration is very unlikely to result in ground instability.</p>

Ground instability problems may be present or anticipated, but increased infiltration is unlikely to result in ground instability.</p>
	<p>

Ground instability problems are probably present. Increased infiltration may result in ground instability.</p>
	<p>

There is a very significant potential for one or more geohazards associated with infiltration.</p>
Is the groundwater susceptible to deterioration in quality?

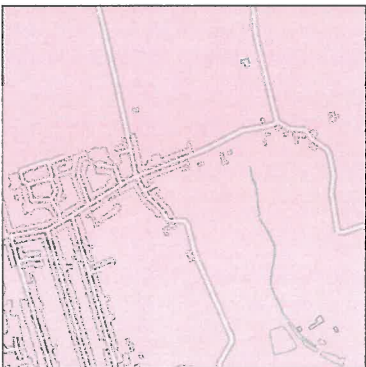
Made ground is present at the surface. Infiltration may increase the possibility of remobilising pollutants.</p>

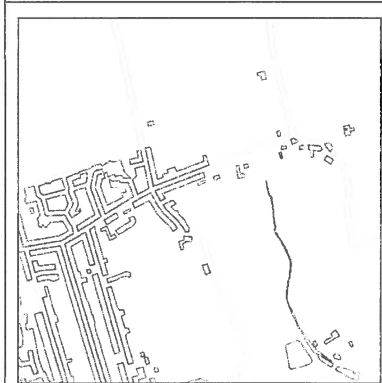
Soluble rock hazard

<p>Contains OS data © Crown Copyright and database right 2020</p>	<p><input checked="" type="checkbox"/> Very significant soluble rock hazard. Soluble rocks are present with a very significant possibility of localised subsidence that could be initiated or made worse by infiltration. The site investigation should consider whether the potential for or the consequences of subsidence as a result of infiltration are significant.</p>
	<p><input type="checkbox"/> Very significant soluble rock hazards are not present; however this hazard may still need to be considered. See Part 3.</p>
Landslide hazard

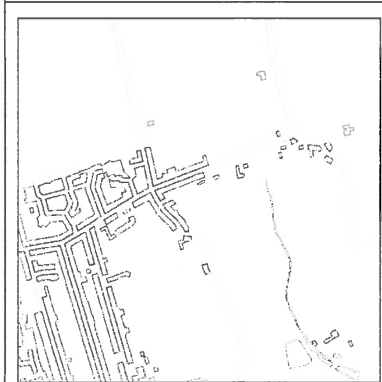
<p>Contains OS data © Crown Copyright and database right 2020</p>	<p><input checked="" type="checkbox"/> Very significant landslide hazard. Slope instability problems are almost certainly present and may be active. An increase in moisture content as a result of infiltration may cause the slope to fail. The site investigation should consider whether the potential for or the consequences of landslide as a result of infiltration are significant.</p>

<p><input type="checkbox"/> Very significant landslide hazards are not present; however this hazard may still need to be considered. See Part 3.</p>

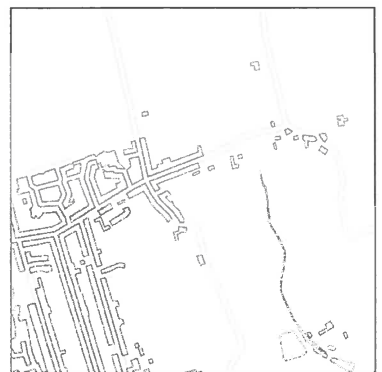
Shallow mining hazard

<p>Contains OS data © Crown Copyright and database right 2020</p>	<p><input checked="" type="checkbox"/> Very significant mining hazard. Shallow mining is likely to be present with a very significant possibility of localised subsidence that could be initiated or made worse by increased infiltration. Also, infiltration may increase the possibility of remobilising pollutants. The site investigation should consider whether the potential for or consequences of subsidence and/or remobilisation of pollutants as a result of infiltration are significant.</p>
	<p><input type="checkbox"/> Very significant mining hazards are not present; however this hazard may still need to be considered. See Part 3.</p>
Persistent shallow groundwater

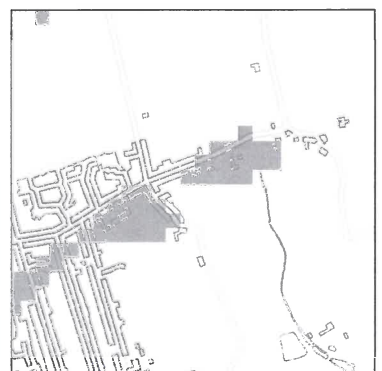
<p>Contains OS data © Crown Copyright and database right 2020</p>	<p><input checked="" type="checkbox"/> Very high likelihood of persistent or seasonally shallow groundwater. Persistent or seasonally shallow groundwater is likely to be present. Infiltration may increase the likelihood of soakaway inundation, or groundwater emergence at the surface. The site investigation should consider whether the potential for or the consequences of groundwater level rise as a result of infiltration are significant.</p>

<p><input type="checkbox"/> See Part 2 for the likely depth to water table.</p>
Made ground

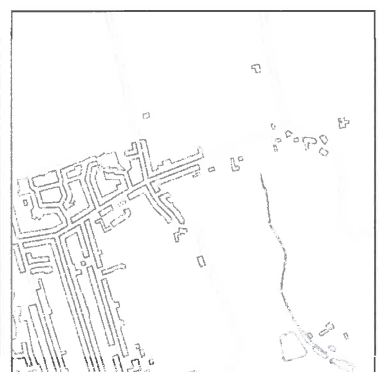
<p>Contains OS data © Crown Copyright and database right 2020</p>	<p><input checked="" type="checkbox"/> Made ground present. Made ground is present at the surface. Infiltration may affect ground stability or increase the possibility of remobilising pollutants. The site investigation should consider whether the potential for or consequences of ground instability and/or pollutant leaching as a result of infiltration are significant.</p>
	<p><input type="checkbox"/> None recorded</p>

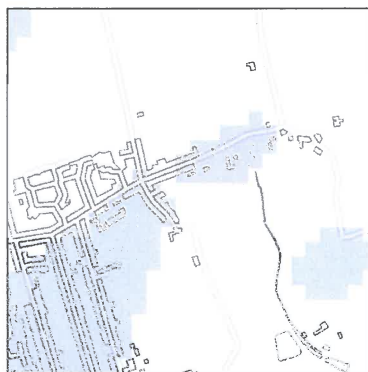
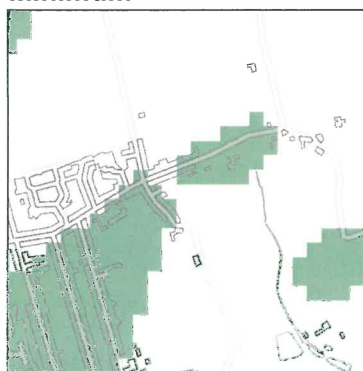
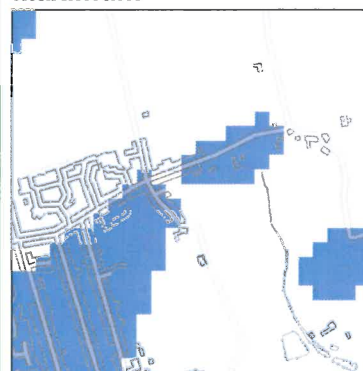
Superficial deposit permeability

The superficial deposit permeability is **spatially variable**, but likely to permit moderate infiltration.

-   Very Low
-   Low
-   Moderate
-   High
-   Very High

Superficial deposits are not present everywhere and therefore some areas of the *superficial deposit permeability* map may not be coloured. Where this is the case, the *bedrock permeability* map shows the likely permeability of the ground. Superficial deposits in some places are very thin and hence in these places you may wish to consider both the permeability of the superficial deposits and the permeability of the bedrock. The *superficial thickness* map will tell you whether the superficial deposits are thin (< 3 m thick) or thick (>3 m). Where they are over 3 m thick, the permeability of the bedrock may not be relevant.

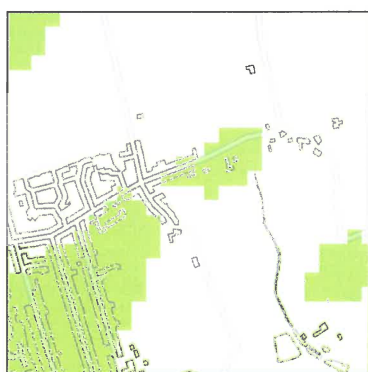
Superficial deposit thickness

The thickness of superficial deposits is **> 3 m** and hence the permeability of the superficial deposits is likely to determine the permeability of the ground.

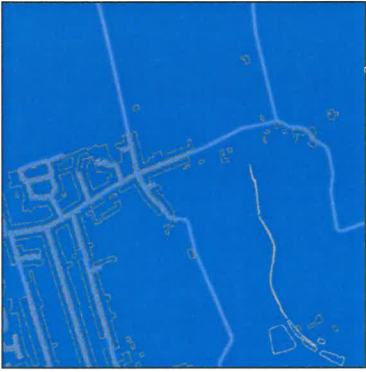
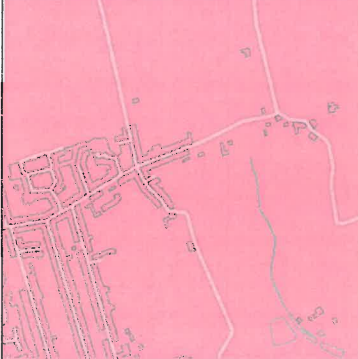
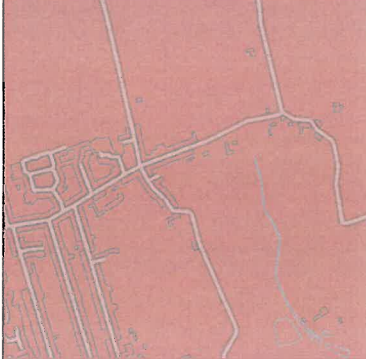
Bedrock permeability

<p>Contains OS data © Crown Copyright and database right 2020</p>	<ul style="list-style-type: none"> Bedrock deposits are likely to be free-draining. The bedrock permeability is spatially variable, but likely to permit moderate infiltration. Bedrock deposits are likely to be poorly draining. 	
<p>These maps show the permeability range that is summarised above.</p> <p>Key</p> <ul style="list-style-type: none"> Very Low Low Moderate High Very High 	<p>Minimum</p>

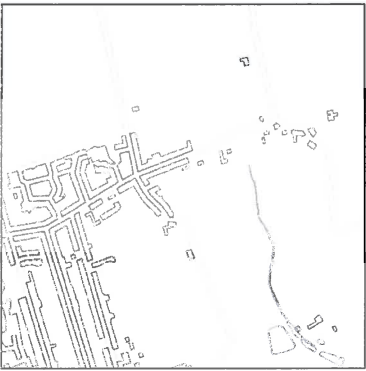
<p>Contains OS data © Crown Copyright and database right 2020</p>	<ul style="list-style-type: none"> Superficial floodplain deposits or low-lying coastal areas have been identified. Groundwater levels may rise in response to high river or tide levels, potentially causing inundation of subsurface infiltration SuDS.

In floodplain deposits, groundwater level can be influenced by the water level in the adjacent river. Groundwater level may increase during periods of fluvial flood and therefore this should be taken into account when designing infiltration systems on such deposits. The *geological indicators of flooding* dataset shows where there is geological evidence (floodplain deposits) that flooding has occurred in the past.

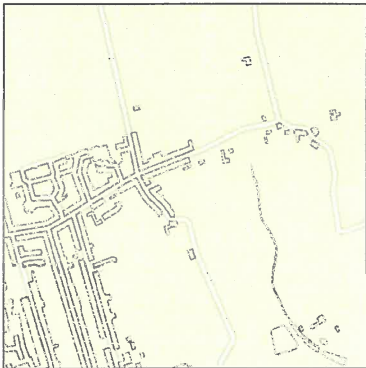
Soluble rocks

Increased infiltration is unlikely to result in subsidence.

Increased infiltration is unlikely to cause localised subsidence, but potential impacts should be considered.

Increased infiltration may result in localised subsidence. The potential for or the consequences of subsidence associated with soluble rocks should be considered.

Very significant possibility of localised subsidence that could be initiated or made worse by infiltration.

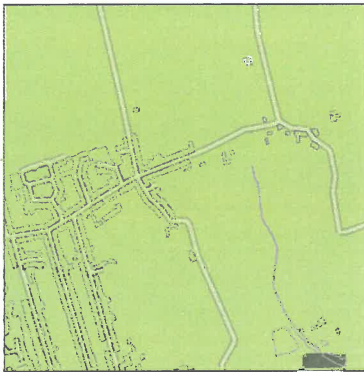
Landslides

- Increased infiltration is unlikely to lead to slope instability.
- Slope instability problems may be present or anticipated, but increased infiltration is unlikely to cause instability
- Slope instability problems are probably present or have occurred in the past, and increased infiltration may result in slope instability.
- Slope instability problems are almost certainly present and may be active. An increase in moisture content as a result of infiltration may cause the slope to fail.

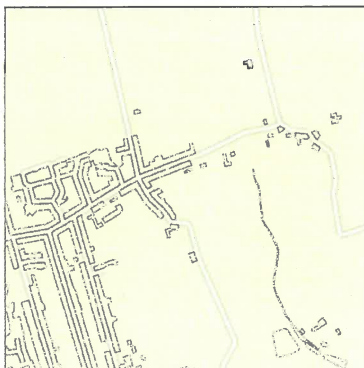
- Increased infiltration is unlikely to lead to subsidence.
- Shallow mining is possibly present. Increased infiltration is unlikely to cause a geohazard, but potential impacts should be considered.
- Shallow mining could be present with a significant possibility that localised subsidence could be initiated or made worse by increased infiltration.
- Shallow mining is likely to be present, with a very significant possibility that localised subsidence may be initiated or made worse by increased infiltration.

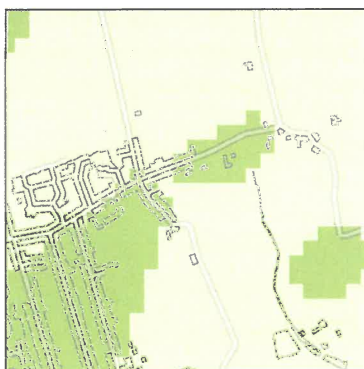
- Increased infiltration is unlikely to cause ground collapse associated with running sands.
- Running sand is possibly present. Increased infiltration is unlikely to cause a geohazard, but potential impacts should be considered.
- Significant possibility for running sand problems. Increased infiltration may result in a geohazard.

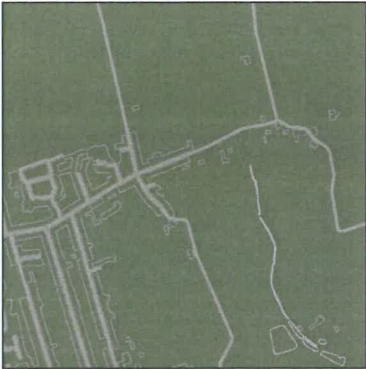
<h3>Swelling clays</h3>

<p>Contains OS data © Crown Copyright and database right 2020</p>	<p>  Increased infiltration is unlikely to cause shrink-swell ground movement.</p>
	<p>  Ground is susceptible to shrink-swell ground movement. Increased infiltration is unlikely to cause a geohazard, but potential impacts should be considered.</p>
	<p>  Ground is susceptible to shrink-swell ground movement. Increased infiltration may result in a geohazard.</p>
<h3>Compressible ground</h3>

A shrinking and swelling clay changes volume significantly according to how much water it contains. All clay deposits change volume as their water content varies, typically swelling in winter and shrinking in summer, but some do so to a greater extent than others. Contributory circumstances could include drought, leaking service pipes, tree roots drying-out the ground or changes to local drainage patterns, such as the creation of soakaways. Shrinkage may remove support from the foundations of buildings and structures, whereas clay expansion may lead to uplift (heave) or lateral stress on part or all of a structure; any such movements may cause cracking and distortion.

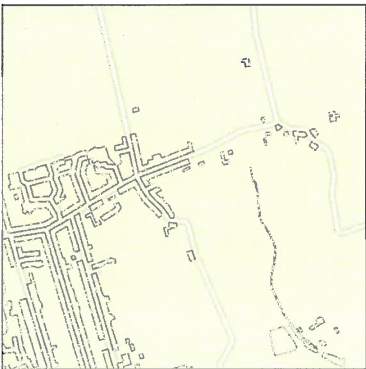
Increased infiltration is unlikely to lead to ground compression.</p>
	<p>  Compressibility and uneven settlement hazards are probably present. Increased infiltration may result in a geohazard.</p>
<h3>Collapsible ground</h3>	
  <p>Contains OS data © Crown Copyright and database right 2020</p>	<p>  Increased infiltration is unlikely to result in subsidence.</p>

<p>  Deposits with potential to collapse when loaded and saturated are possibly present in places. Increased infiltration is unlikely to cause a geohazard, but potential impacts should be considered.</p>
	<p>  Deposits with potential to collapse when loaded and saturated are probably present in places. Increased infiltration may result in a geohazard.</p>

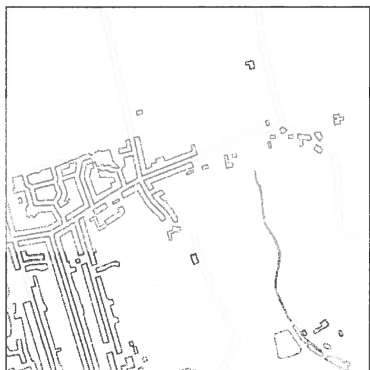
Groundwater source protection zones

<p>Contains OS data © Crown Copyright and database right 2020</p> <p>Derived in part from Source Protection Zone data provided under licence from the Environment Agency © Environment Agency 2020.</p>	<input type="checkbox"/> Groundwater is not within a source protection zone.
	<input type="checkbox"/> Source protection zone IV
	<input type="checkbox"/> Source protection zone III
	<input type="checkbox"/> Source protection zone II
	<input type="checkbox"/> Source protection zone I
Predominant flow mechanism

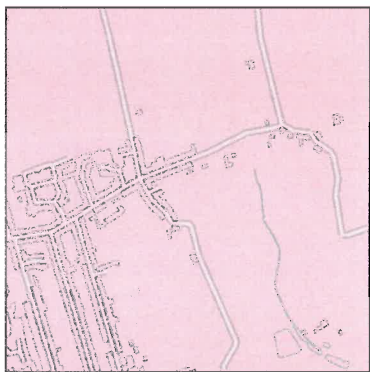
<p>Contains OS data © Crown Copyright and database right 2020</p>	<input type="checkbox"/> Water is likely to percolate through the unsaturated zone to the groundwater through either the pore space in granular media or through porespace and fractures; these processes have some potential for contaminant removal and breakdown.
	<input type="checkbox"/> Water is likely to percolate through the unsaturated zone to the groundwater through fractures, a process which has little potential for contaminant removal and breakdown.

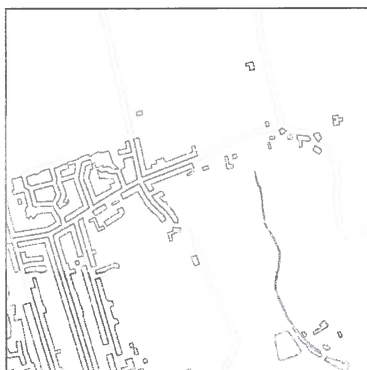
Made ground is present at the surface. Infiltration may increase the possibility of remobilising pollutants.

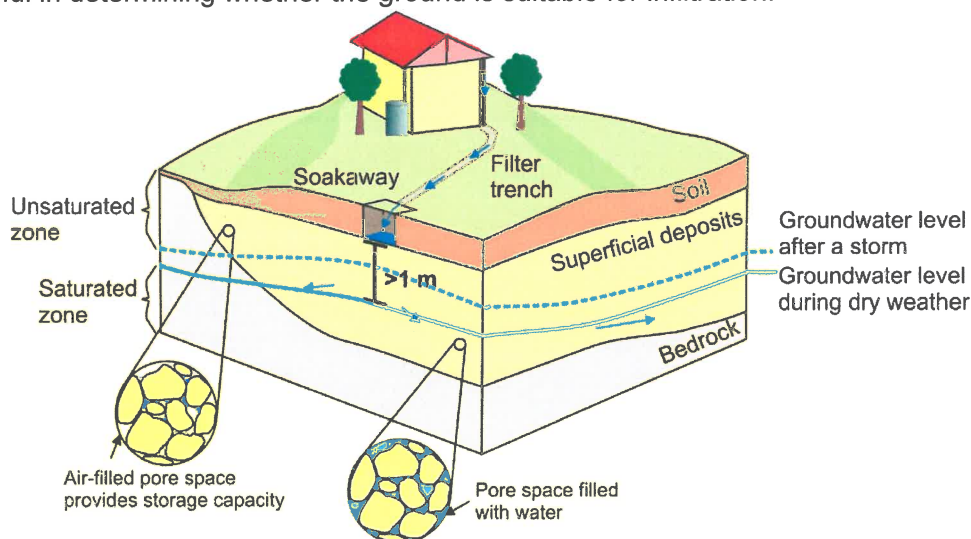
Depth to groundwater

In the shallow subsurface, the ground is commonly unsaturated with respect to water. Air fills the spaces within the soil and the underlying superficial deposits and bedrock. At some depth below the ground surface, there is a level below which these spaces are full of water. This level is known as the groundwater level, and the water below it is termed the groundwater. When water is infiltrated, the groundwater level may rise temporarily. To ensure that there is space in the unsaturated zone to accommodate this, there should be a minimum thickness of 1 m between the base of the infiltration system and the water table. An estimate of the *depth to groundwater* is therefore useful in determining whether the ground is suitable for infiltration.

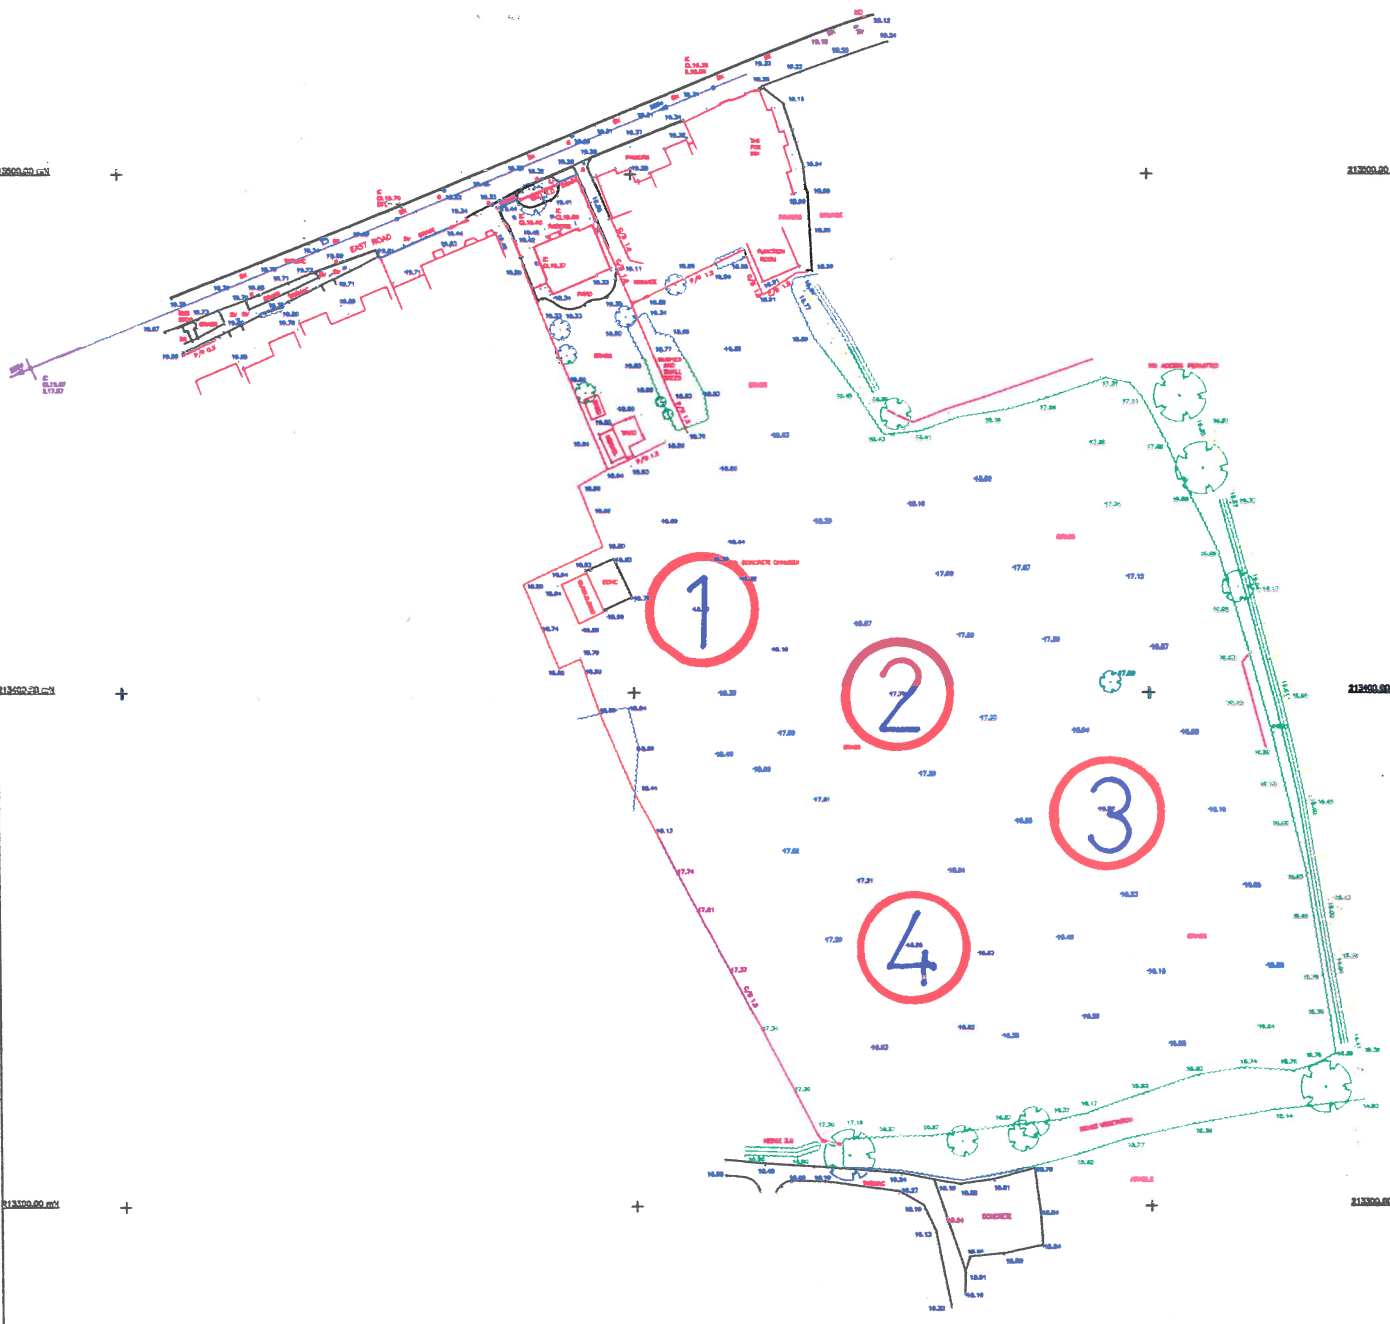
**SURFACE WATER DRAINAGE STRATEGY
TRIAL PIT LOG LOCATION**

- SY High Point
- SY Low Point
- SY Boundary Point
- SY Low Point
- SY Road Edge
- SY Area Marker
- SY Station
- SY Bench
- SY New System
- SY Old System
- SY Inspection Chamber

Soakaway Test Reference Number	Test Depth Range (m.bgl)	Infiltration Rate	Geology
SA 1	0.80 – 1.60	Failed	Gravelly Clayey Sand
SA 2	0.60 – 1.50	Failed	
SA 3	1.70 – 1.60	Failed	
SA 4	0.60 – 1.60	Failed

The infiltration testing has been undertaken at an available range of depths above a shallow ground water table in the silty gravelly sands, which are considered to represent the mapped superficial deposits. However, given the high proportions of site and some clays all the infiltration tests failed to reach 75% effective depth over a 24 hour period and as such, the Site is unlikely to be suitable for traditional soakaways as a method of drainage.

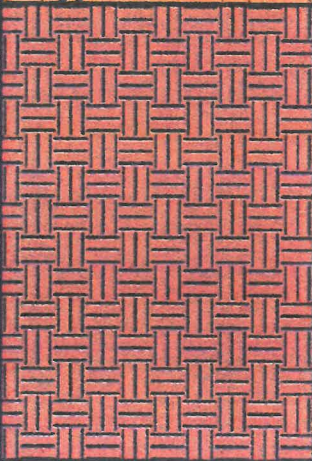
0.700	47.60	
LOOSE ORANGERY BROWN, SLIGHTLY CLAYEY FINE TO MEDIUM SAND. SAND IS FINE TO MEDIUM, SUBANGULAR TO SUBROUNDED WITH OCCASIONAL GRAVEL OF MIXED LITHOLOGES.

2.100	46.40	1.200

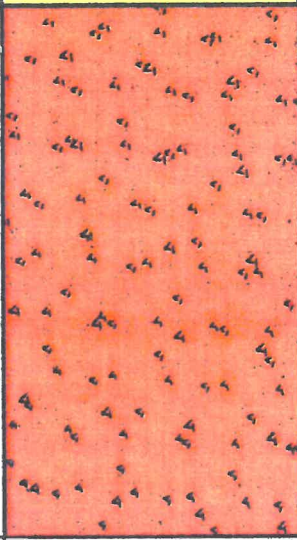
0.500	47.70	
ORANGERY BROWN, SLIGHTLY CLAYEY, SANDY GRAVEL SAND IS FINE TO MEDIUM, GRAVEL IS COARSE SUBANGULAR TO SUBROUNDED MIXED LITHOLOGES

2.200	45.50

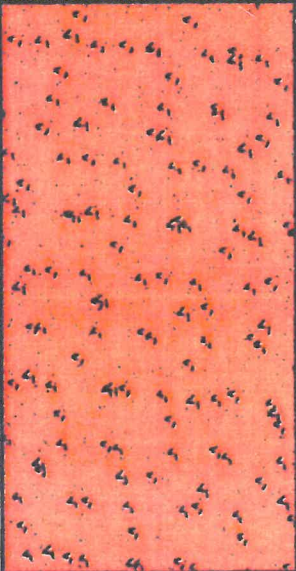
0.500	48.50	
ORANGERY BROWN SLIGHTLY CLAYEY, SANDY GRAVEL. SAND IS FINE TO MEDIUM GRAVEL IS COARSE SUBANGULAR TO SUBROUNDED MIXED LITHOLOGES

2.350	46.15	1.100
			47.40

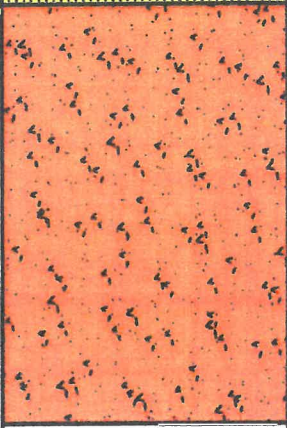
0.500	4.8.80	
ORANGERY BROWN, SLIGHTLY CLAYEY, SANDY GRAVEL. SAND IS FINE TO MEDIUM GRAVEL IS COARSE SUBANGULAR TO SUBROUNDED MIXED LITHOLOGIES

1.900	4.7.50	1.300
			4.6.90

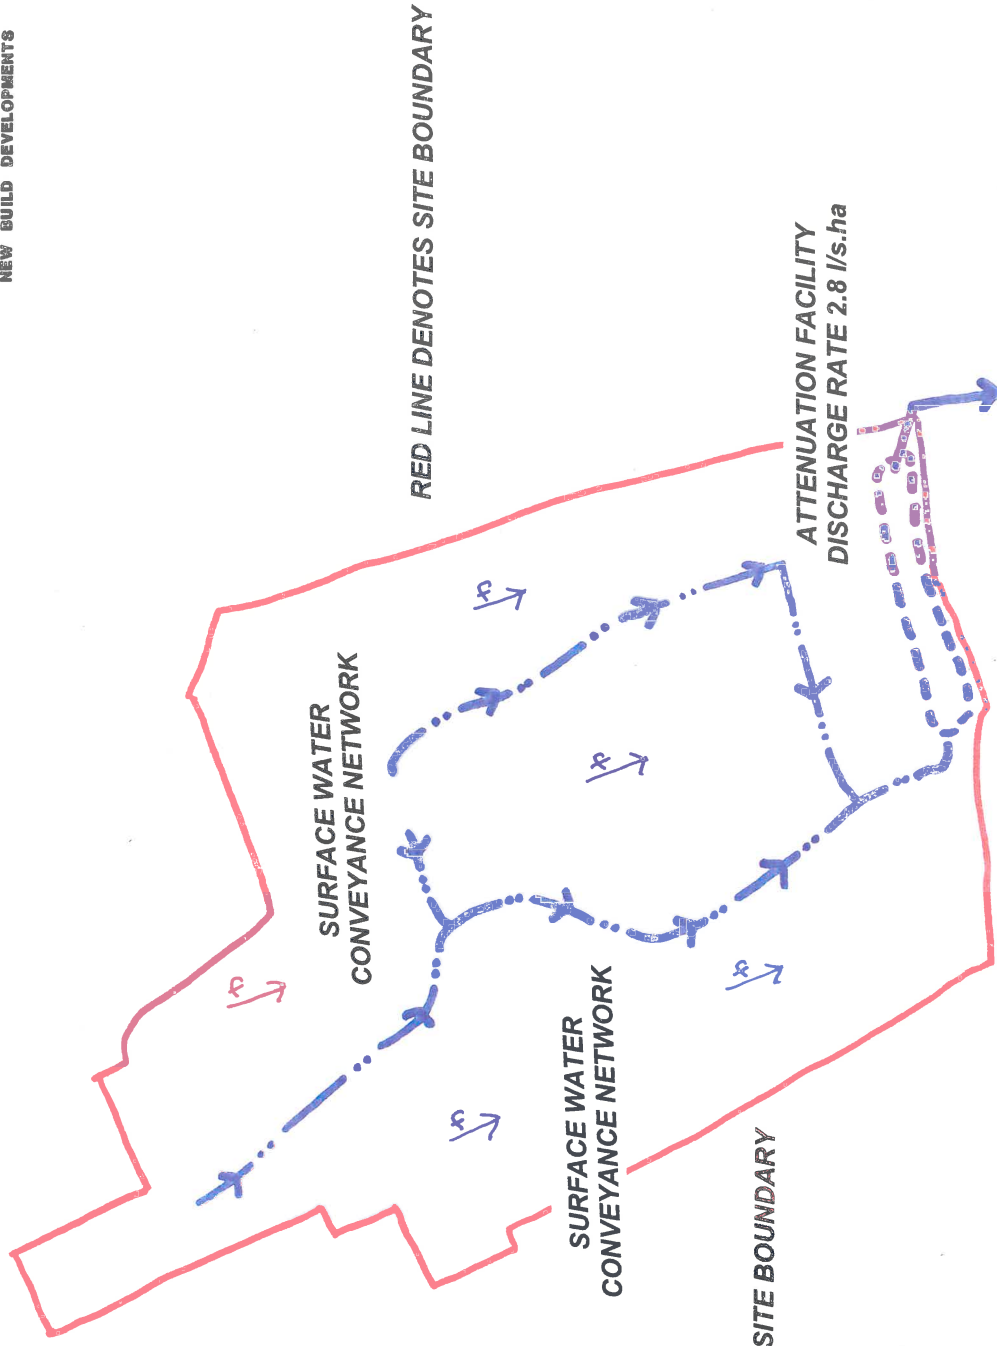
**PROPOSED OUTFALL TO
EXISTING DITCH/WATERCOURSE**

SCALE 1:500 (A1)

Attenuation Facility Design
 Catchment Area = 1.02 ha
 Impermeable Area = 0.40 ha
 Facility Depth = 0.9 m
 Basin Area = 970 m²
 Side Slope = 1 in 4
 Outfall Rate = 2.81/s/ha
